COUNCIL MEETING AGENDA

TOWN OF LUNENBURG

Tuesday, December 13, 2022 at 6 p.m.

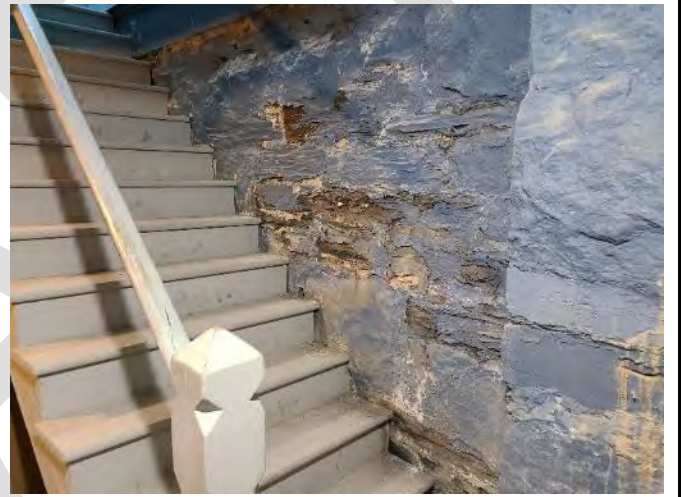
Basement

- Typical stone foundation visible throughout basement.

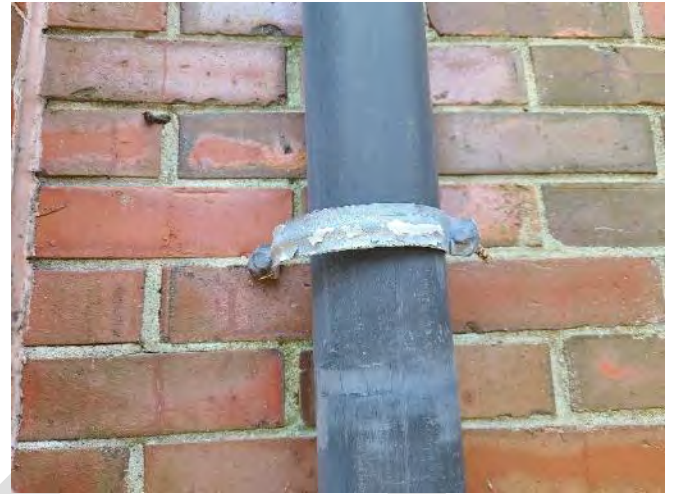
- Unsecured downspout support brackets were observed.

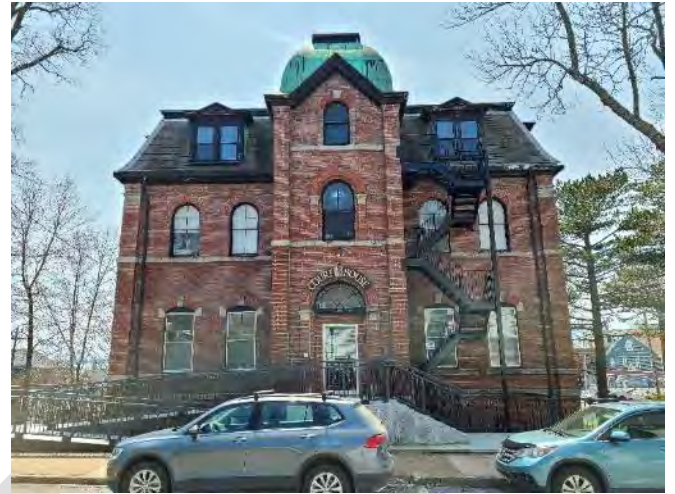
- General image of north elevation.
- Substantial crazing of masonry units was observed at multiple locations.

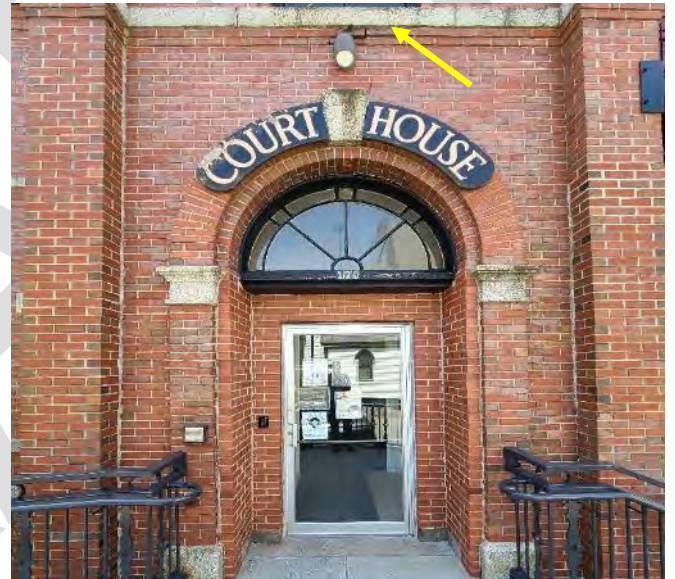
North Elevation

- General image of north elevation.
- Deteriorated mortar was observed below the first granite ribbon.
- Staining was observed at the granite keystone above the entrance and a granite ribbons.

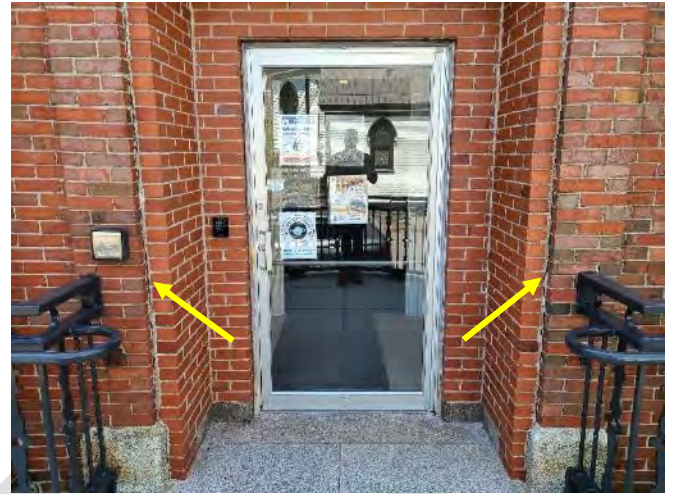
- Cracking of the mortar between the newer masonry and older, likely original, pilasters to the right and left of the entrance was observed.
- The inset entranceway, similar to that observed at the south elevation appears to be of relatively new construction as the masonry varies from the original.
- Significant crazing of masonry units was observed to both the right and left of the entrance. See following observation.

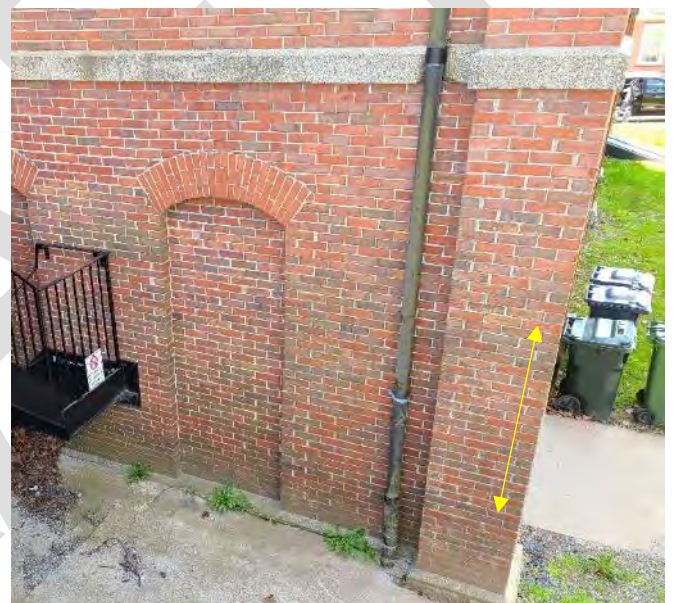
- Cracking through the masonry was observed at the base of the pilaster (yellow arrow).
- The original copper downspout has been replaced with plastic and is observed to drain beneath grade level.

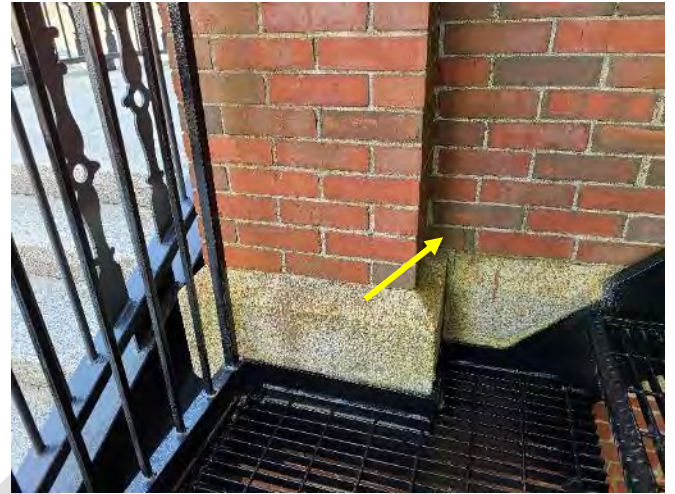
- Cracking of the masonry was observed (yellow arrow). See following image.

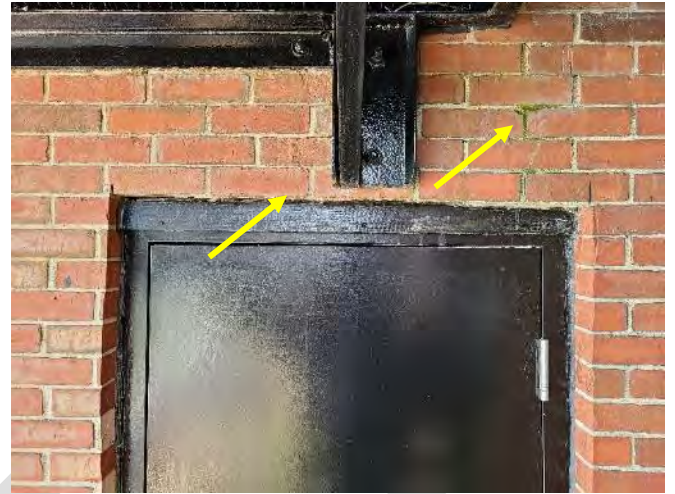
- No masonry lintel was observed above the exterior steel exit doors. See following image.
- Staining of the masonry was observed.
- Some organic growth was observed, particularly above the exit door.

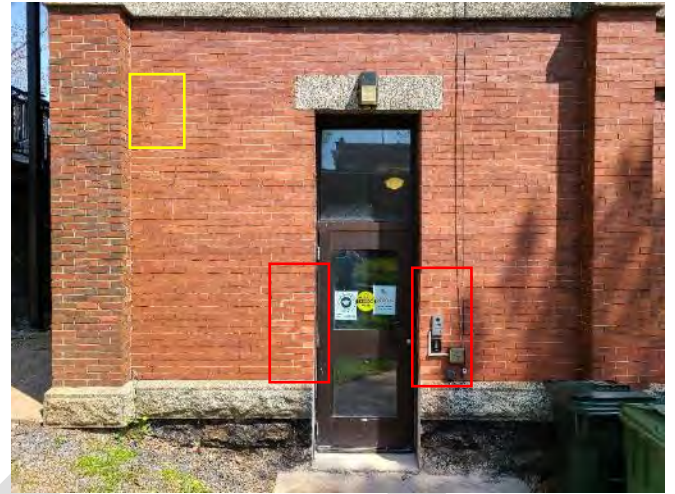
- Spalling of masonry faces was observed (yellow box).
- Previous repointing and masonry repairs were observed (red boxes).

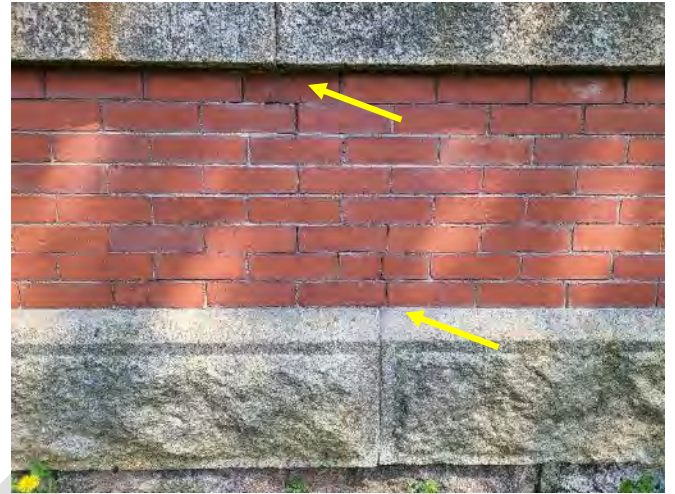
- Masonry cracking was observed at multiple locations.
- The crack, pictured here, originated at the granite foundation and travels vertically above the first-floor windows.

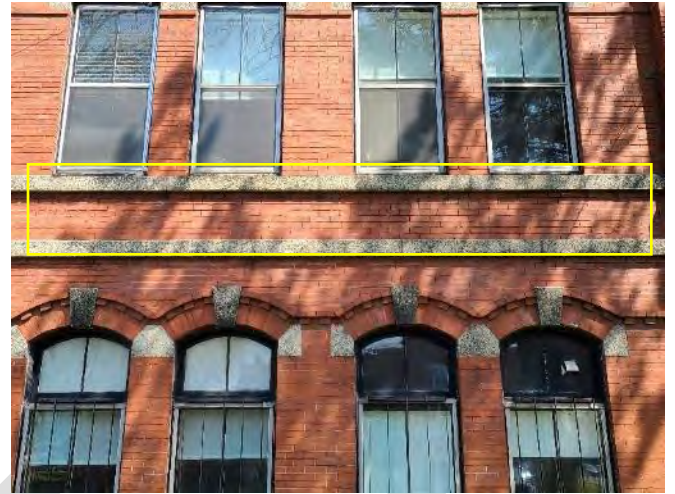
- Deteriorated masonry was observed between the first and second floor windows.

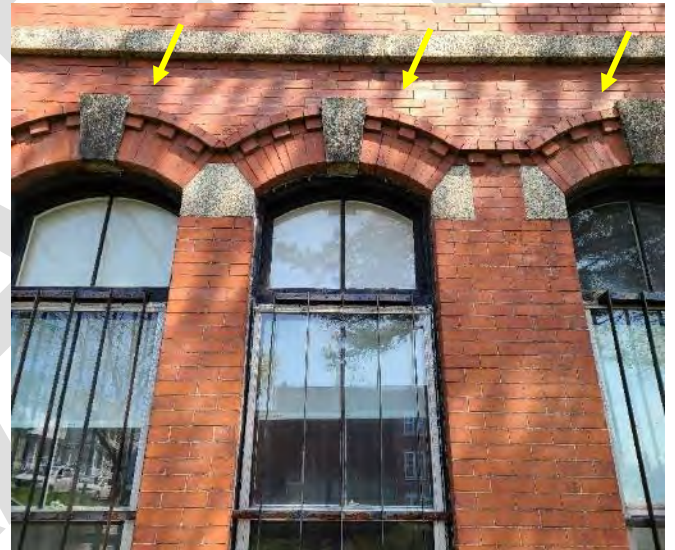
West Elevation

- Typical masonry arch detail above first floor windows.
- Deterioration of mortar joints between the cap bricks of the masonry eyebrow was observed (yellow arrows).
- Spalled masonry faces were observed at this location.
- Previous repairs were observed at the head of windows.
- Deteriorated sealant was observed.
- Staining of the granite keystones was observed.

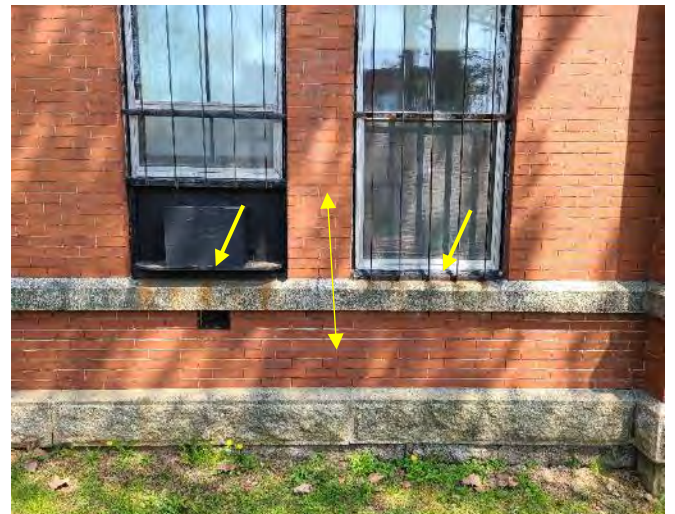
West Elevation

- Staining was observed at the granite ribbon below the first-floor windows. This is likely caused by the deteriorated, metal security bars at windows.
- Deteriorated mortar joints were observed below the granite ribbon.
- A masonry crack originating at the foundation was observed to travel vertically between windows.
- Efflorescence and crazing of the masonry units was observed at window level.

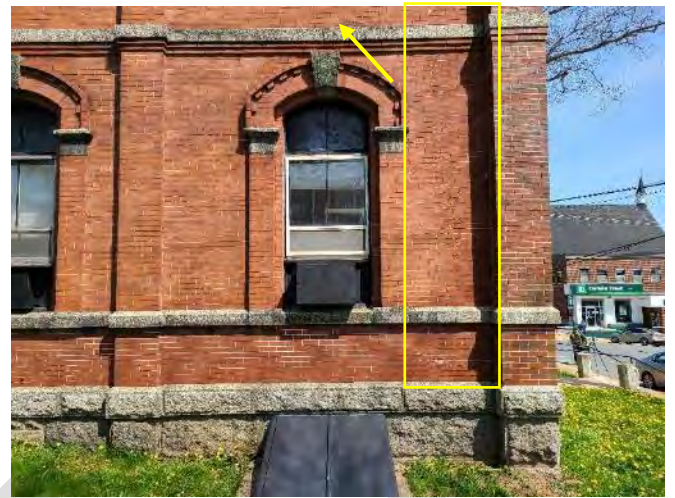
- Spalling of masonry was observed two to the left of the pilaster (yellow box).
- A masonry crack was observed above the window (yellow arrow).
- Staining of granite ribbons was observed.

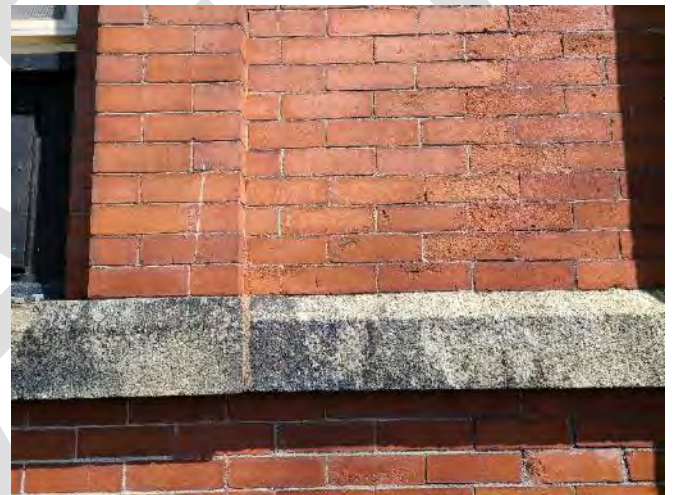
West Elevation

- Spalling of masonry was observed two to the left of the pilaster.
- Staining of granite ribbons was observed.

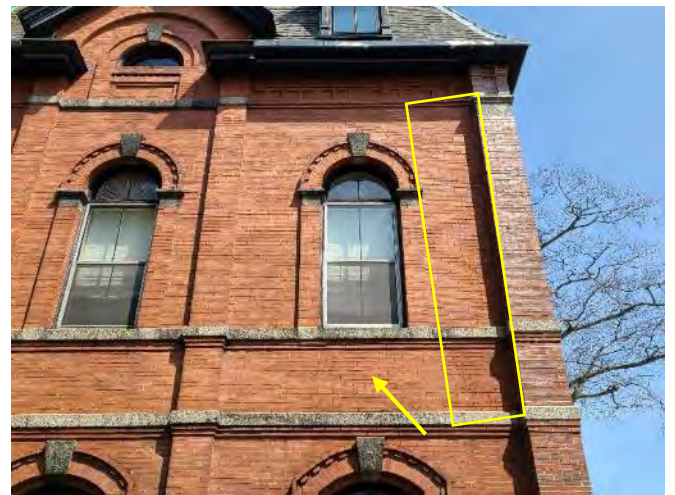
West Elevation

- Spalling of masonry was observed two to the left of the pilaster (yellow box).
- A masonry crack was observed (yellow arrow).
- See following observation.

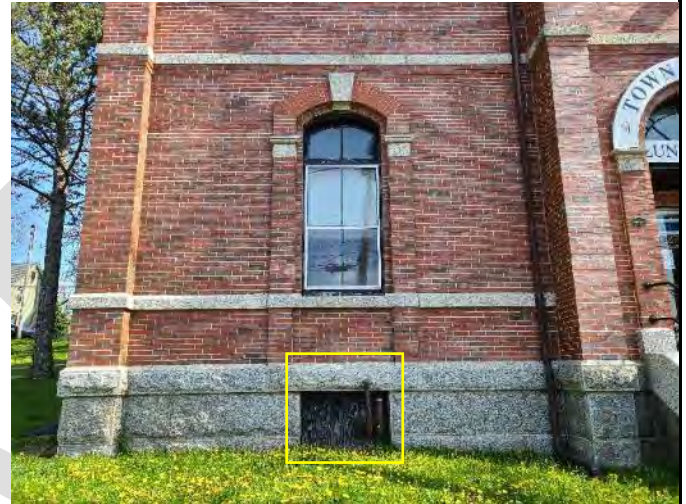
- Window frames were generally observed to be sound; however, paint was observed to be deteriorated.
- Sealant was observed to be deteriorated.
- The basement window is infilled with painted plywood. An oil fill and vent pipe were observed to penetrate the window area. Paint was observed to be deteriorated.

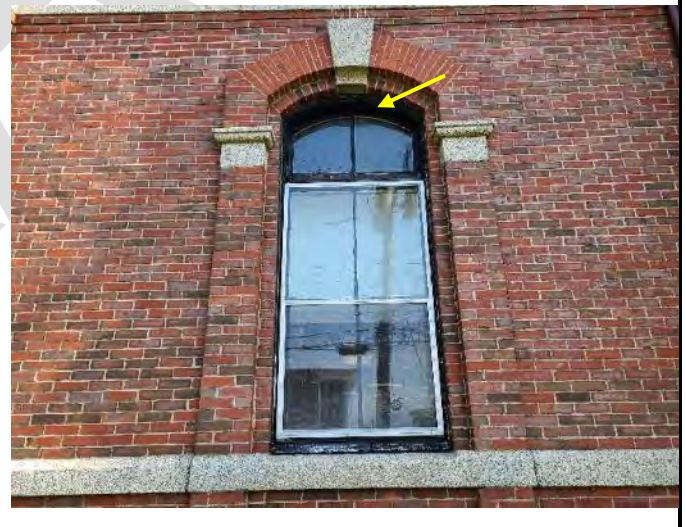
South Elevation

- Window frames were generally observed to be sound; however, paint was observed to be deteriorated.
- Sealant was observed to be deteriorated.
- A crack glazing unit was observed in the upper left arched window (yellow arrow).

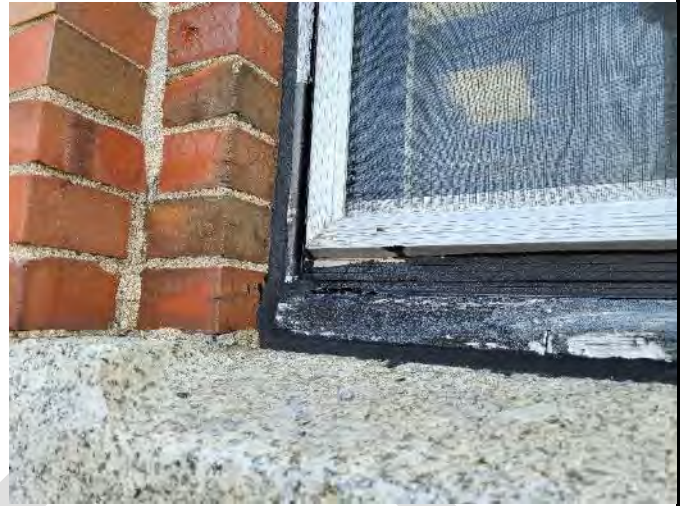
- In many instances, sealant has been replaced between window frames and masonry; however, the sealant used and it's application is inconsistent and was often observed to be deteriorated.
- Paint/stain was generally observed to be deteriorated at wooded window frames and sills.

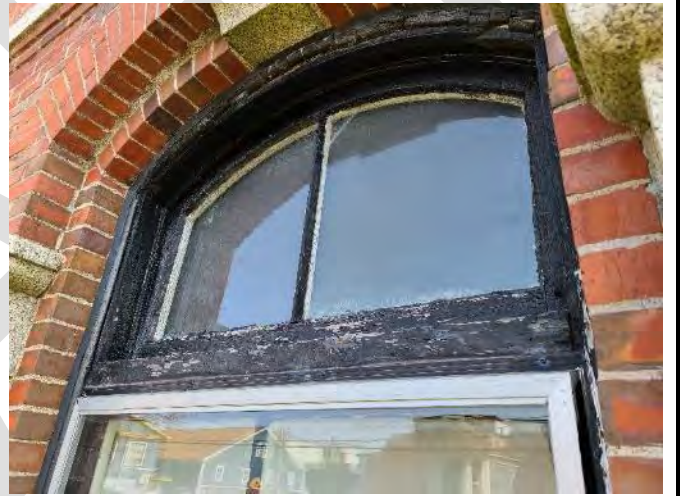
South Elevation

- Paint/stain at the upper arched window was observed to be deteriorated.
- The brickmould for the arch appears to be constructed of multiple pieces of quarter round. This does not appear to be of original construction.

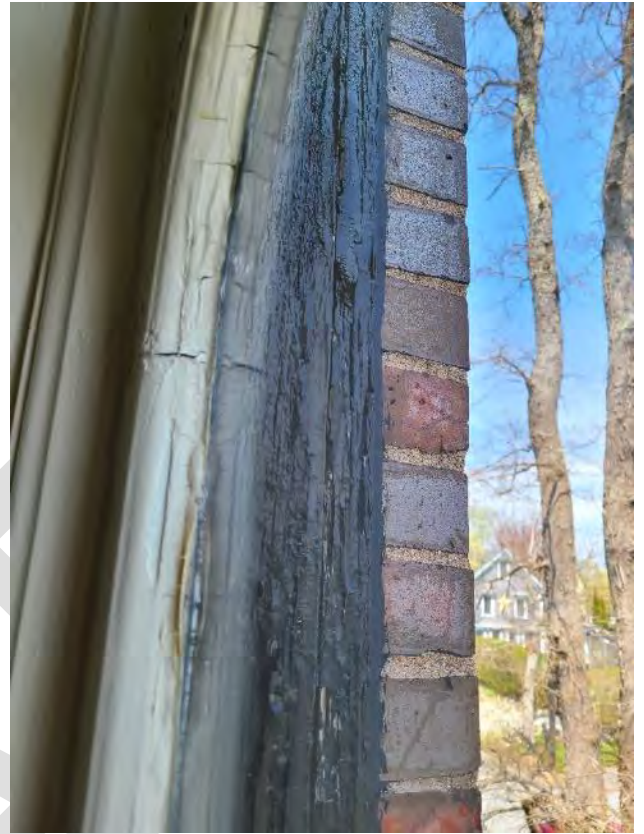
- In general, wood sashes and window frames were observed to be in deteriorating condition and in need of rejuvenation.
- Crazeing can be seen at the masonry.

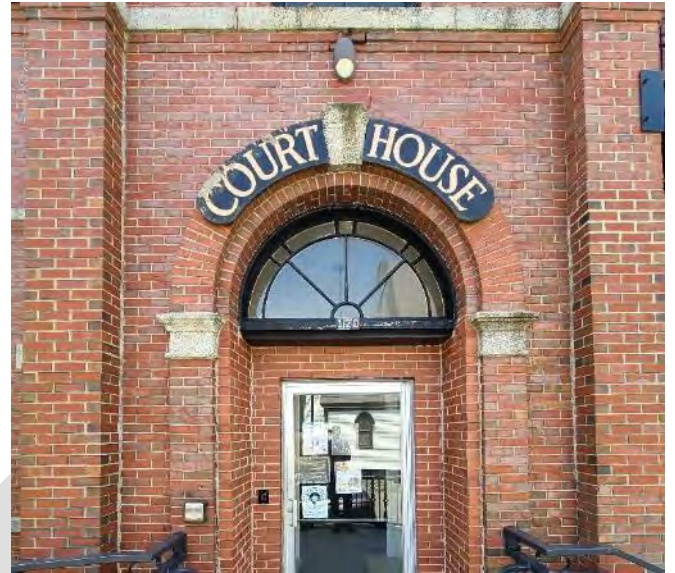
- An arched window is observed over the north entrance. This appears to match the arched window over the south entrance.
- Deteriorated paint/stain and sealant was observed.

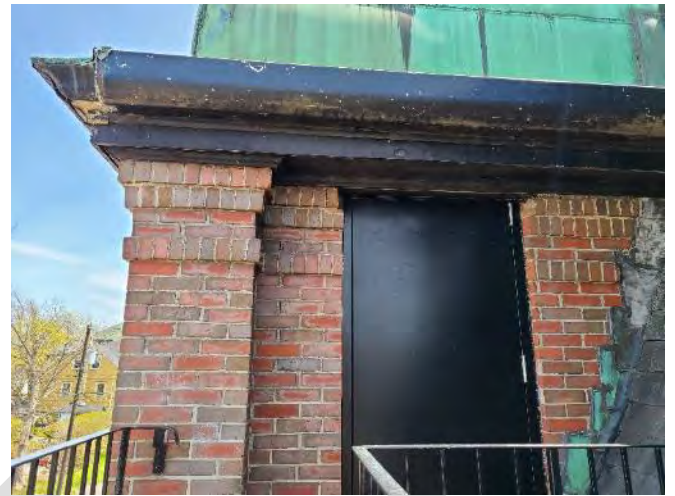
- Newly installed metal slab door for emergency egress at the third floor. This does not appear to be part of the original construction.
- FSA could not confirm if an adequate header/lintel was installed above the door.

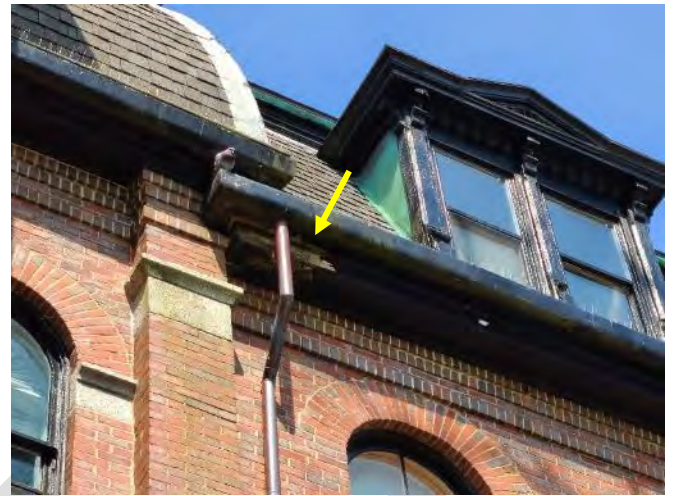
- Some deterioration was observed at soffits in isolated areas including deteriorated wood and flaking paint/stain. This was typical of all elevations.

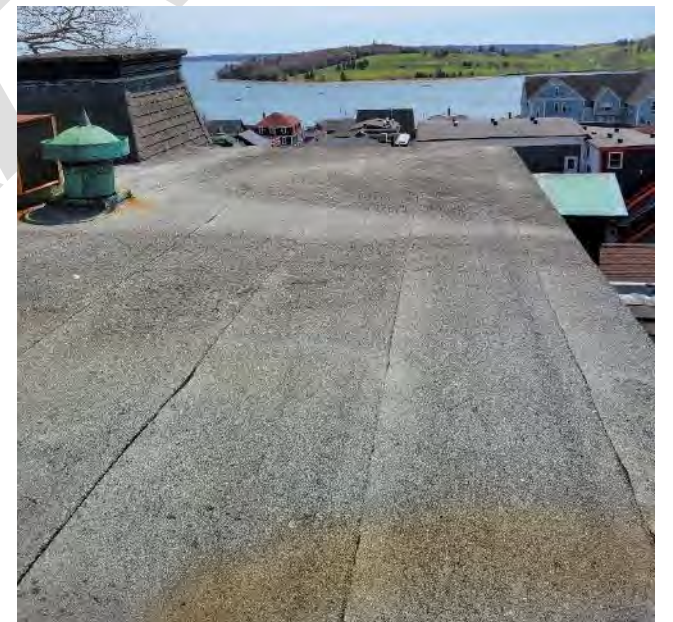
- Low slope roof area is of mod. bit. membrane construction. In general, the roof area has reached the end of its useful life and needs replacement.
- Staining and organic growth were observed at various locations.
- Various open seams were observed in the MB membrane at the roof area.

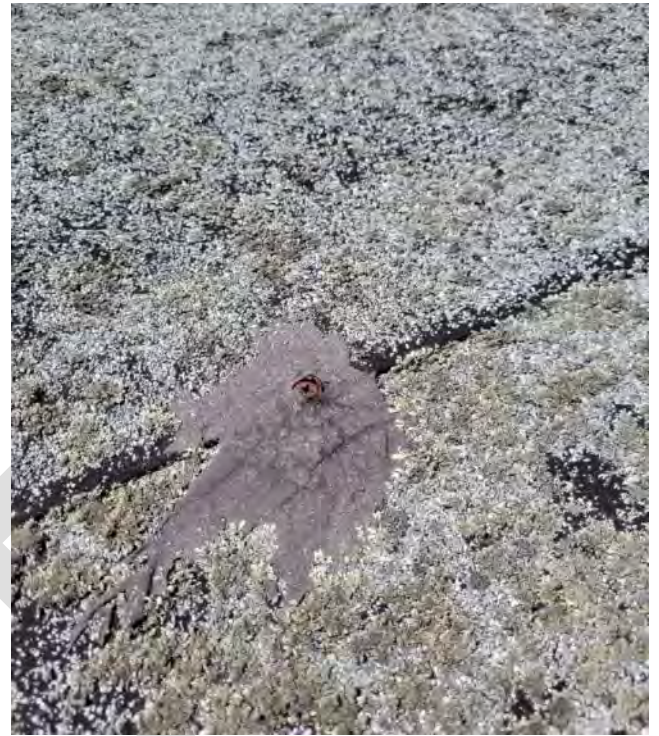
- Multiple fasteners were observed penetrating the mod. bit. membrane in the field of the roof. Corroded fasteners and deteriorated sealant were observed.
- Note the deterioration of the mod. bit. cap sheet.
- Note the organic growth visible at the mod. bit. cap sheet.
- See following observation.

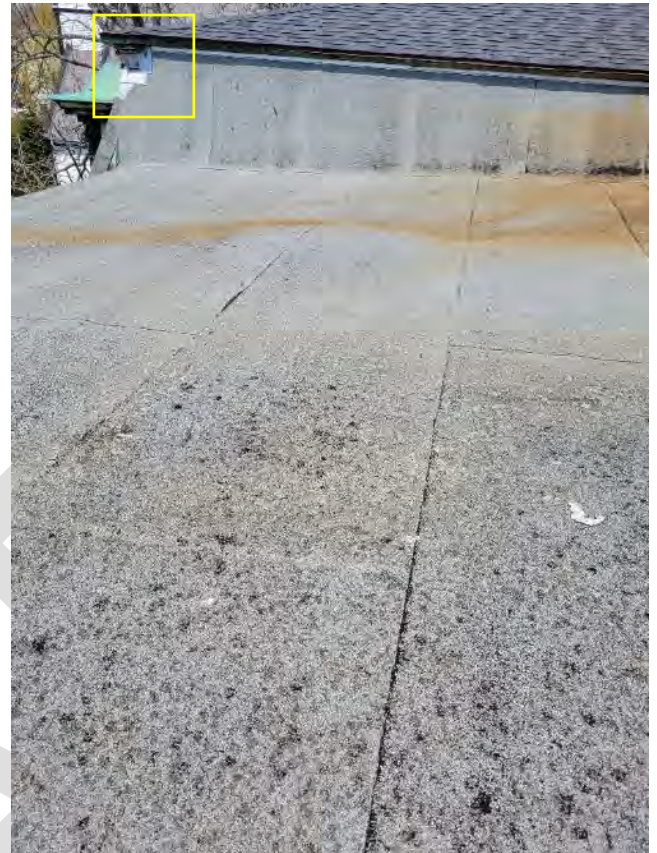
- In general, the mod. bit. membrane cap sheet was observed to have reached the end of its serviceable life and replacement is recommended.
- Organic growth and loss of granules was observed across the field of the roof area.
- Deteriorated wood trim along with paint/stain were observed (yellow box). See following observation.

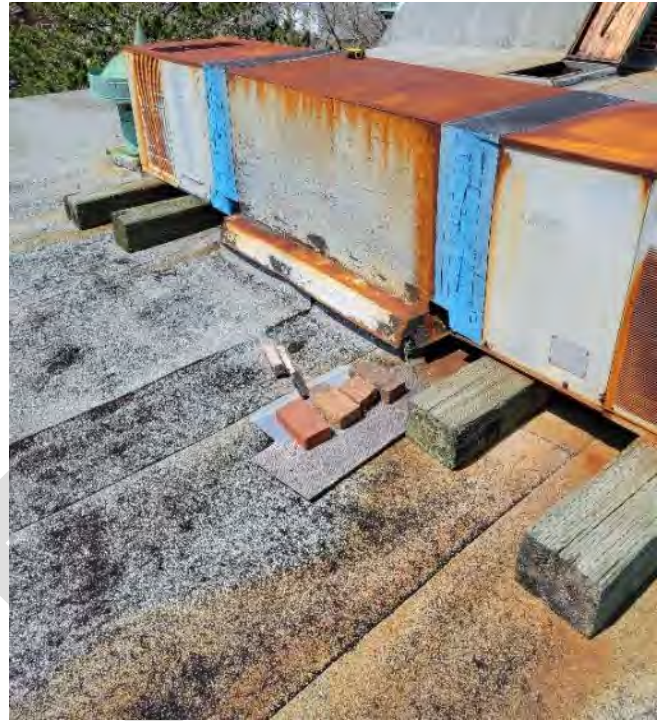
- Low slope roof area is of mod. bit. membrane construction. In general, the roof area has reached the end of its useful, serviceable life and needs replacement.
- The rooftop unit (RTU) was observed to be severely corroded and placed on wooden sleepers which appeared to be loose laid on the roof resulting in potential for roof membrane damage and inadequate securement of the RTU

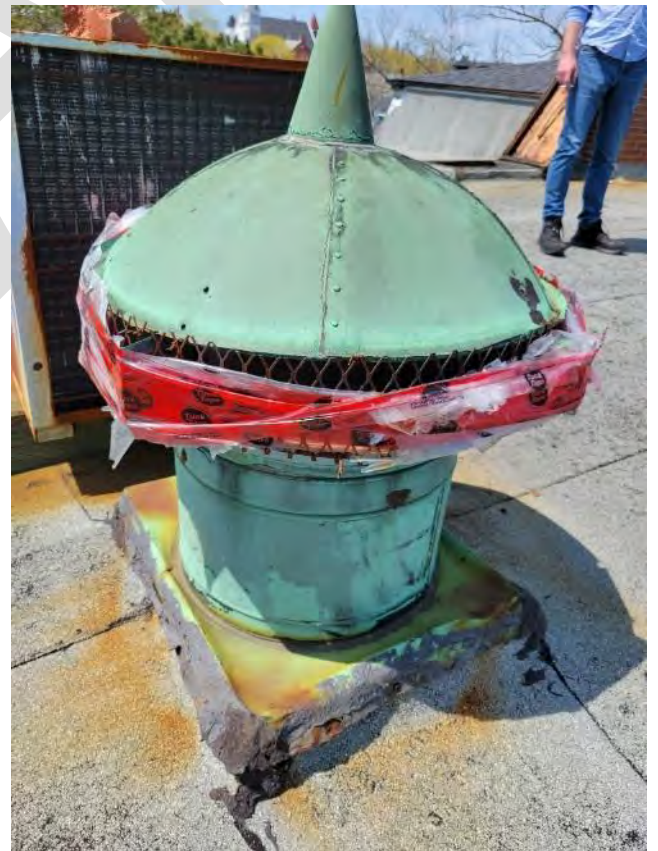
General Image – low slope/mod. bit. membrane roof area

- Copper roof vents were observed to have reached the end of their serviceable life. Many were observed to be damaged with various repairs made.
- Waterproofing and sealant at the foot of copper roof vents was observed to be deteriorated. See following observations.
- No separate membrane flashing ply was observed suggesting a weak transition that relies on mastics.

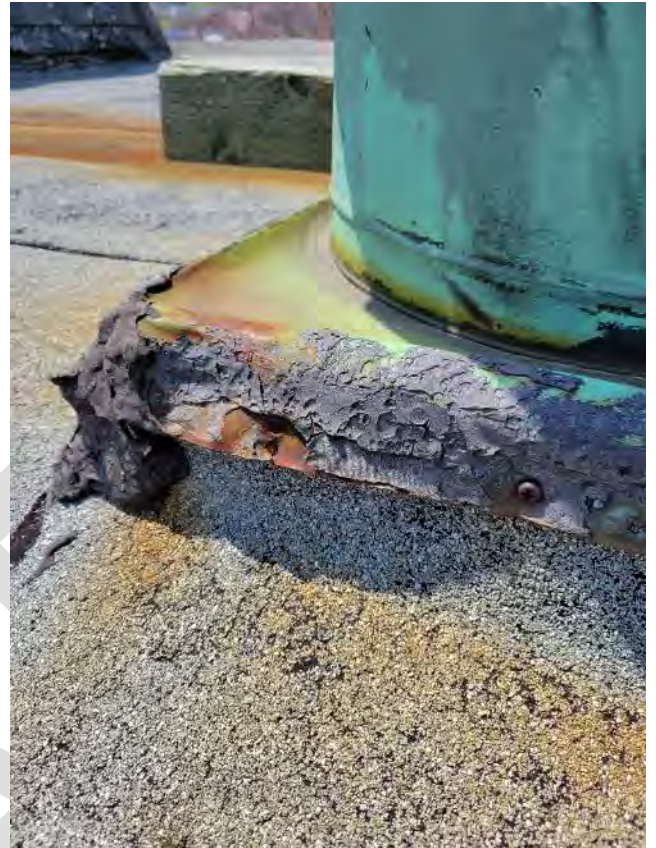
- Waterproofing and sealant at the foot of copper roof vents was observed to be deteriorated.
- Fasteners were observed to be of non-compatible material.
- Note the deterioration of the mod. bit. membrane cap sheet flashing.
- No separate interlapping membrane flashing and unlikely any reinforcing gussets at corner details.

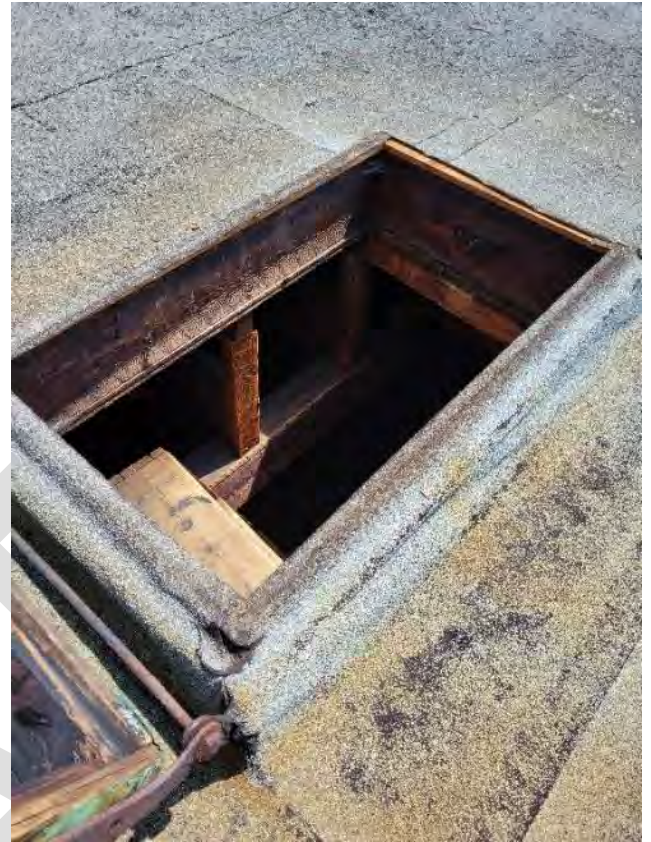
- The roof hatch was observed to be uninsulated and poorly sealed.
- Mod. bit. membrane was observed to be substantially deteriorated.
- No use of interlapping flashing applications was observed which is recommended by all mod. bit. membrane manufacturers.

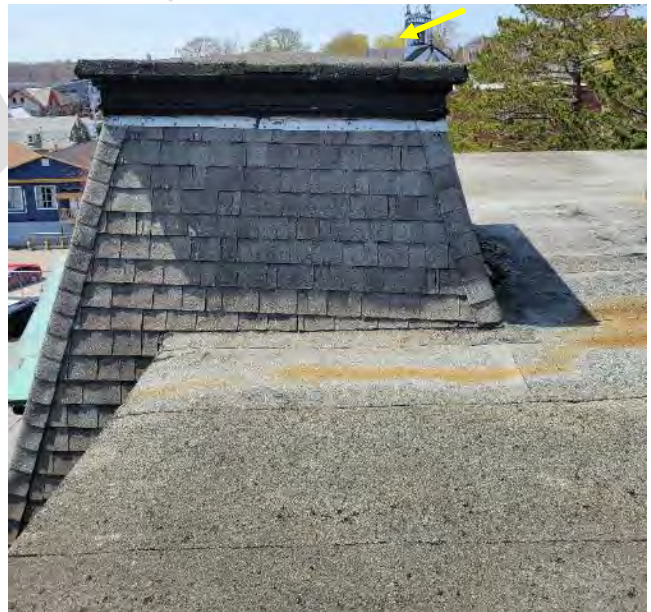
Shingled roof – south elevation

- Mod. bit. membrane was observed on the flat top of the roof area (yellow arrow) and has reached the end of its serviceable life.
- Deteriorated paint/stain was observed on the cornice elements beneath the flat top of the copper roof.

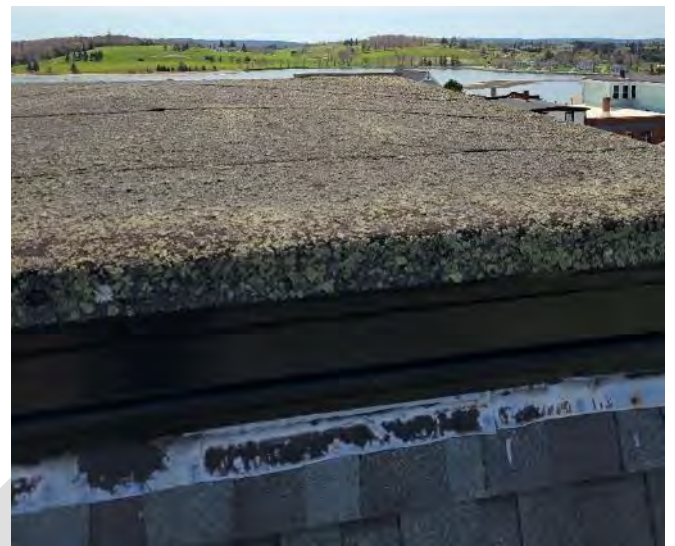
- Mod. bit. membrane roof covering was observed on the flat top of the roof area (yellow arrow) and has reached the end of its serviceable life.
- Significant organic growth on the surface of the membrane was observed.

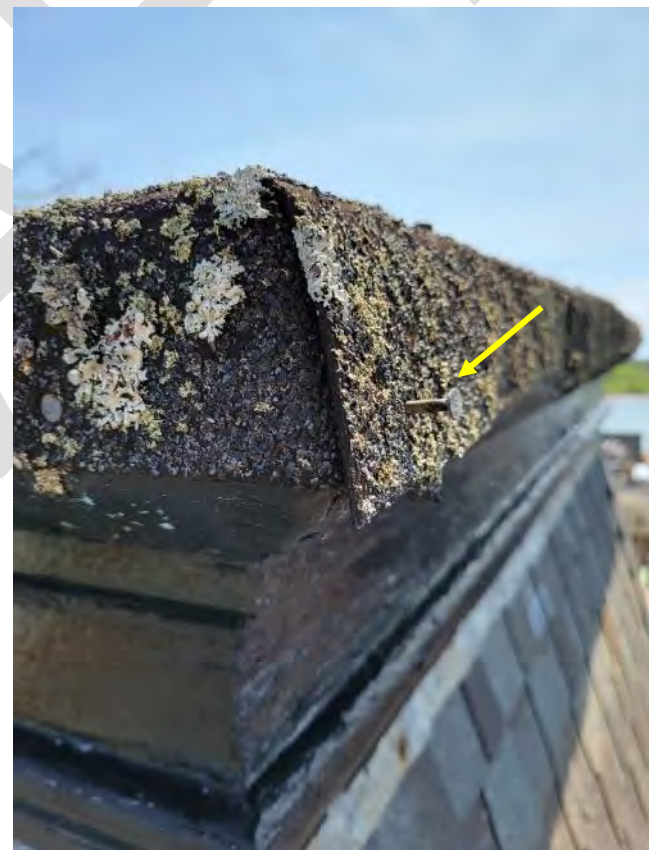
Shingled roof – south elevation

- Pulled fasteners securing the edge of the mod. bit. membrane were observed. Pulled fasteners no longer provide the intended securement.
- Note the substantial organic growth.

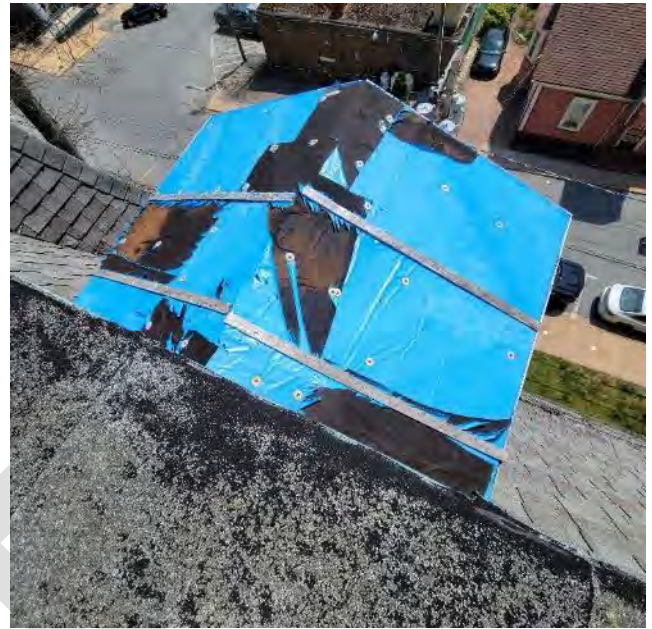
- The roof of the left dormer was observed to be temporarily repaired; however, the pressure sensitive material applied is now deteriorated, missing and no longer providing protection.
- Note the deterioration of the mod. bit. membrane cap sheet at the edge of the main roof visible in the foreground of the image.

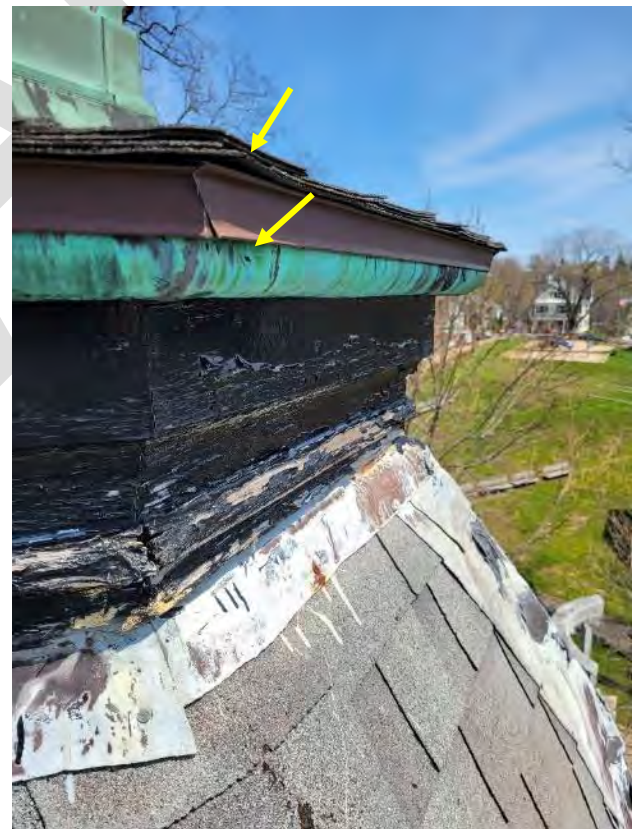
East Stair Tower Roof – facing east

- Shingles were observed to be poorly fastened at roof edge leaving gaps beneath the drip/starter flashing.
- Dissimilar metals were observed.
- Holes and missing fasteners were observed at the copper.
- Deteriorated paint/stain was observed at wood working.

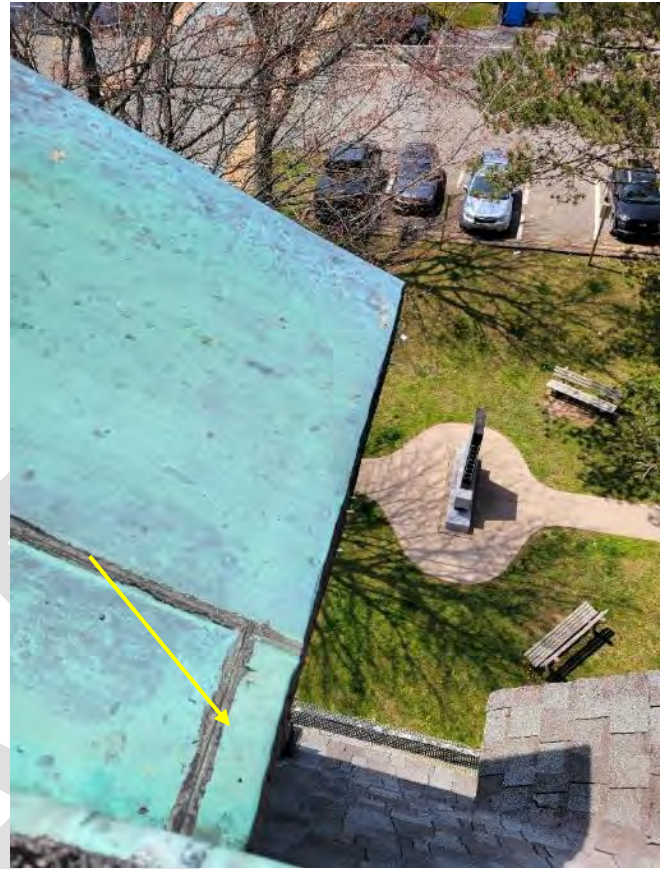
- In general, copper roofs were observed to be pitted.
- Various repairs were observed including the use of sealant at copper seams. Sealant was observed to be deteriorated.
- Fasteners were observed to be pulled. Pulled fasteners no longer provide the intended securement. See following observation.
- An absence of solder at seams and poor sizing of copper sheets – see yellow arrow, suggest an inexperienced copper installer.

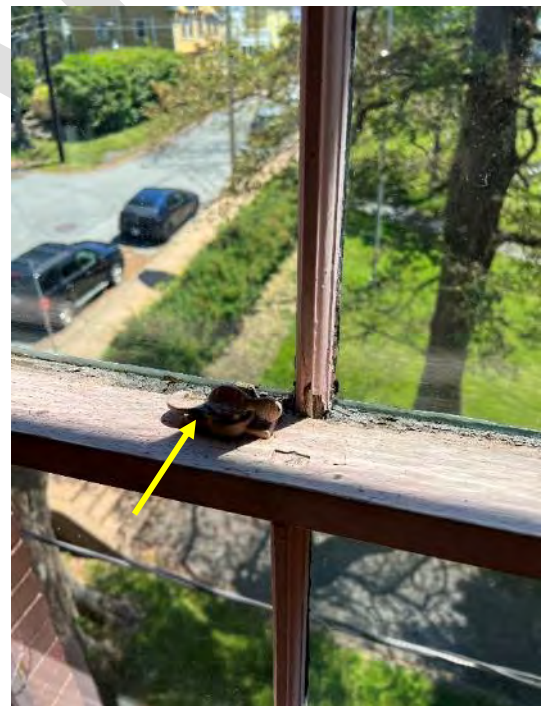
- At the interior, windows were observed to be in various stages of repair and operation. Aging and poorly functioning window locks are visible here.

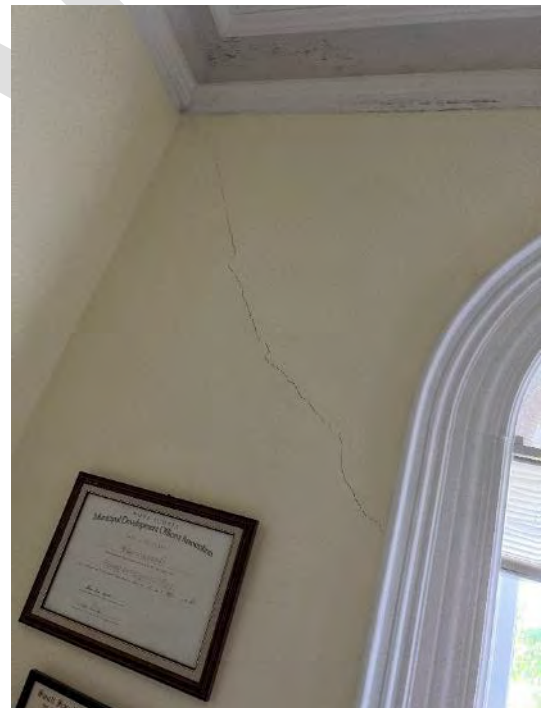
- Notice the diagonal crack traveling from the window casing towards the ceiling.
- This crack suggests significant movement of the exterior wall. Further intrusive investigation is recommended to determine the overall degree and implications of any deterioration within the mass masonry wall.

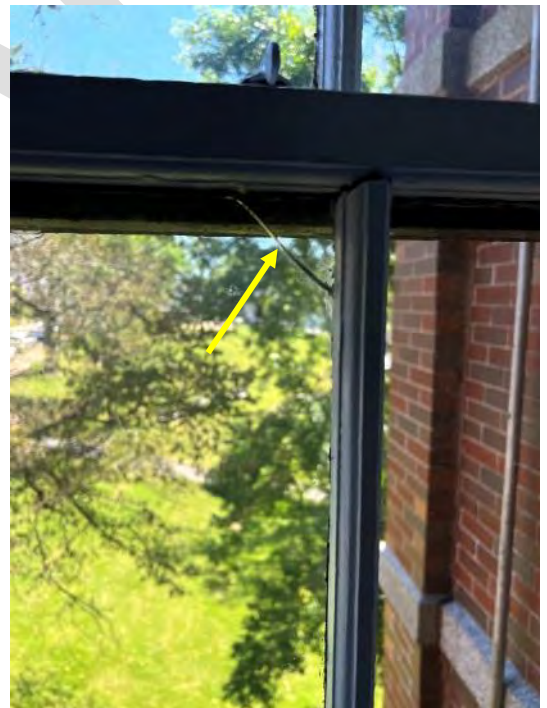
- In general, single-glazing was observed to be in good condition; however, some cracked and damaged panes were observed requiring replacement.

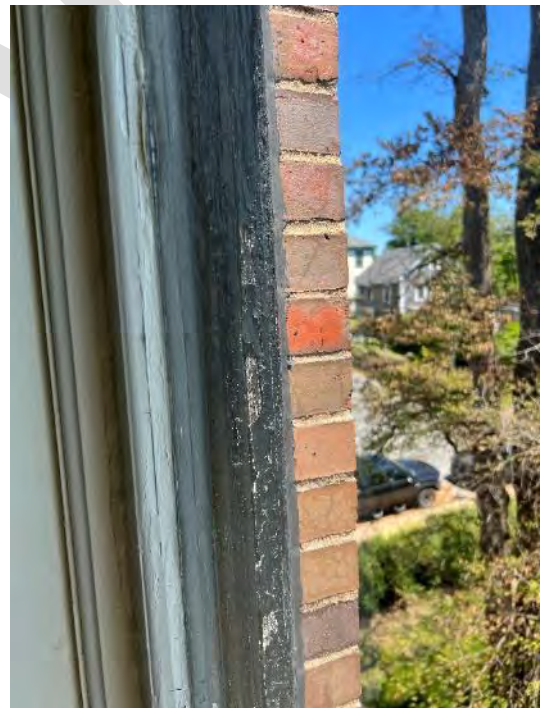
- At the exterior, some deterioration of the window frame was observed requiring the removal of all sealants, stripping and sanding of the window frame, sash, mullions and sill followed by refinishing.

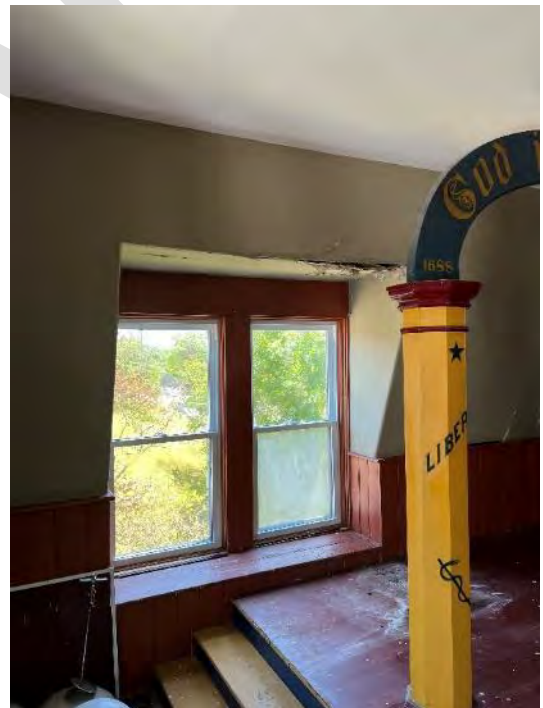
- Newer vinyl windows were observed to be installed at the north upper floor.
- At the north interior, substantial water ingress was observed around dormer windows.
- Deteriorated, crumbling and stained drywall and/or plaster was observed. Water stains were further observed around windows.

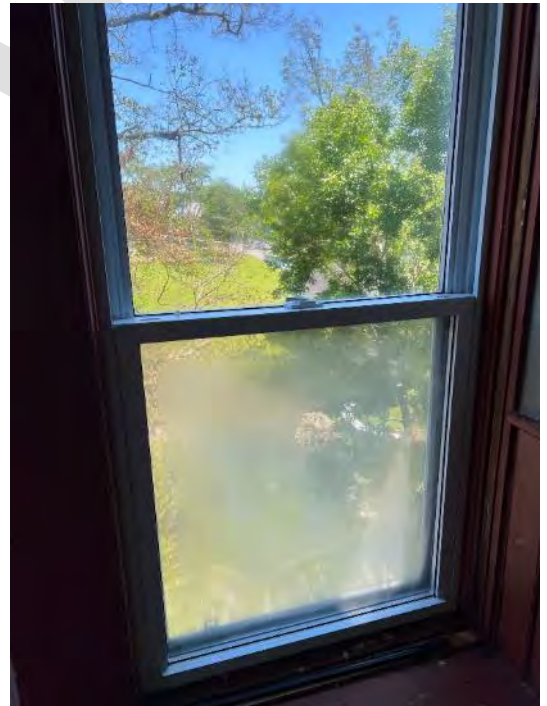
- A newer vinyl window was observed to have a broken seal between glazing causing condensation and fogging.

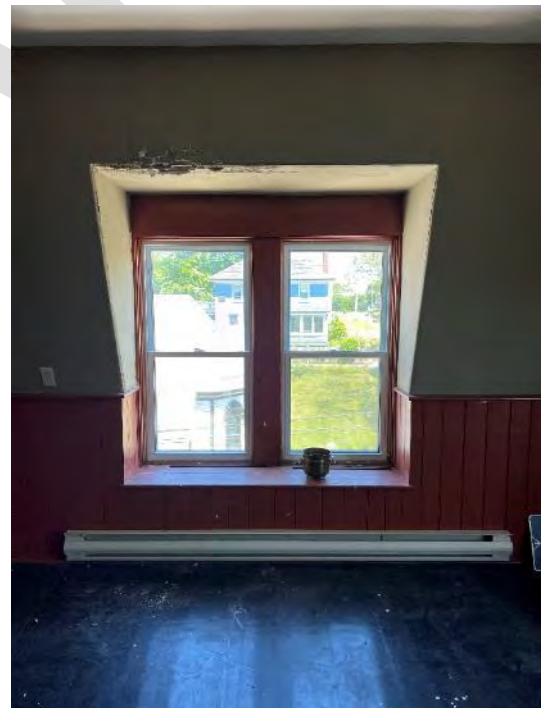
- Significant water ingress was observed possibly due to roofing and/or flashing deficiencies at the exterior. These areas of water ingress will be addressed in the overall rejuvenation effort.
- Ongoing water intrusion has the potential to create indoor air quality issues and the growth of harmful organics. Mold may be present in these areas. Further evaluation is recommended.

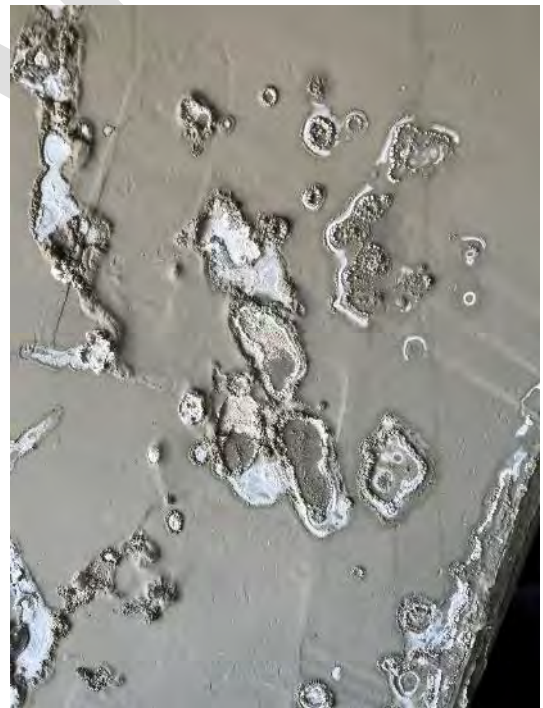
- Significant water ingress was observed possibly due to roofing and/or flashing deficiencies at the exterior. These areas of water ingress will be addressed in the overall rejuvenation effort.
- Ongoing water intrusion has the potential to create indoor air quality issues and the growth or harmful organics. Mold may be present in these areas. Further evaluation is recommended.
