**TOWN OF LUNENBURG  
RFP #TOL2021028**

**REQUEST FOR PROPOSALS  
Town Hall Exterior Restoration**

# LUNENBURG TOWN HALL & COURTHOUSE

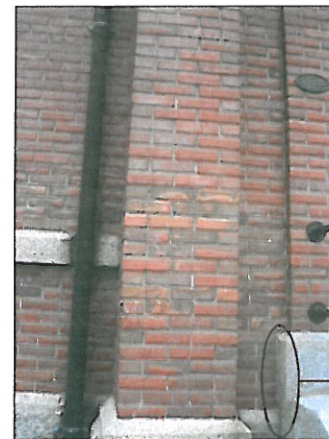
4. PILASTER FAILING.

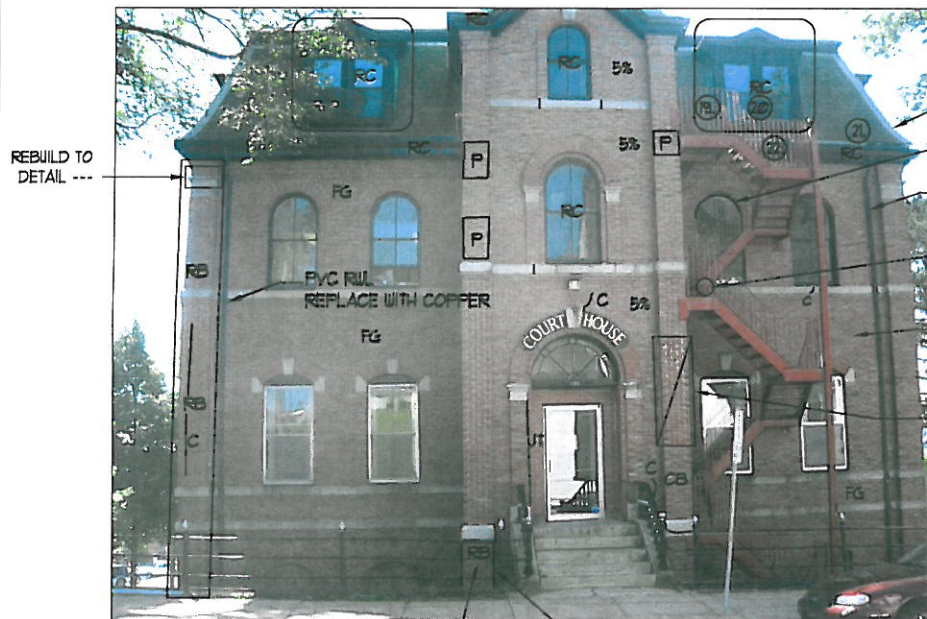
PILASTER OUT OF PLUMB -  
1 BROWN BRICK REPLACE

CRACKED WALL DUE TO  
POOR PILASTER REPAIR

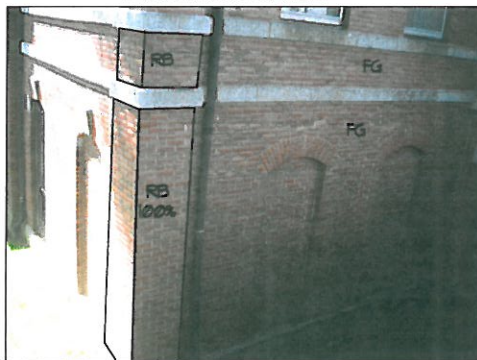
AREA HAS MOSS  
GROWTH AND  
MORTAR IS WASHING  
OUT, REPOINT.

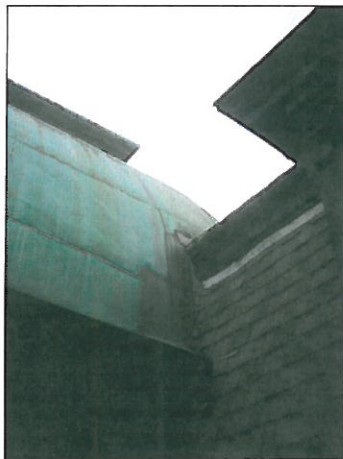
COPPER ROOF, MANSARD INTERSECTION. 17.  
INSPECT - MAKE REPAIRS (T&M)

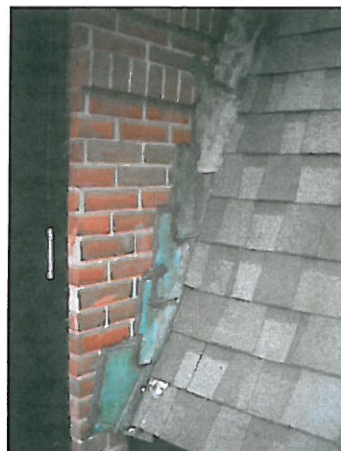
18.

STEP FLASHING ROOF/TOWER  
LEAD & COPPER

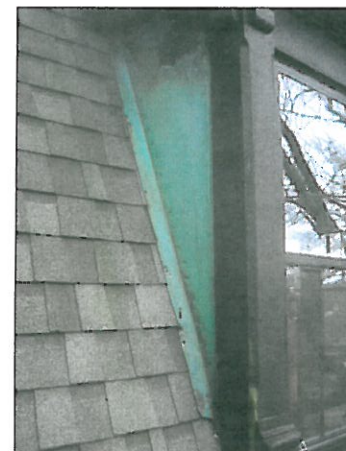
COPPER ON SIDE OF DOMERS, WRONG NAILS 19.  
REPAIR / RECONDITION

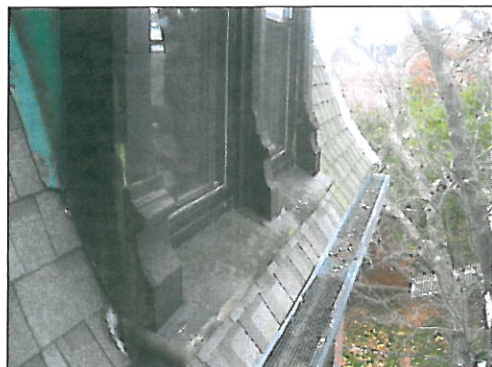
20.

DOMER - WEATHERING, NEEDS REPAIR  
RECONDITION WOODWORK

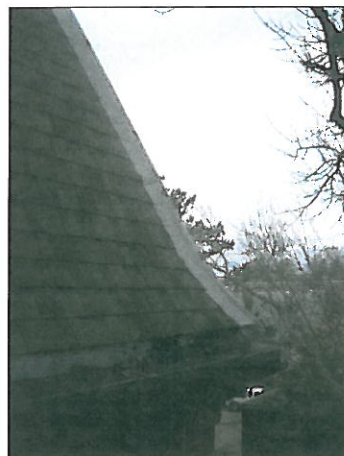
21.

GUTTER, PAINT FLAKING - REPAINT

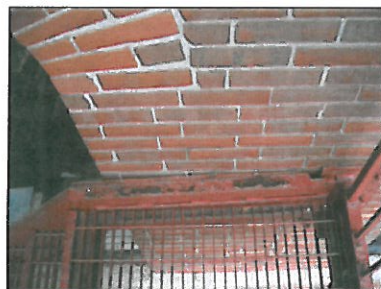
24. STRINGER AT LANDING - CORROSION. BLAST AND REPAINT

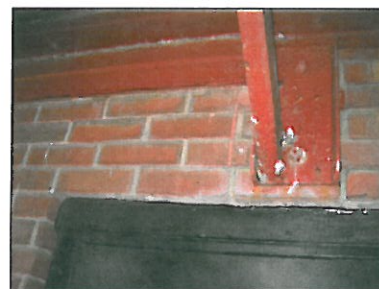
25. NO LINTEL AT NEW DOOR - CUT OUT BRICK AND INSTALL GALVANIZED LINTEL. SIZED TO SUIT

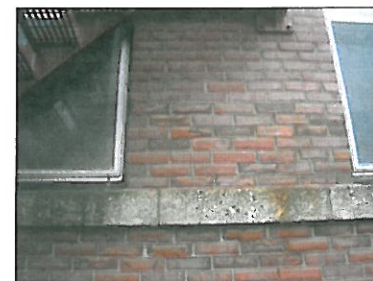
30. RUST ON STONE BAND COURSE - CLEAN POINT ALL JOINTS ON STONE TRIM - V4H

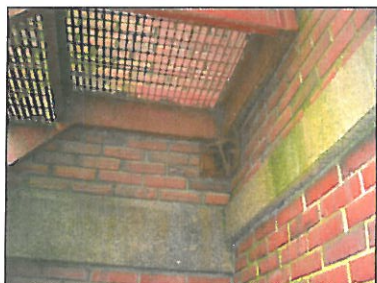
CORROSION TO FRAMES AND SUPPORTS. 31.  
BLAST PRIME AND PAINT, AS PER SPEC.

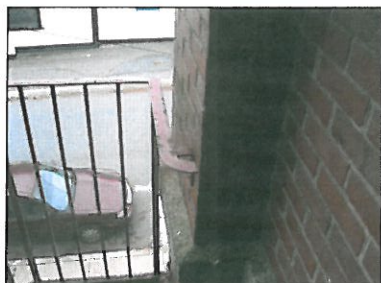
RUST ON RAILING - BLAST PRIME AND PAINT 32.

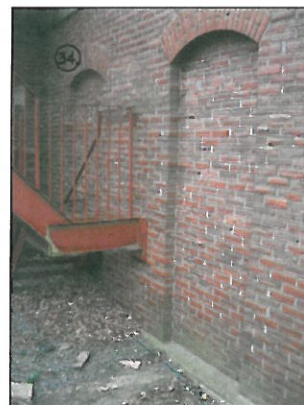
LANDING NEEDS PAINTING. 33.

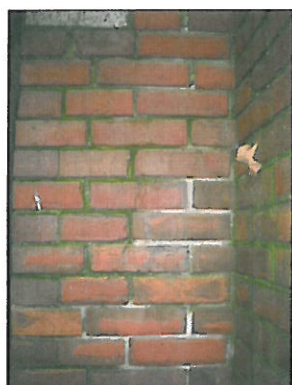
MOSS & BAD REPAIRS. 35.  
CLEAN AND REPOINT

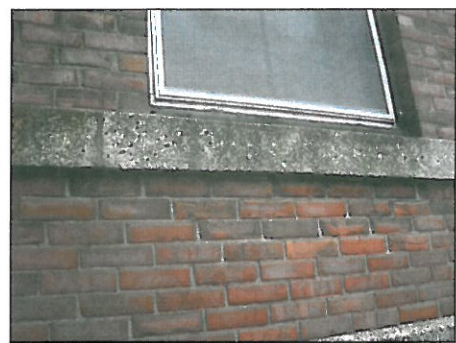
JOINT FAILURES - CRACKED BRICK 36.

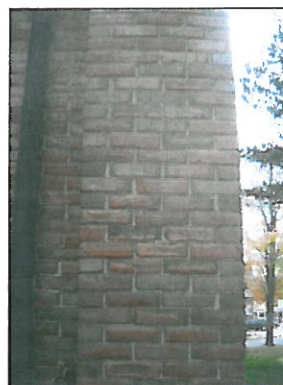
CRACKED BRICK PILASTER 37.  
REBUILD

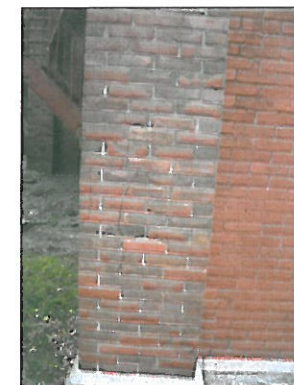
STRESS CRACK, SAME PILASTER 38.  
REBUILD

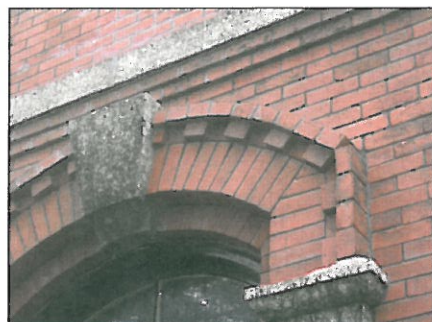
SOME MISSING BRICKS IN ARCHES - REPAIR ALL BRICK ARCHES TO BE 100% REPOINTED 42.

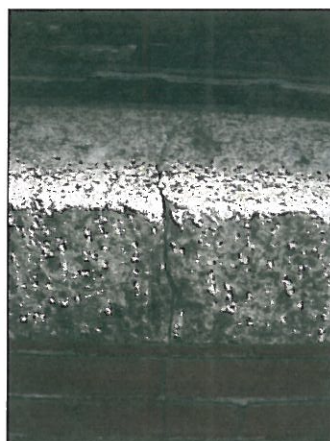
CRACK IN SILL DUTCHMAN REPAIR 43.

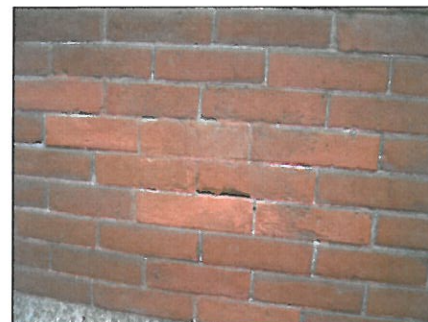
DAMAGED ORIGINAL BRICK WITH SMALL JOINTS. THIS IS DESIRED JOINTING FOR NEW BRICKWORK 44a.

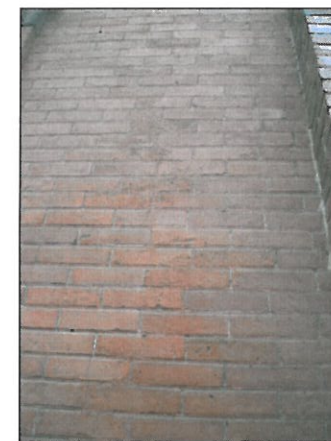
ABRADED ORIGINAL BRICK - INSPECT 44b. POSSIBLY TREAT (T+M)

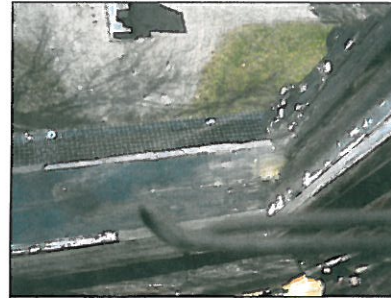
OLD SILL, MISSING PIECE, REPLACE ORIGINAL SASH - STANDARD FOR REPLACEMENT IF REQ'D 48.

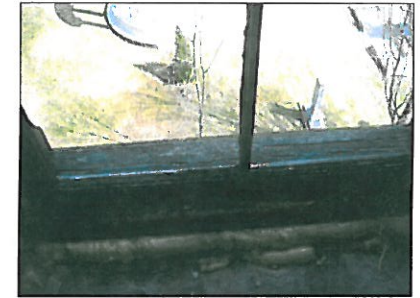
OLD SILL, REPAIR BEFORE CLADDING 49.

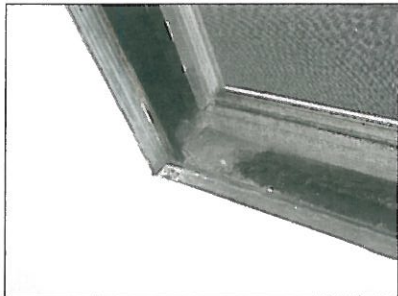
DAMAGED SILL, COURT ROOM WINDOW REPAIR LEAKS - INSPECT, REPAIR & CAULK 50.

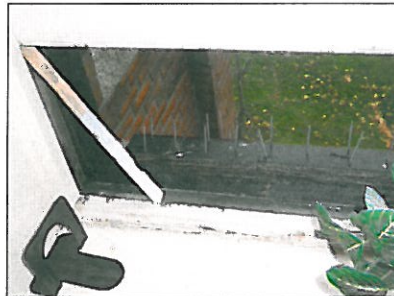
BATHROOM WINDOW, SPIKES IN SILL, REMOVE & REPLACE WITH SPECIFIED BIRD REPELLANT SYSTEM 51.

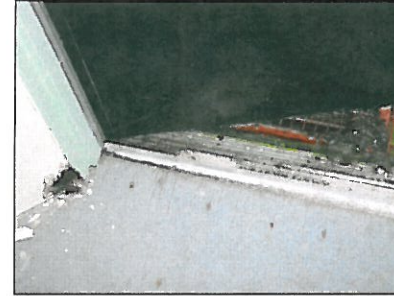
FIRE EXIT DOOR - WALL DETERIORATION - LEAK 52.

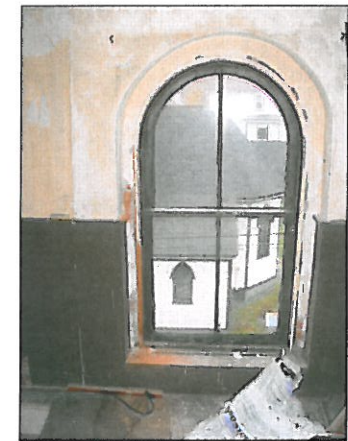
NORTH TOWER WINDOW. (RC) 53.

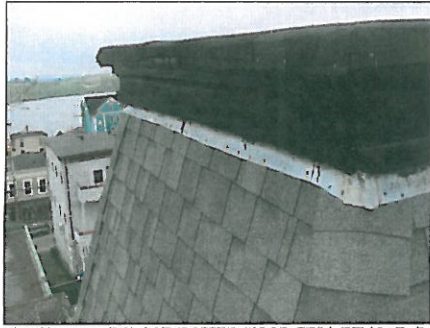
REPAIR OR REPLACE ROTTED WOOD TRIM, REMOVE  
NAILS ON LEAD & REPLACE WITH STAINLESS OR  
HOT DIPPED GALVANIZED.

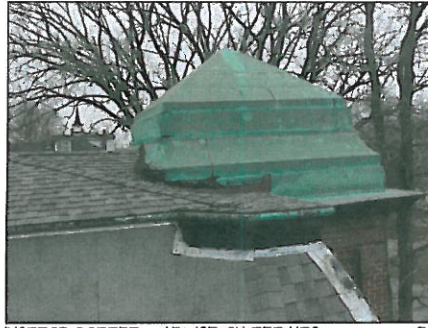
INSPECT COPPER - ADVISE ON REPAIRS  
UNDERTAKE AS APPROVED ON (T&M BASIS)  
REPLACE ALL NON COPPER NAILS WITH COPPER (L&S)

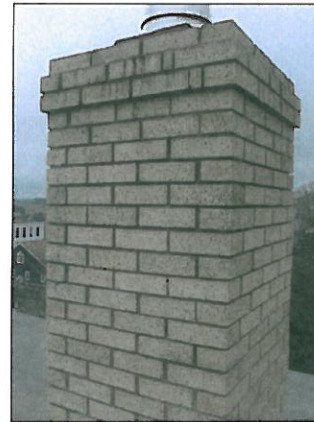
CHIMNEY REPOINT 100% 56.

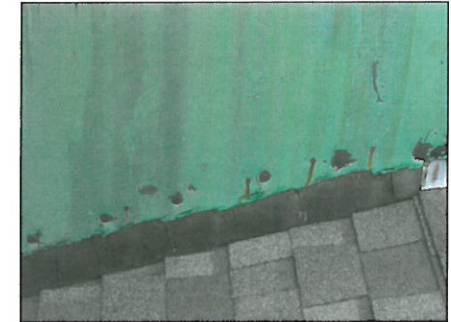
REPLACE ALL NON COPPER NAILS WITH COPPER  
(L&S) 61.

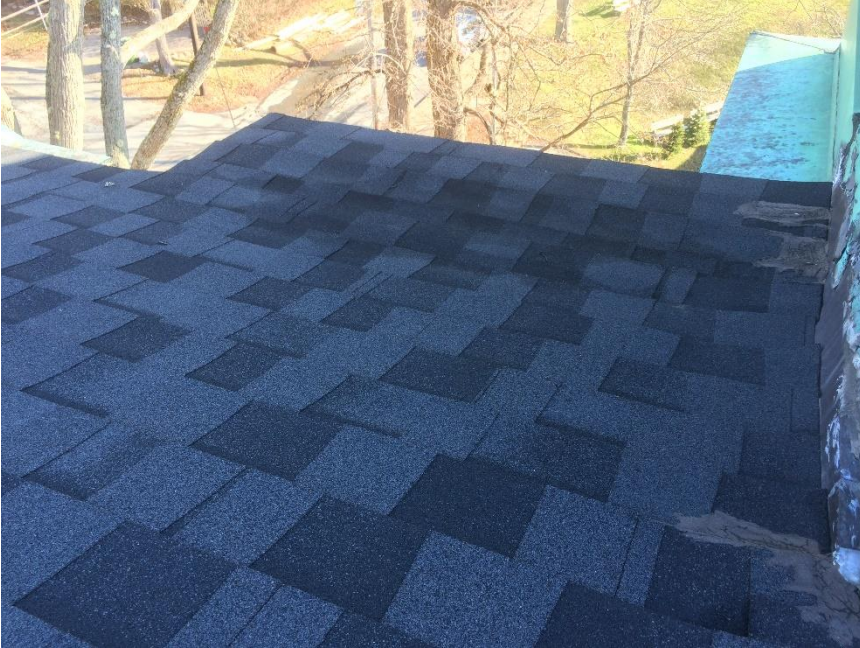
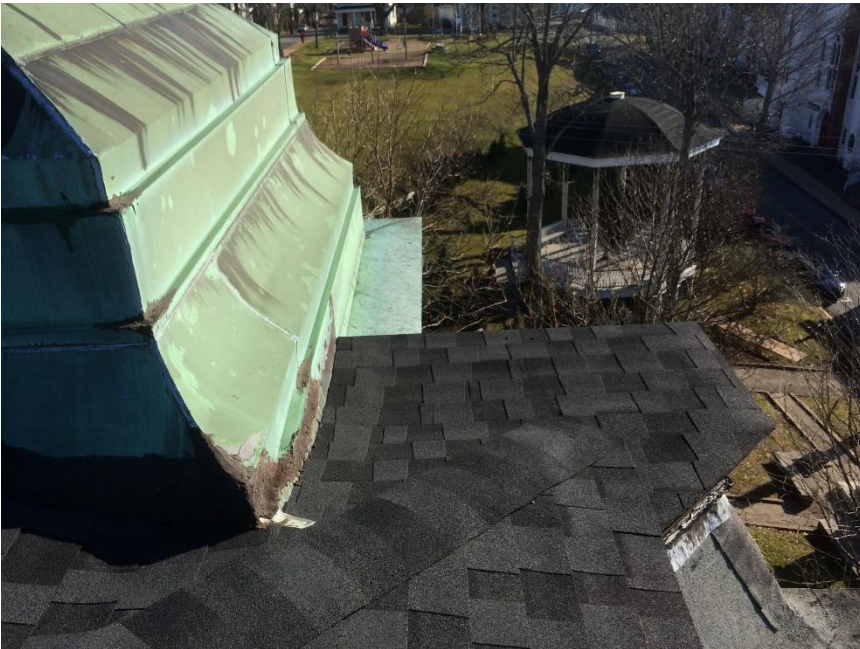
The roofing material on the upper, hipped portion of the roof of the north section of the building is also composed of asphalt shingles. Most of the asphalt shingles appear to be in relatively good shape, however, near the cupola on the east side of this roof, there are two, small, flat section of shingles that appear to have water damage (see Photos 17 and 18).

The shingles on the flat section of roof near the cupola appear to be water-damaged due to the flatness of the roof, which creates a condition in which rainwater is unable to properly shed. The shingles on these flat sections of the roof should be removed and replaced with roofing membrane. The shingles on the Mansard-style lower section of this roof should also be considered for replacement when the flashing around the dormers is being replaced.

Photo 17 – Water-damaged shingles (1 of 2)

Photo 18 – Water-damaged shingles (2 of 2)

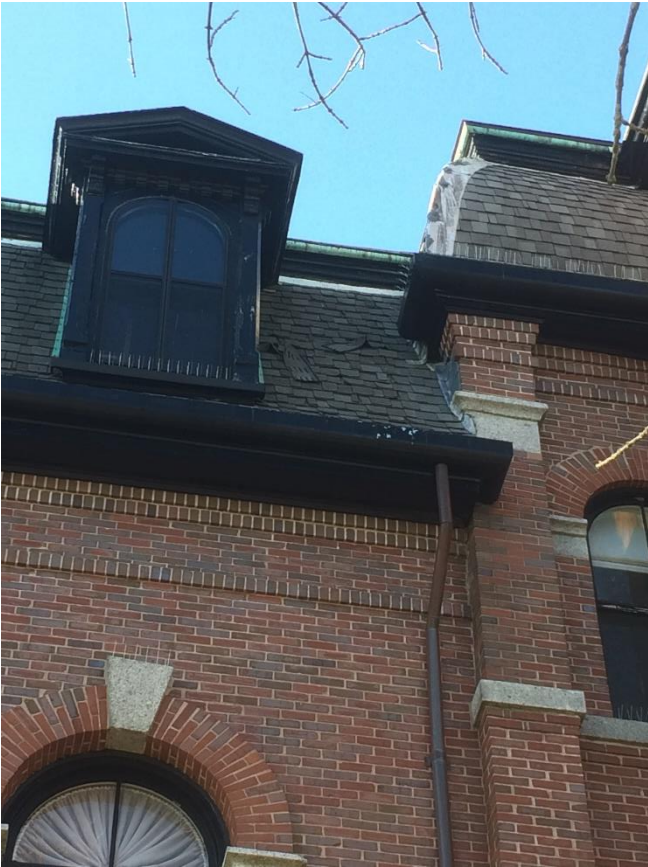
The roofing material on the lower Mansard-style portion of the roof of the south section of the building is composed of asphalt shingles (see Photo 1). The shingles on this section of roof appear to be of the same vintage as the shingles on the lower Mansard-style portion of the roof of the north section of the building, although some damage was observed on the east side of the building (see Photo 19).

**Photo 19 – Damaged shingles on Mansard-style roof (west side of building)**

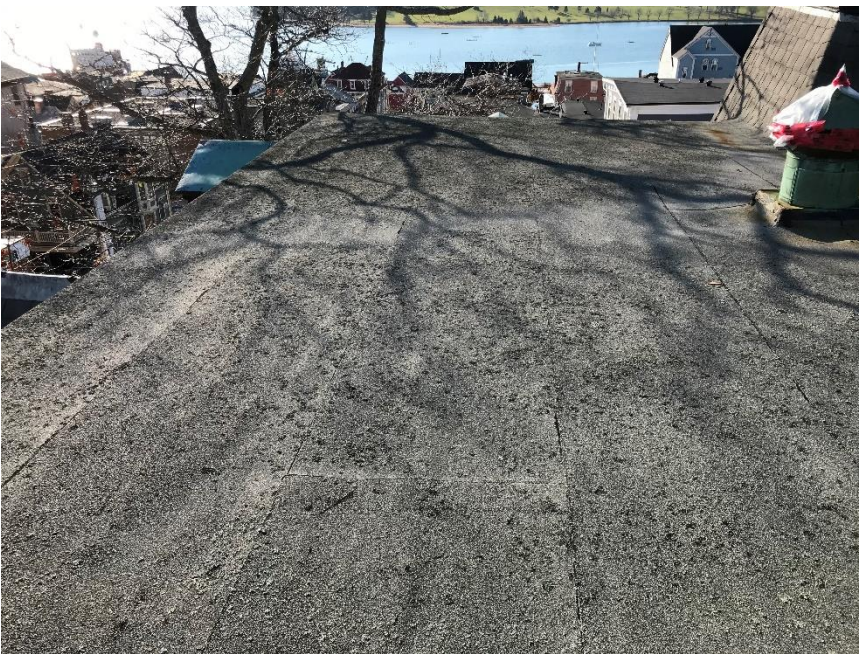
The roofing material on the upper flat portion of the roof of the south section of the building is composed of asphaltic roofing membrane. Moss growth was observed on this membrane (see Photo 20). Screws penetrating the roofing membrane were observed in two locations (see Photos 21 and 22).

**Photo 20 – Moss growth on roof membrane**

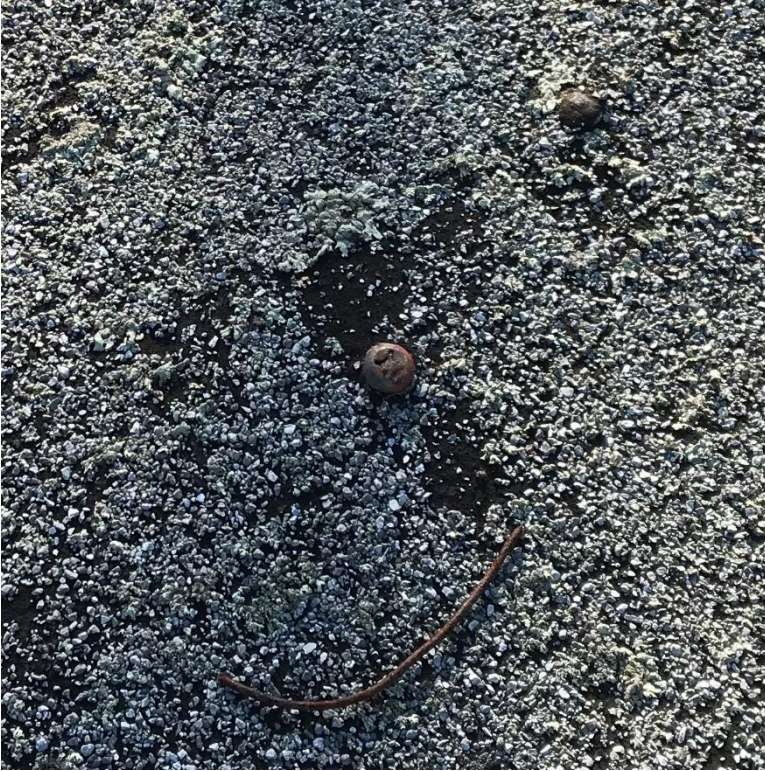
Photo 21 – Screw in roof membrane (1 of 2)

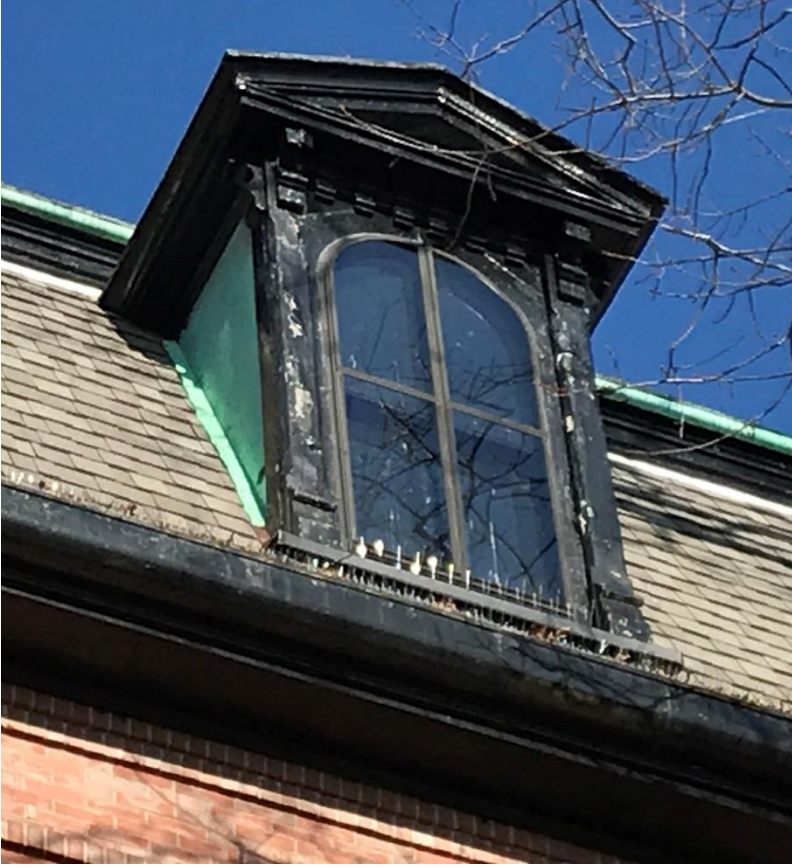
Photo 25 – Paint peeling from wood trim on dormer

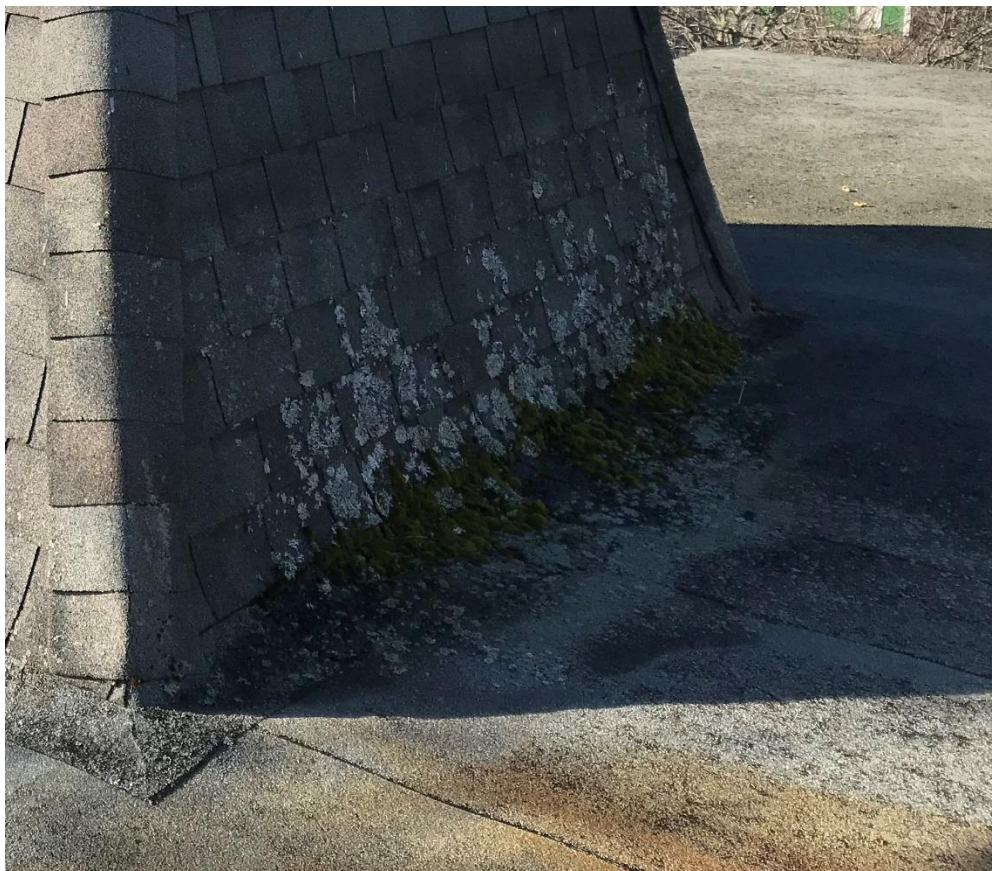
The roof of the south section of the building contains a wood-framed base of a former clock tower (see Photo 28). The sides of this base are covered with asphalt shingles. The base also contains a wooden lid also covered in shingles. Lead flashing is installed at the base of the lid. Moss and lichen growth were observed on the shingles of this base (see Photo 29).

**Photo 29 – Moss and lichen growth at base of former clock tower**

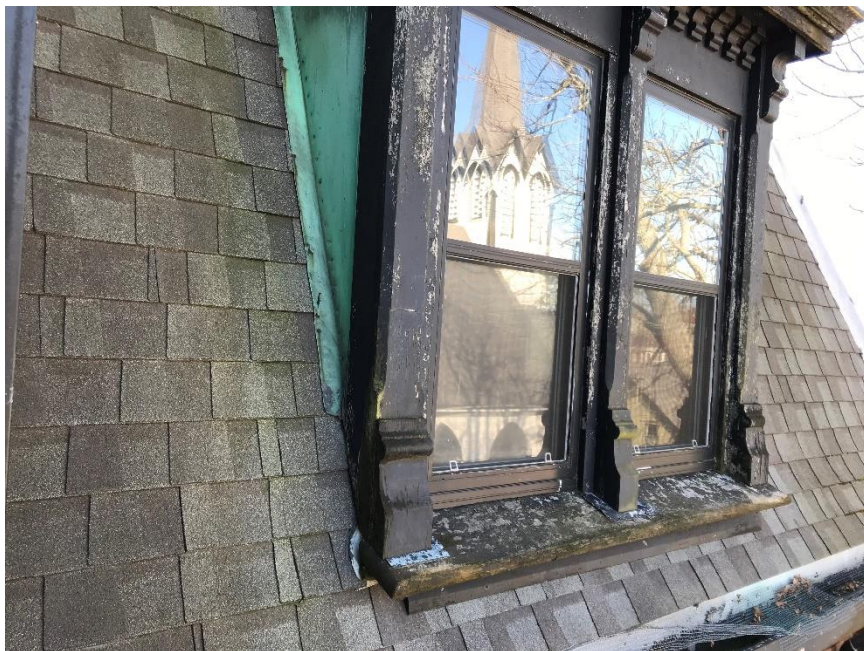
Different types of flashing materials have been used on these roofs. The sides of the dormers are flashed with bent copper panels (see Photo 30). The flashing around the chimney is lead (see Photo 31). The cupolas on the roof of the north building section are covered in copper, but the flashing is lead and tar (see Photo 32). The cupolas in this area also have a copper skirt on the exterior side. The roof hatch is flashed with membrane (see Photo 7). The circular roof vents on the south section of the building are flashed with roofing membrane and deteriorating tar (see Photos 33 and 34). Copper flashing and tar were used at the fire escape on the north side of the building (see Photo 35).

**Photo 30 – Dormer with bent copper panel**

The flashing around the dormers is a main cause of water infiltration into the upper level of the building, especially the flashing between the dormer roofs and the Mansard-style roof. The flashing around each dormer should be removed and replaced properly to ensure a watertight seal.

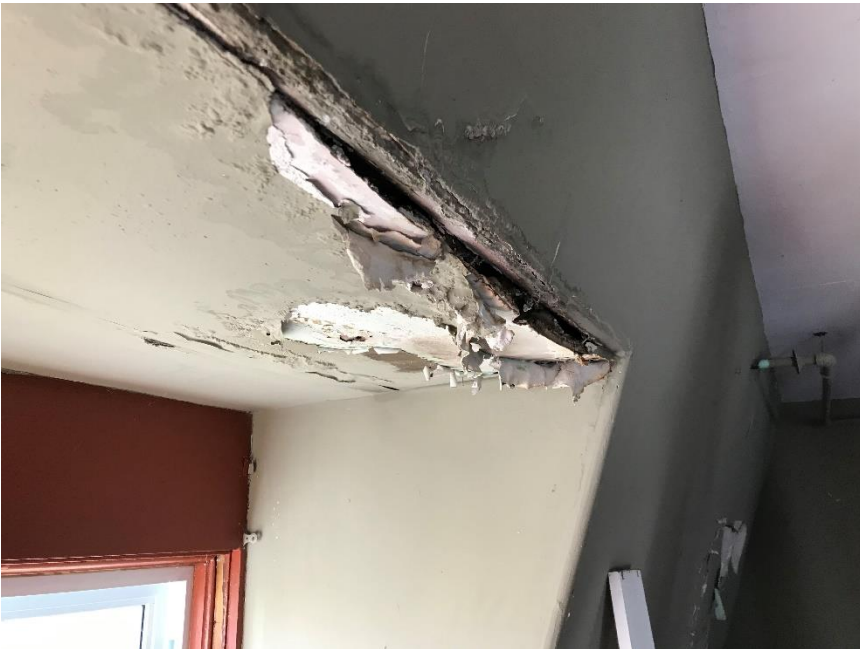
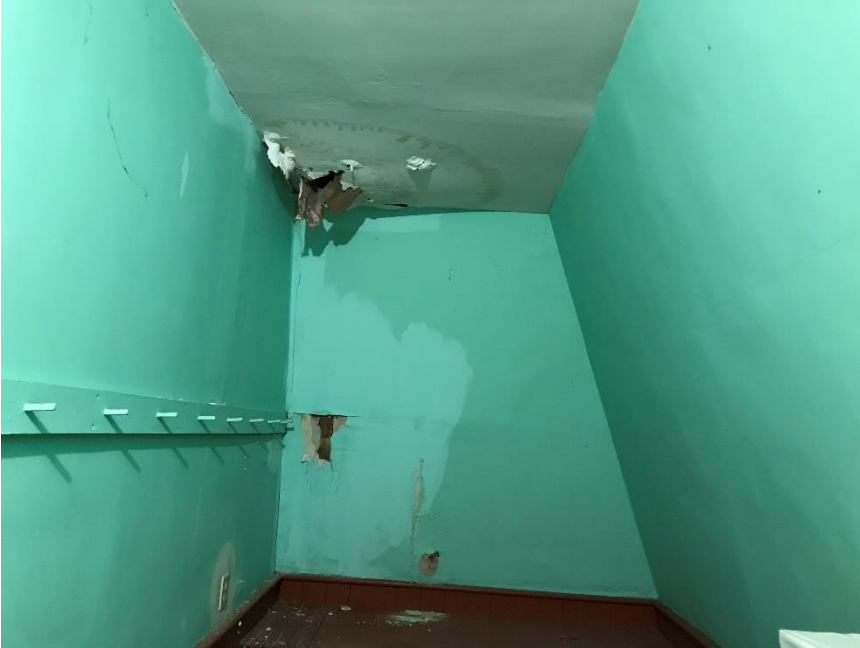
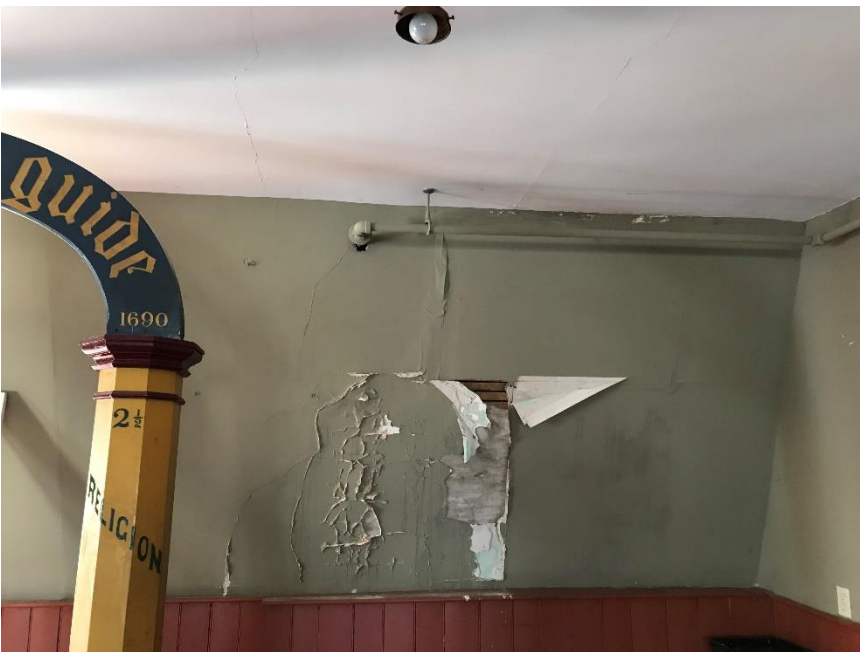
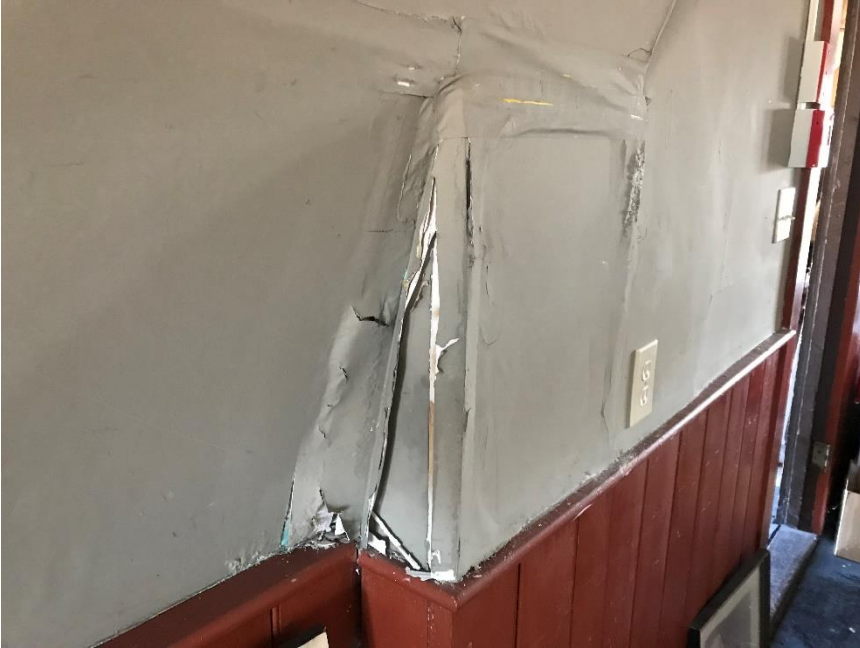
Extensive water damage to the interior lathe and plaster wall sheathing was observed in the top floor of the north section of the building. Most of the water damage was observed at the dormer locations (see Photo 38). Water damage was also observed in the southwest corner of the north section of the building (see Photo 39), in the east side of the north section of the building (see Photo 40), and at the north side of the north section of the building, at a truss-support location (see Photo 41).

Photo 38 – Interior water damage, typical around dormers

Photo 39 – Interior water damage (1 of 3)

Photo 40 – Interior water damage (2 of 3)

Photo 41 – Interior water damage (3 of 3)
