# Building Condition Assessment Town of Lunenburg Wastewater Treatment Plant

Final Report

210803.01 • May 2021

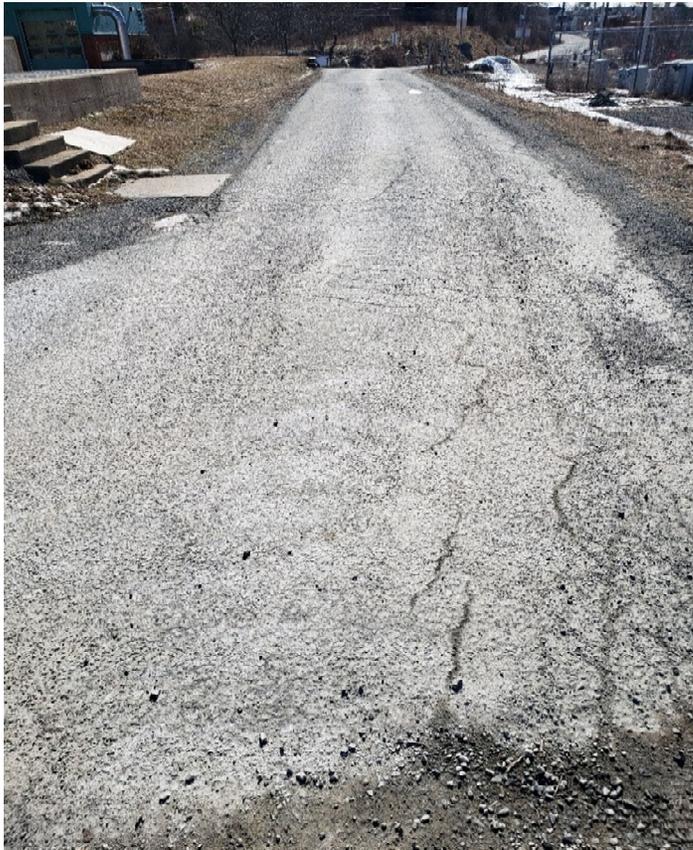
**Bioreactor building access road - rutted and cracked. Repave in 5-10 years.**

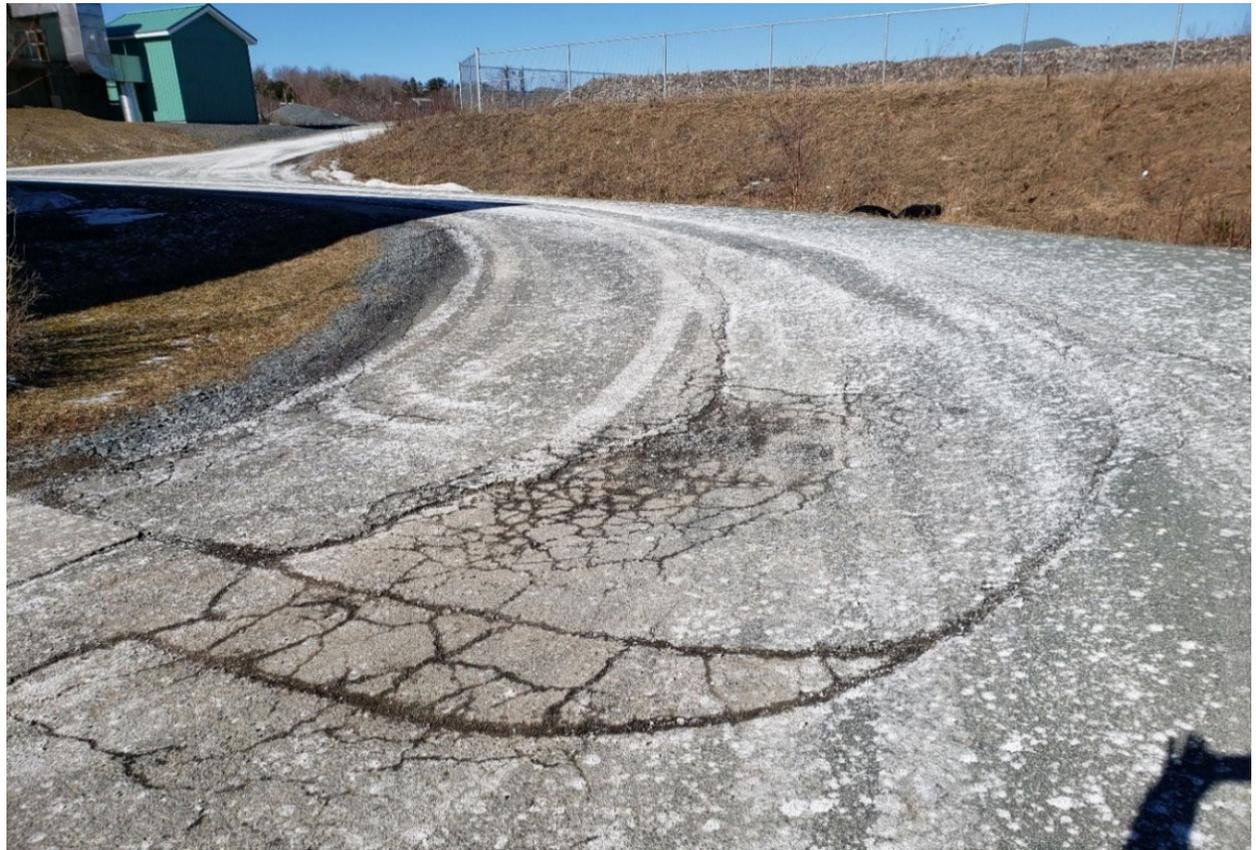
**Access road to overhead garage door and rear of Process Building - localized settlement. Remove unsuitable base and reconstruct/patch roadway in 0-5 years.**

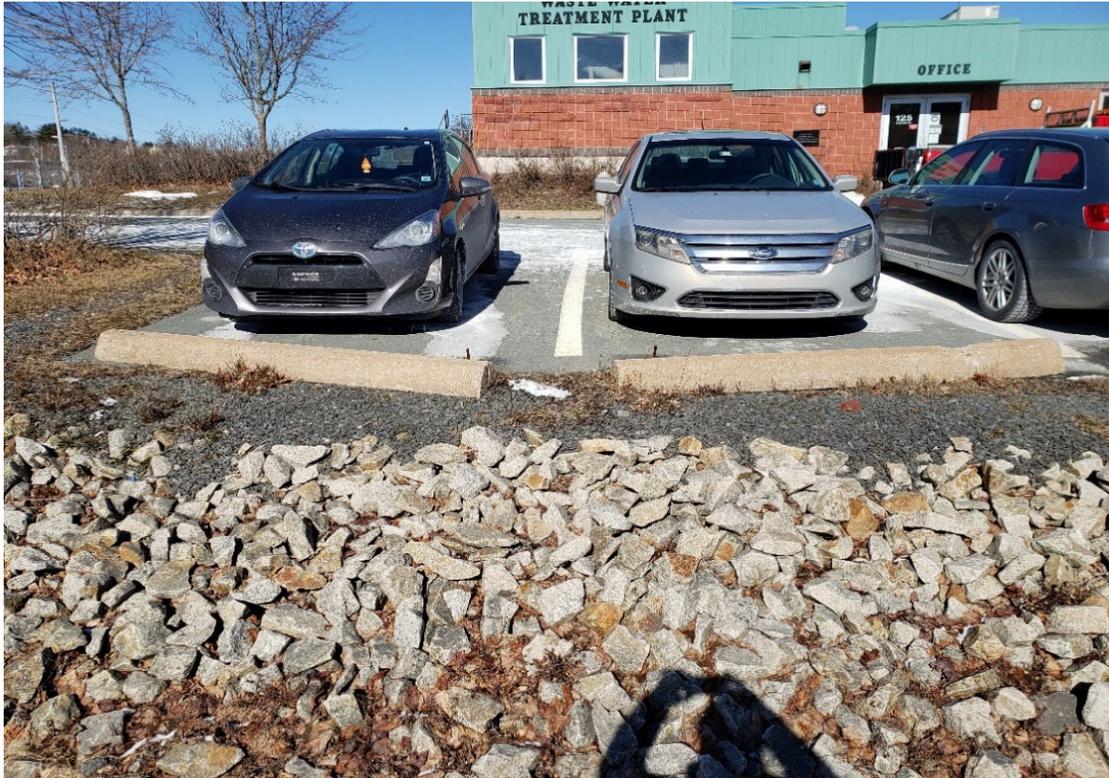
**Precast curb sections dislodged from pins/dowels by apparent snowplow impact damage; it appears that the curb sections are undamaged and could be reinstalled.**

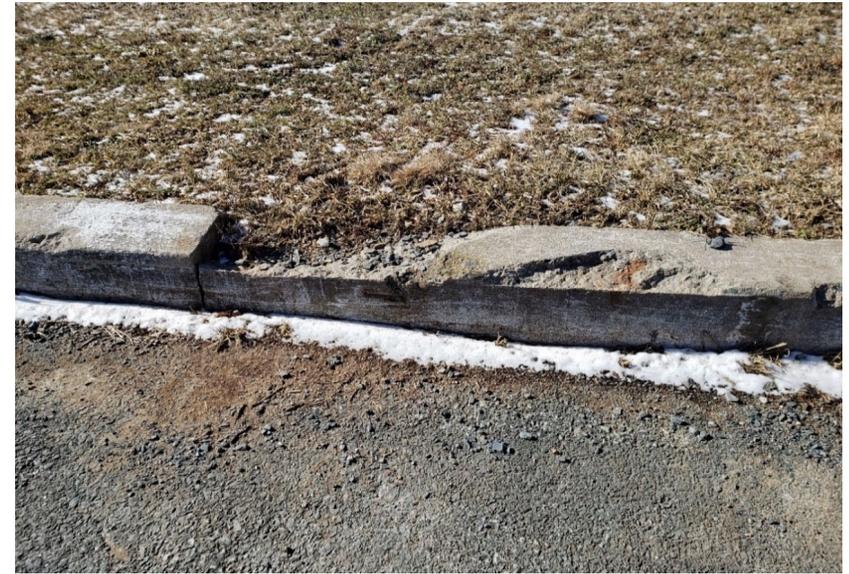
**Impact-damaged high-back concrete curb. Replace damaged curb sections**

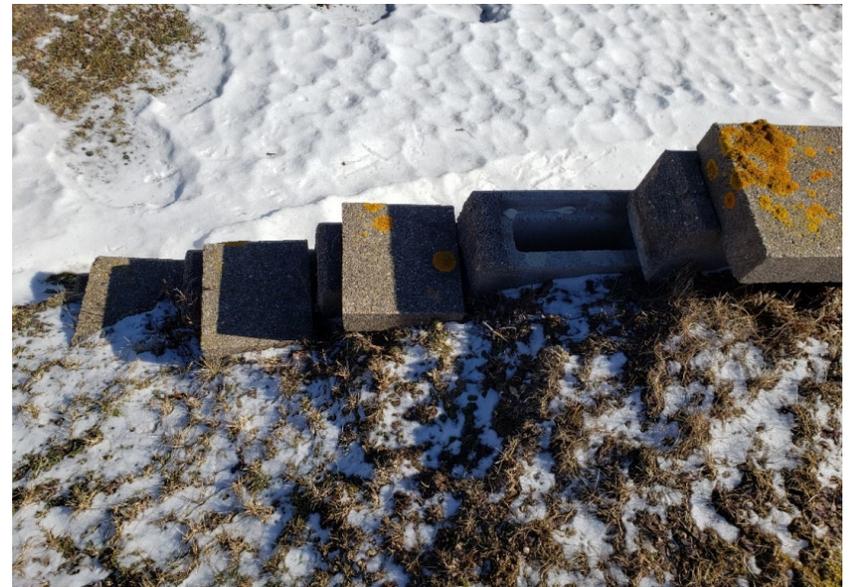
**Missing retaining wall coping/cap section.**

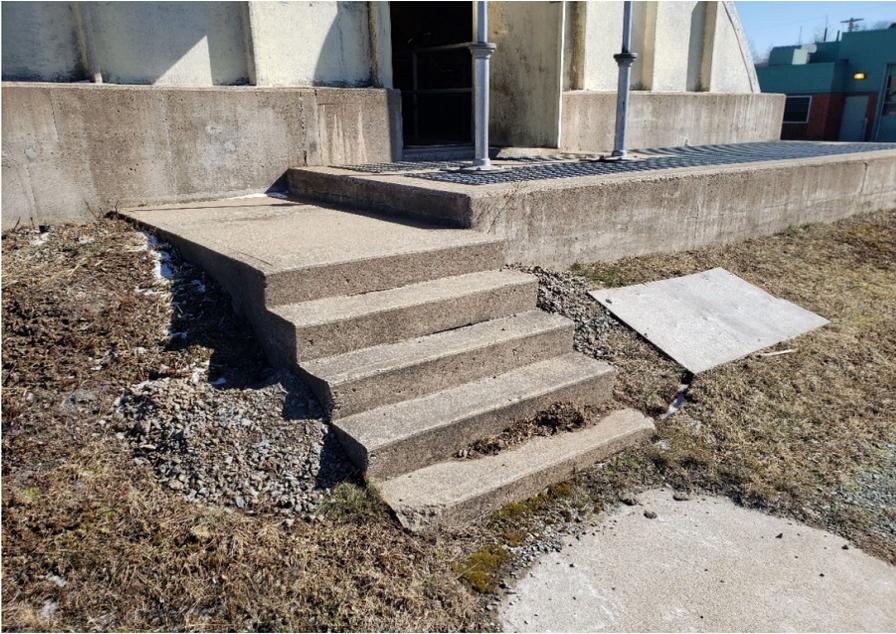
**Bioreactor Building stairs; damaged corner.**

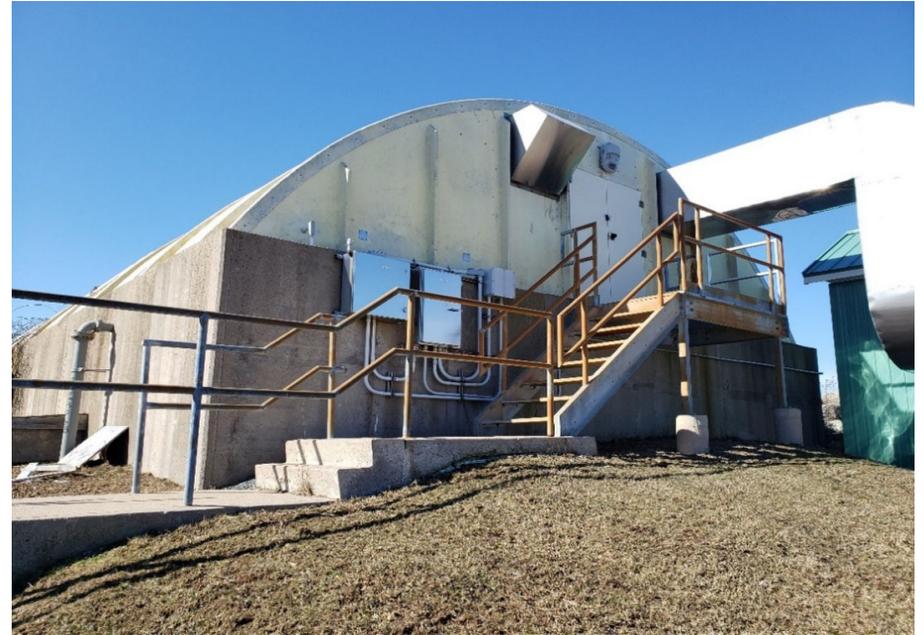
**Bioreactor Building: surface rust on HDG stair assembly and railings.**

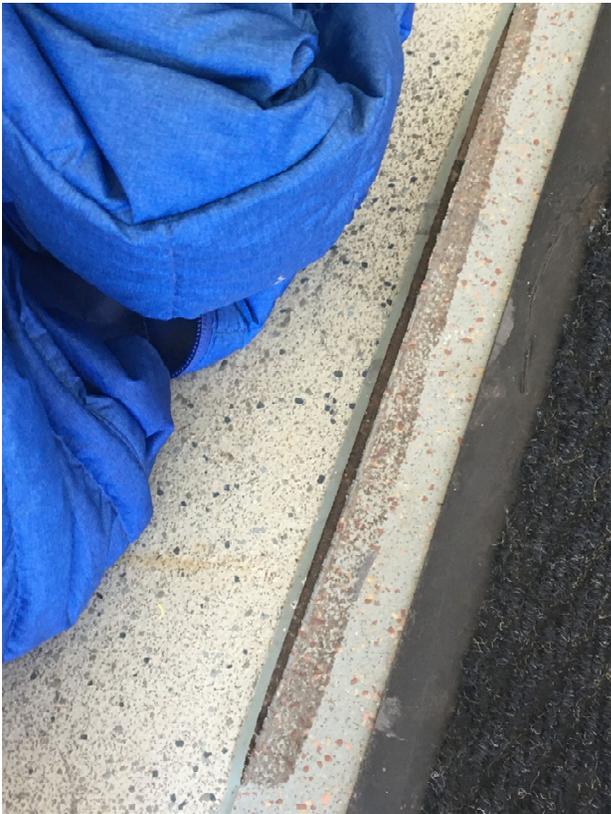
| Architectural Systems | Type/Age | Condition | U/S | POOR | FAIR | GOOD | NEW | Recap Period | | | | |
|---|--|--|---|---|---|---|---|---|---|---|---|---|
| Floor Finishes | Sheet Vinyl, 2003 | Sheet Vinyl in Entry 108 is delaminating from the concrete floor under. Recommend replacement of vinyl in Entry 108. The sheet vinyl in the other areas of the building is in fair condition and should be replaced later. | | X | X | | | \$1,500 | | | | |

Vinyl Flooring in Entry 108

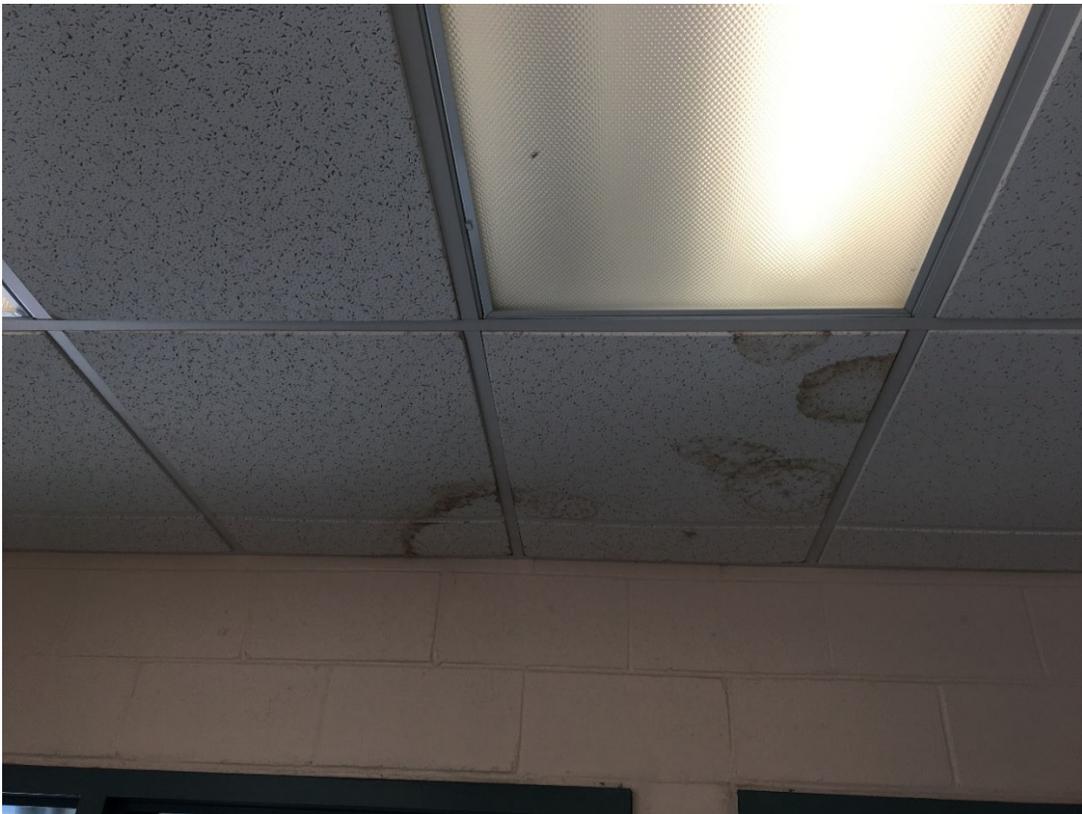
| Ceiling | Suspended Ceiling System, 2003 | Some acoustical tiles in Office 109 are stained from a previous leak above. Recommend replacement of stained tiles. All other areas with tile are in good shape. | | X | | X | | \$800 | | | | | |

Acoustic tile in Office 109

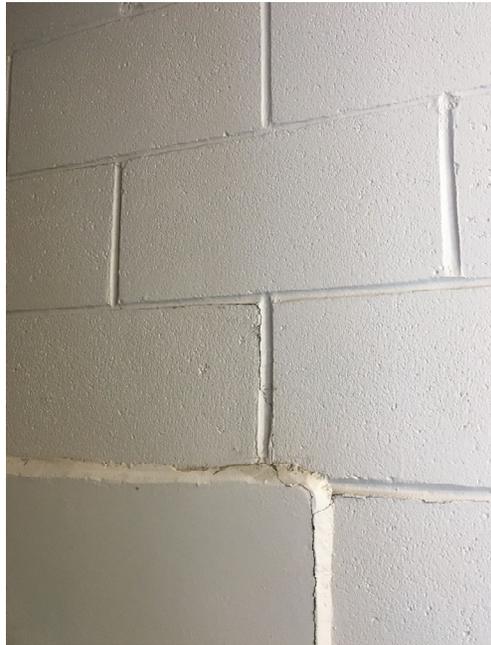
**Block mortar cracking in Cooridor 111**

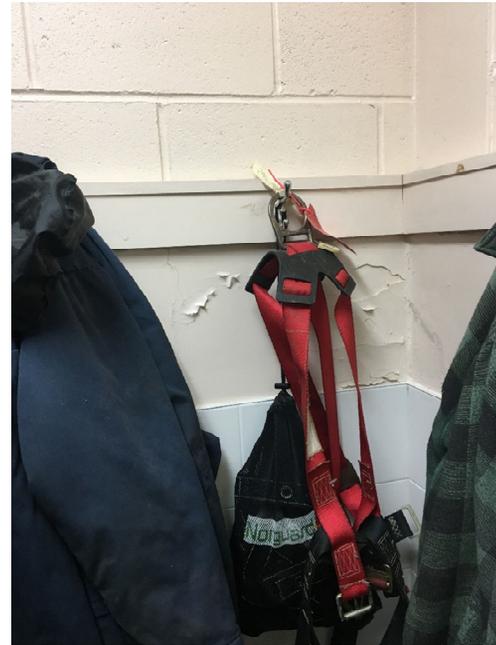
**Peeling Paint in Washroom 107**

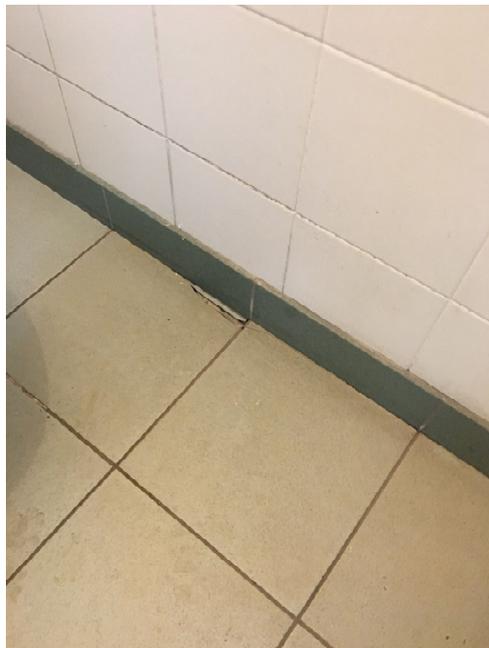
| Architectural Systems | Type/Age | Condition | U/S | POOR | FAIR | GOOD | NEW | Recap Period | | | | |
|---|--|--|---|---|---|---|---|---|---|---|---|---|
| Floor Finishes | Ceramic Tile, 2003 | The ceramic in the Washroom Area 107 is in fair shape. A couple tiles have cracked around toilet. Recommend replacement of those tiles now. | | X | X | | | \$300 | | | | |

**Cracked floor tile in Washroom 107**

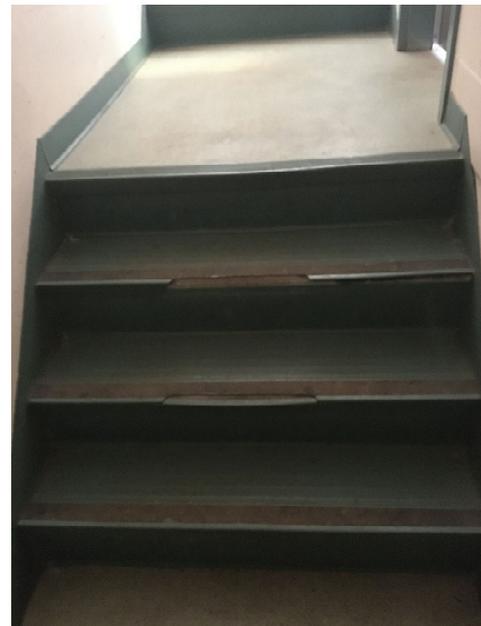
| Interior Stairs | Concrete Stairs, 2003 | Rubber nosing in Corridor 111 on stairs by door to Process Room 112 is torn and is a safety issue. Recommend repair to those nosings. Stairs to Headworks 102 and Blower Rm 103 in good condition. | | X | | X | | \$500 | | | | | |

**Torn nosing on stairs in Cooridor 111**

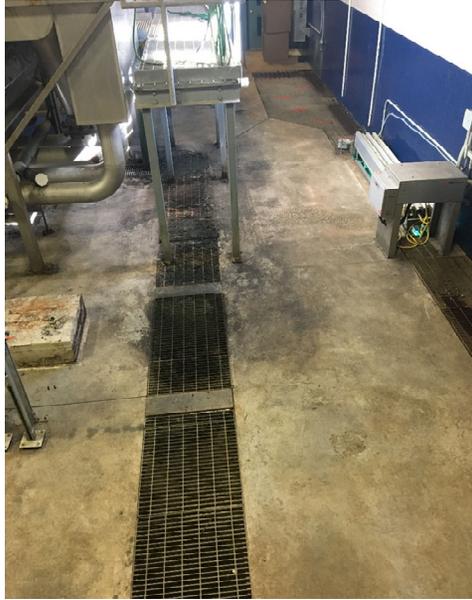
**Floor slab in Process Room 112**

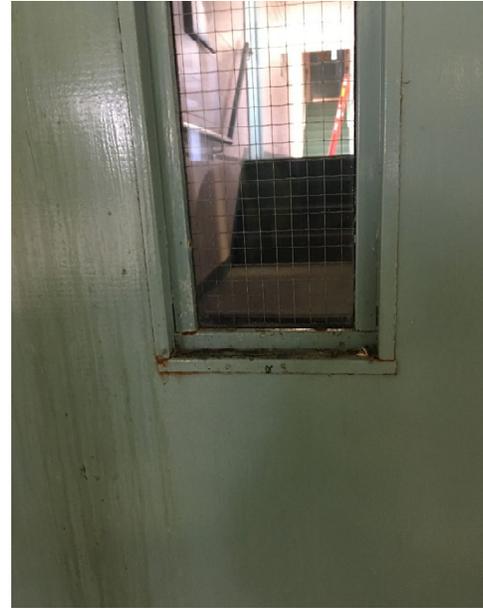
| Interior Doors | Painted pressed steel doors, 2003 | Doors and hardware very good condition. Door from Headworks 102 to Corridor 111 is rusting. Recommend replacement of door and hardware. | | X | | X | | \$1,400 | | | | | |

**Rust on pressed steel door**

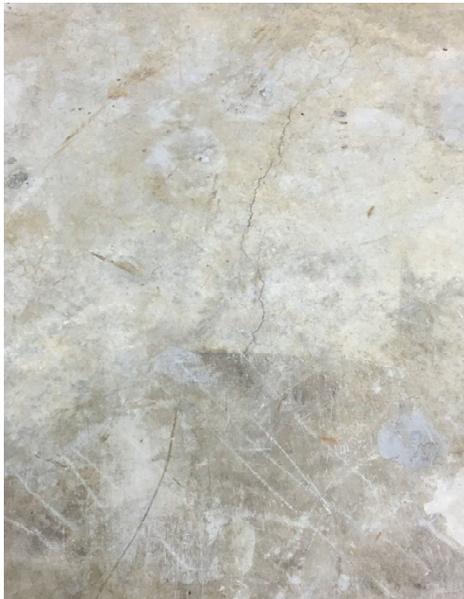
| Architectural Systems | Type/Age | Condition | U/S | POOR | FAIR | GOOD | NEW | Recap Period | | | | |
|---|--|--|---|---|---|---|---|---|---|---|---|---|
| Floor Finishes | Concrete floor slabs, 2003 | Slabs are in good shape but require cleaning. Some slight cracking in Process Room 112. Floors should be degreased and cleaned. | | | | X | | \$1,000 | | | | |

**Cracks in floor slab of Process Room 112**

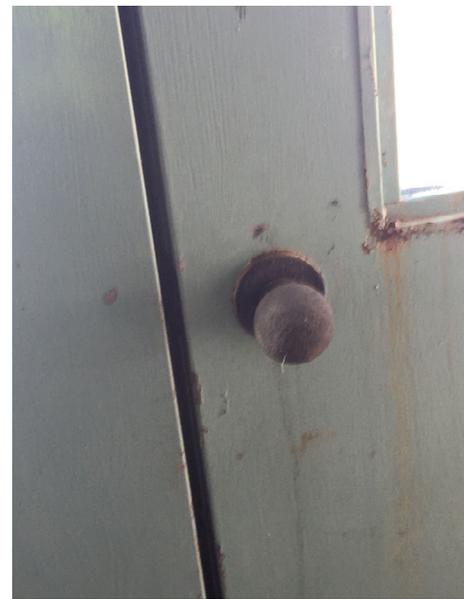
| Architectural Systems | Type/Age | Condition | U/S | POOR | FAIR | GOOD | NEW | Recap Period | | | | |
|---|--|--|---|---|---|---|---|---|---|---|---|---|
| Exterior Doors | Painted exterior steel doors, Aluminum entrance system, 2003 | 2 Doors, Double doors (D1) in Headworks RM 102 and a single man door in Dumpster Rm 101 have seen large amounts of moisture on the interior side of the door and the hardware is rusting. Replacement of these doors and hardware is suggested. The rest of the exterior doors are in good shape. Aluminum Entrance system is in good shape. | | X | | | | \$9,500 | | | | |

**Rusty Door hardware on exterior door in  
Headworks 102**

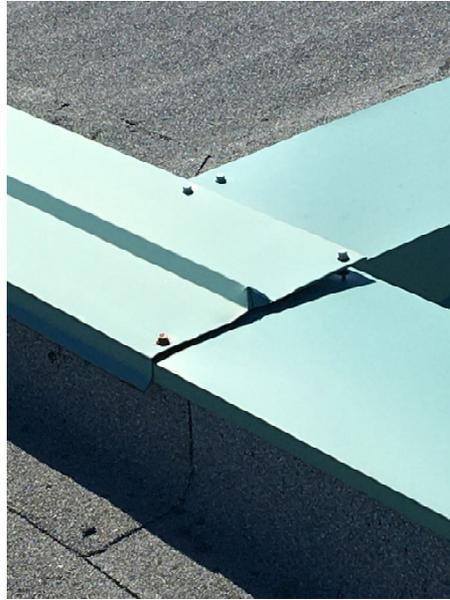
**Loose cap flashing**

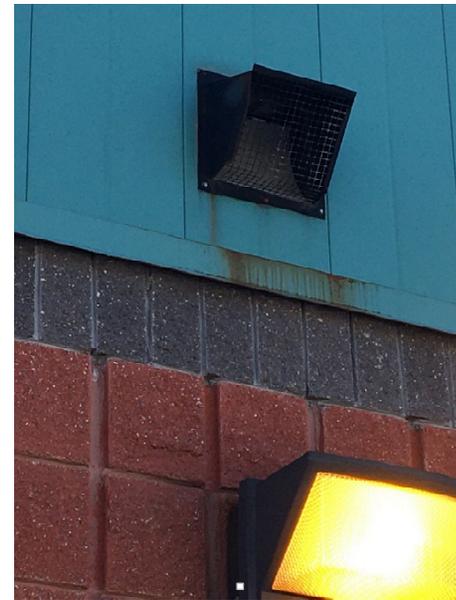
**Staining and rust on metal siding under mech vent.**

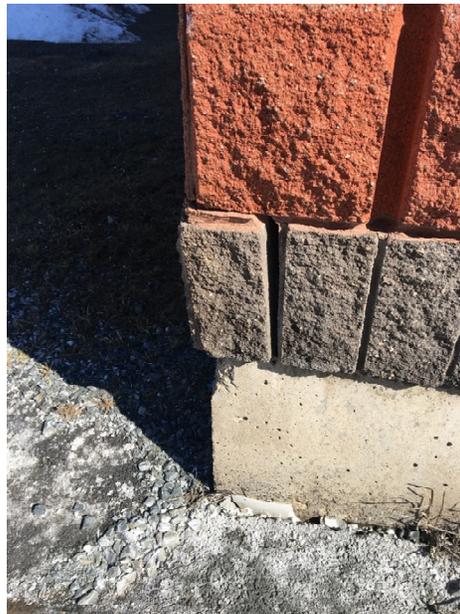
**Loose corner block , North East corner  
of Process building**

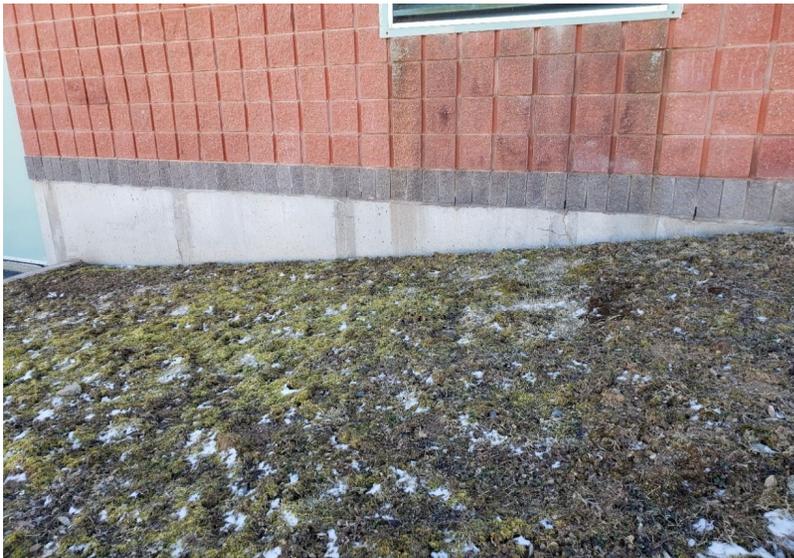
Minor temperature & shrinkage cracks in concrete foundation wall.

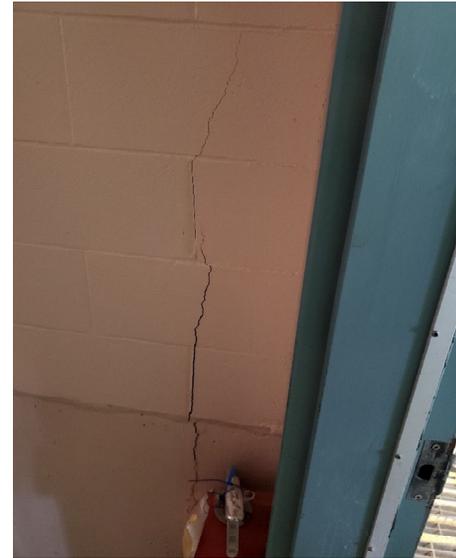
Crack in basement/foundation wall, near entrance to process area (north side of hallway).

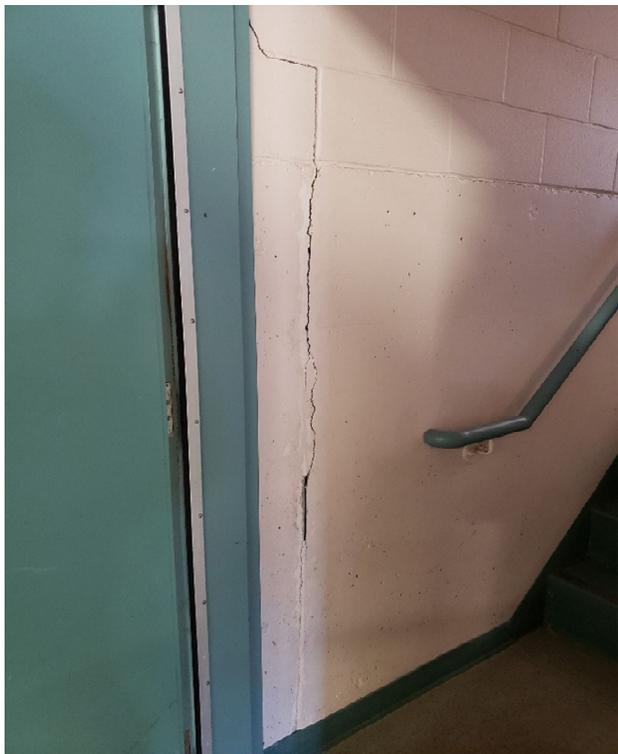
**Crack in basement/foundation wall, near entrance to process**

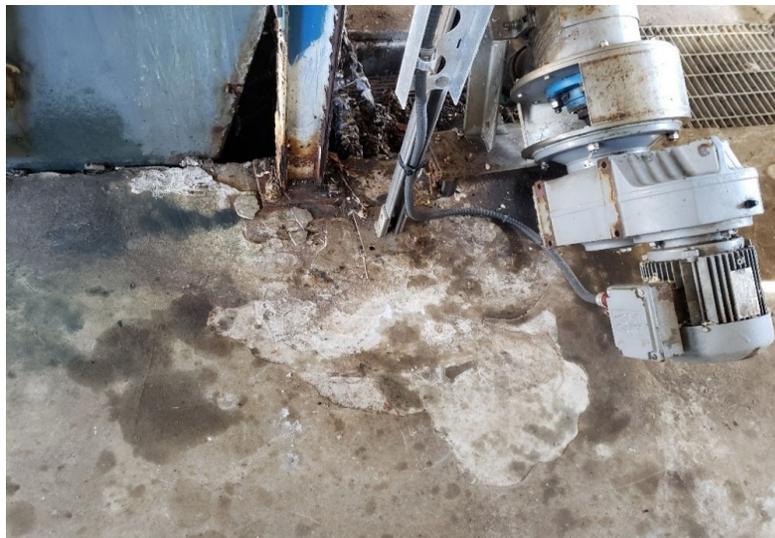
**Surface scaling of concrete in the headworks area. Note: corroded steel is not building structure - it is process equipment that could be replaced during future screen replacement. Processes must change to prevent recurrence.**

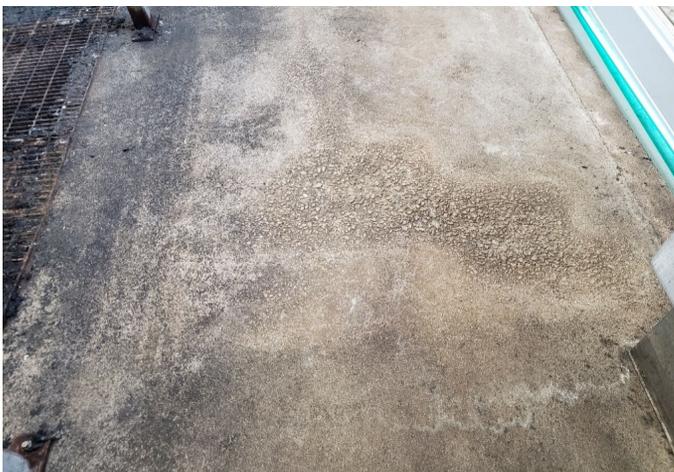
**Surface erosion of concrete in the process area. Processes must change to prevent recurrence.**

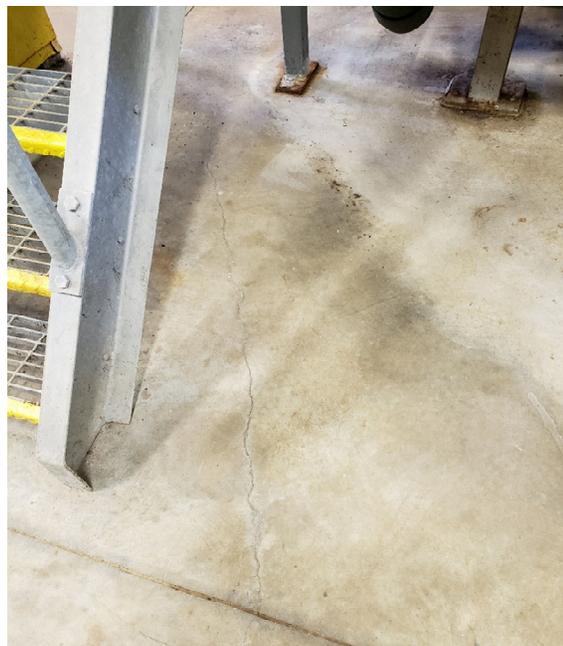
**Typical minor temperature & shrinkage crack in the process area of the Process Building**

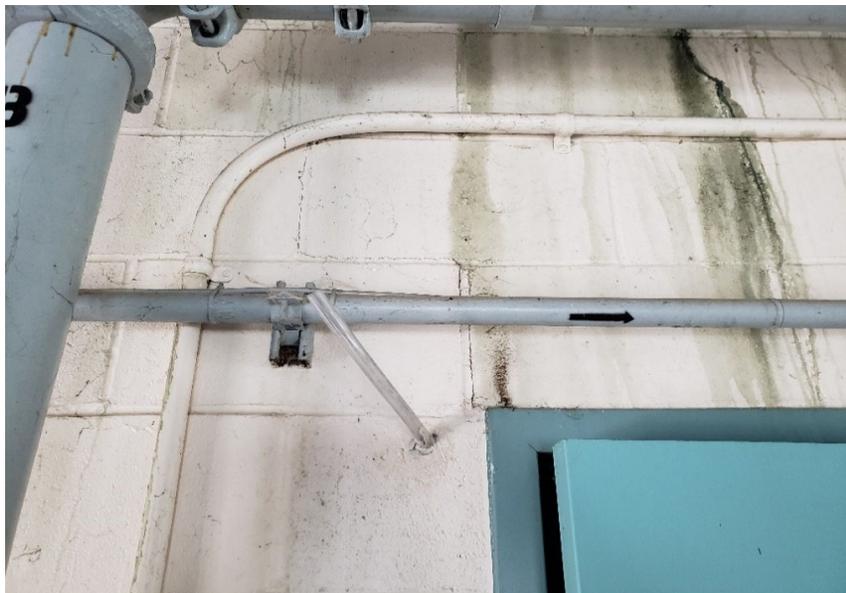
Typical step-crack at a re-entrant corner of masonry construction; headworks area door opening.

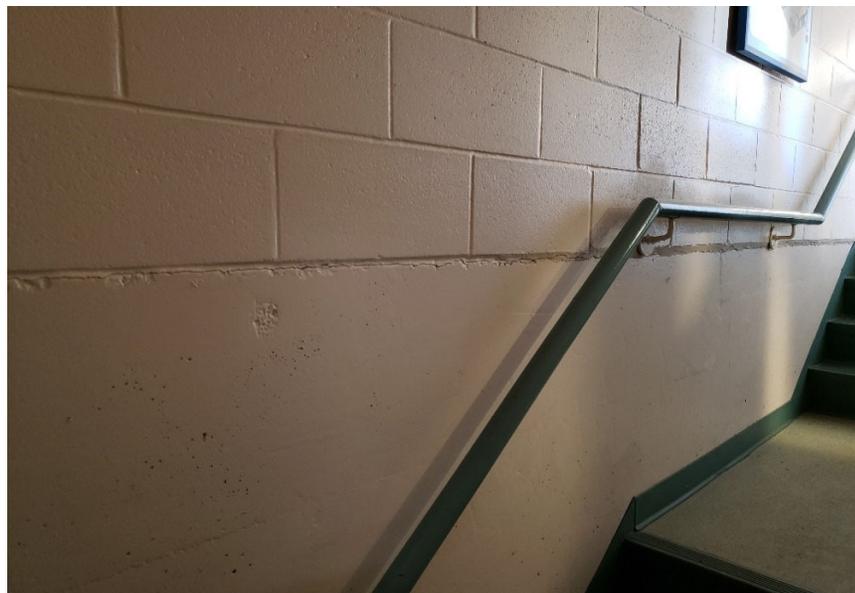
Minor crack in the mortar bed between foundation wall and masonry partition in main hallway of Process Building.

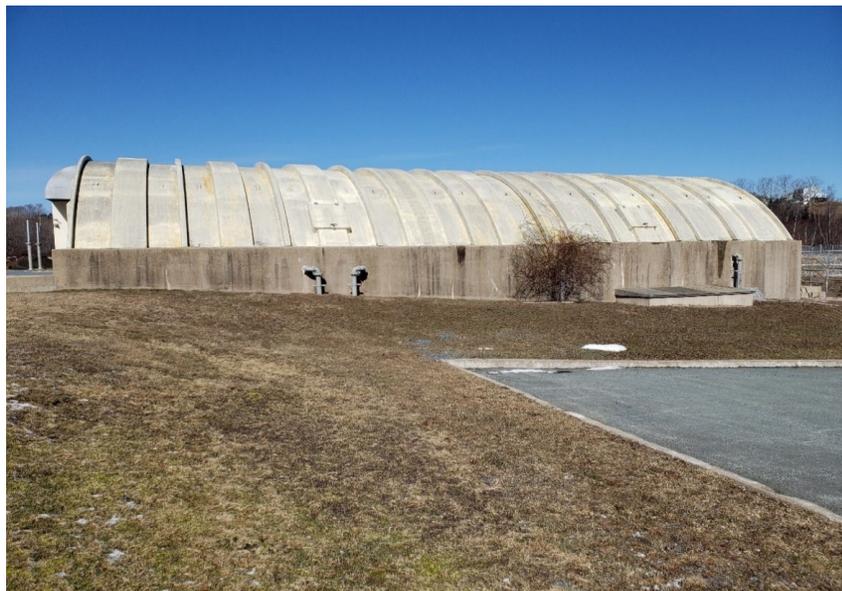
South side elevation of the Bioreactor Building; note efflorescence and random minor

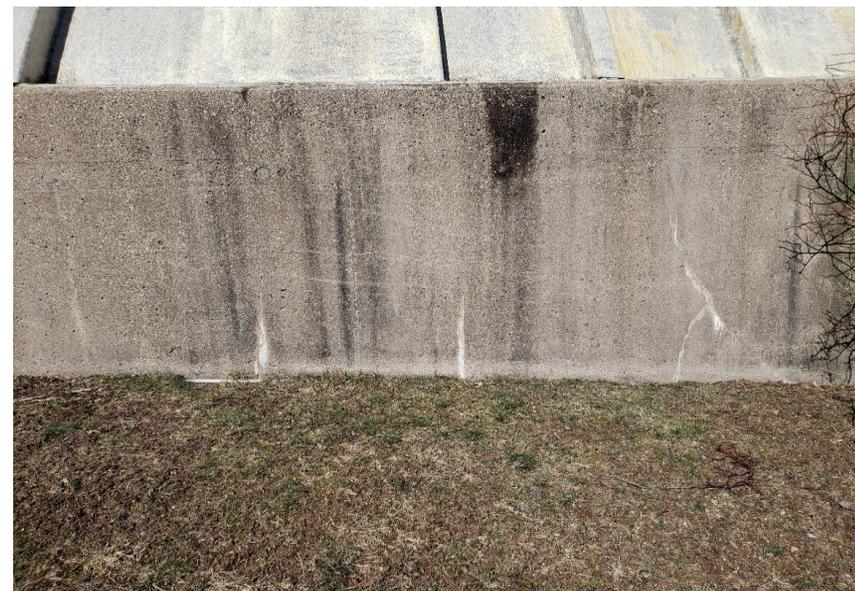
Close-up view of temperature and shrinkage cracks in the perimeter concrete walls of the Bioreactor Building

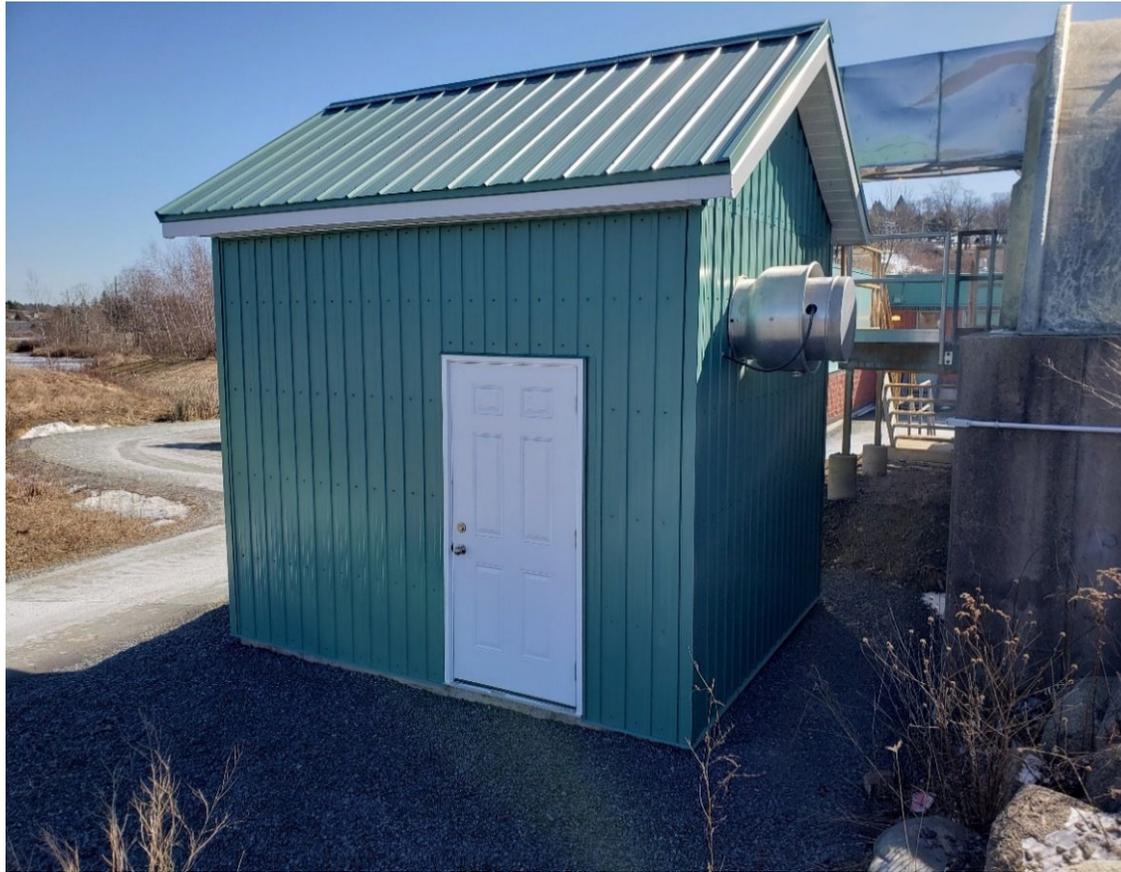
**North elevation of the Biofilter Fan Building; note near-new condition**

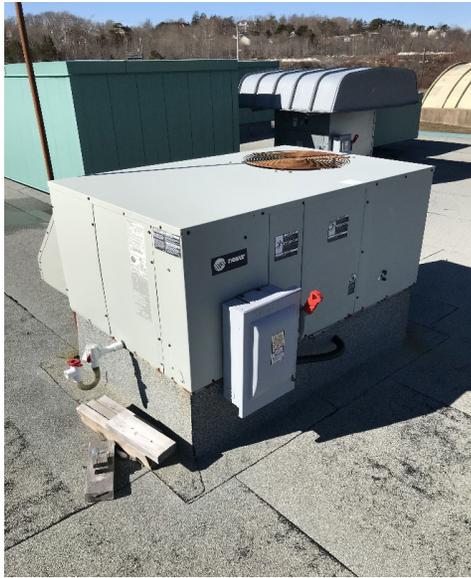
AHU serving office/lab to be replaced.

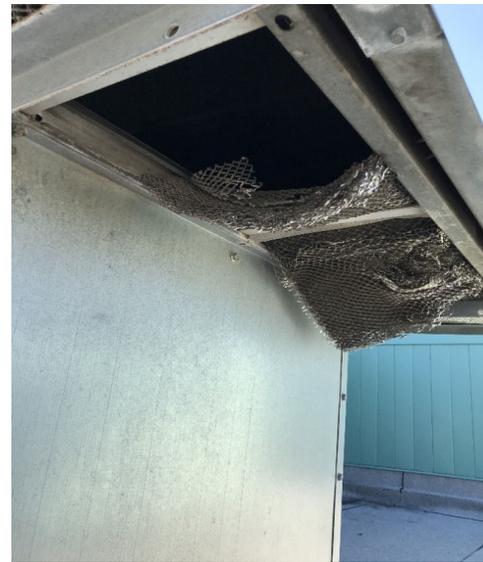
Supply Fan # 1 intake screens damaged and should be replaced.

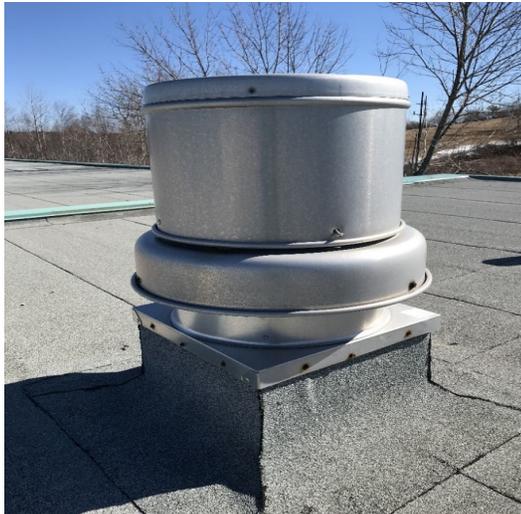
Typical original equipment exhaust fan on roof nearing end of reliable service life (EF-3 shown).

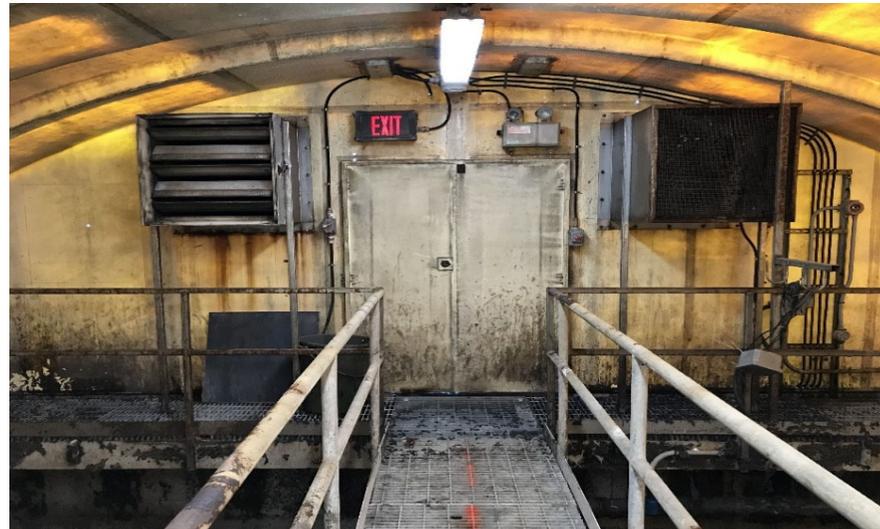
Intake and exhaust air ductwork (to the *Biofilter Fan Building* beyond) in fair condition.

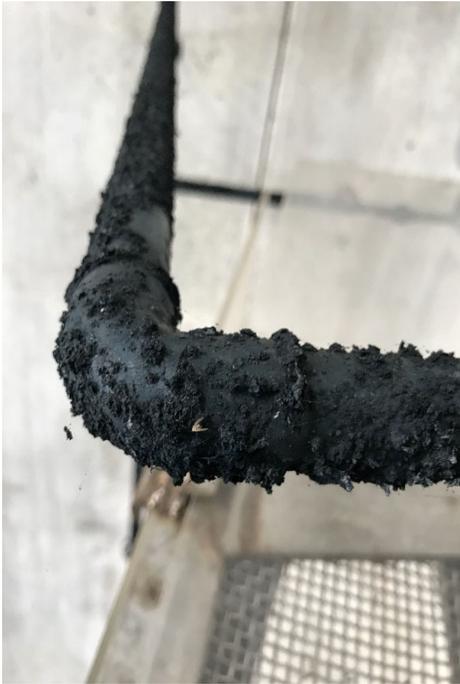
Typical corrosion and blistering paint on copper piping.

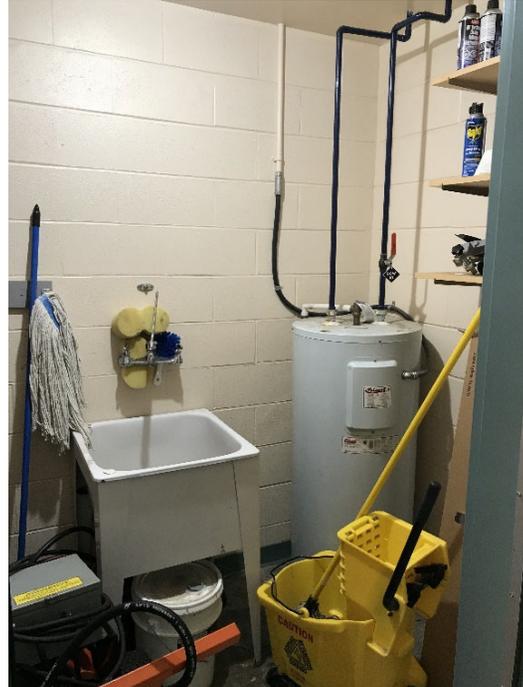
Electric water beyond its reliable service life.

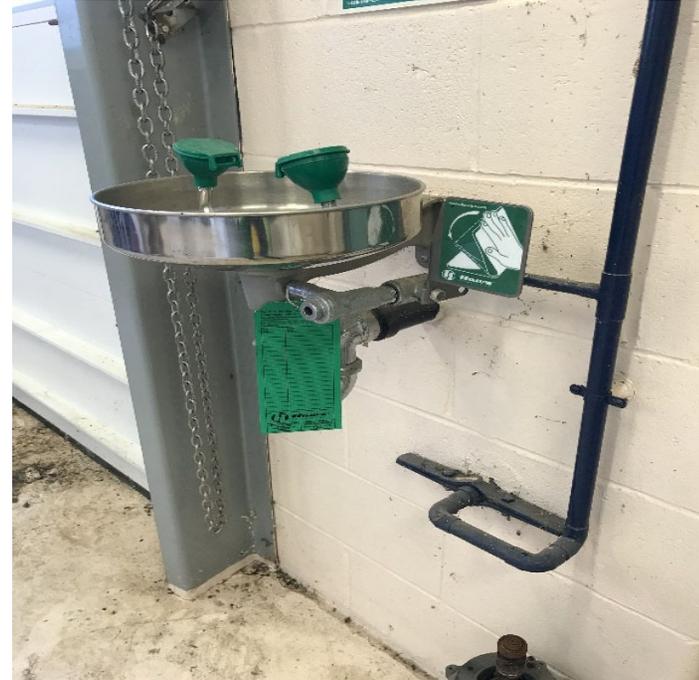
Emergency fixture plumbing only with cold water.

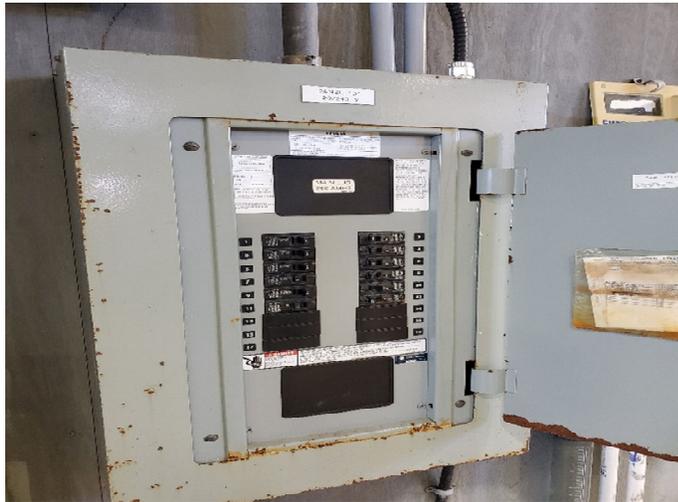
Saltwater flooding in the Process area has caused significant corrosion on many of the electrical enclosures, particularly the equipment that was part of the original construction which has NEMA 1 enclosures. The newer equipment has NEMA 4X stainless steel enclosures and is in very good condition with no signs of corrosion. It is recommended that the corroded equipment be replaced with NEMA 4X equipment soon.

Panelboard in process area is very corroded.

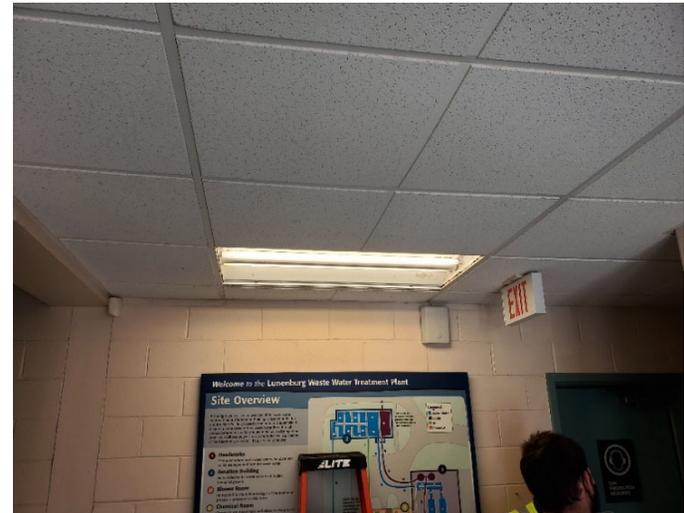
Suggest replacing existing fluorescent lighting with more efficient LED.

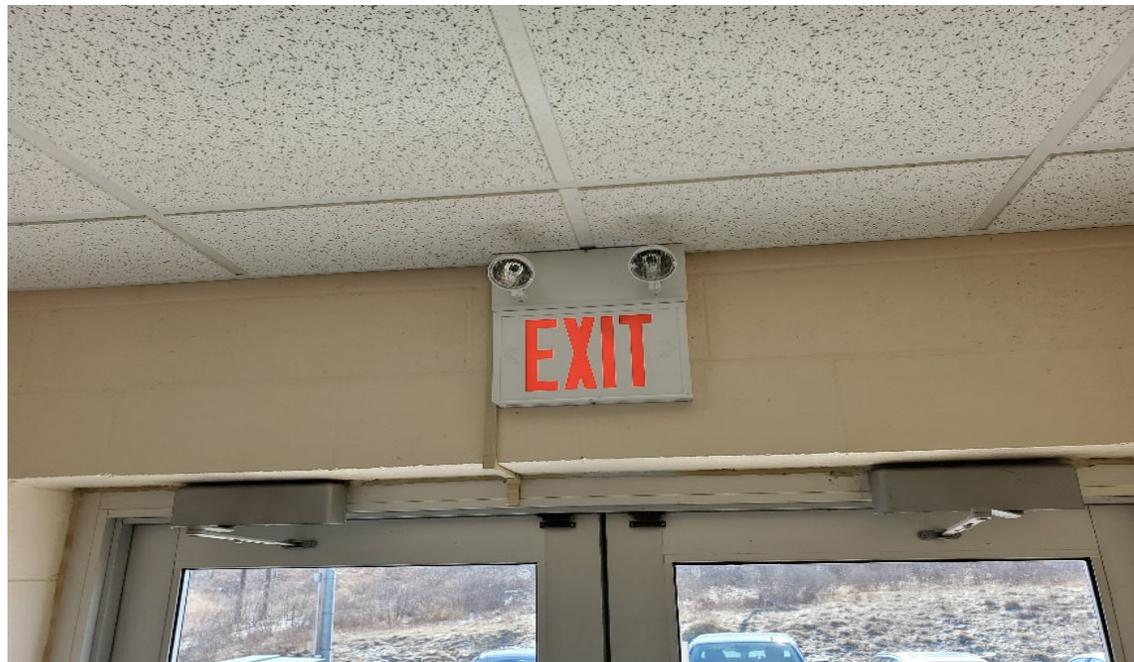
Suggest replacing red exit signs with newer green running man.
