COUNCIL MEETING AGENDA

TOWN OF LUNENBURG

Tuesday, December 13, 2022 at 6 p.m.

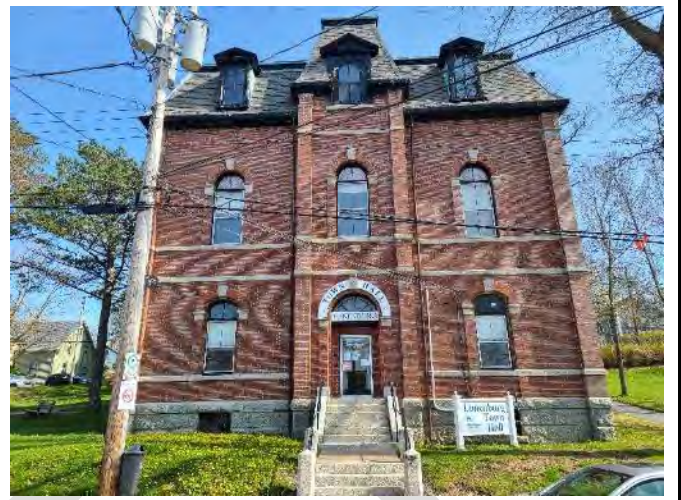
South Elevation

- Visible faced granite at foundation level.
- Mass clay brick masonry walls.
- Granite slab entrance stairs.
- Mansard roof with prominent dormers.

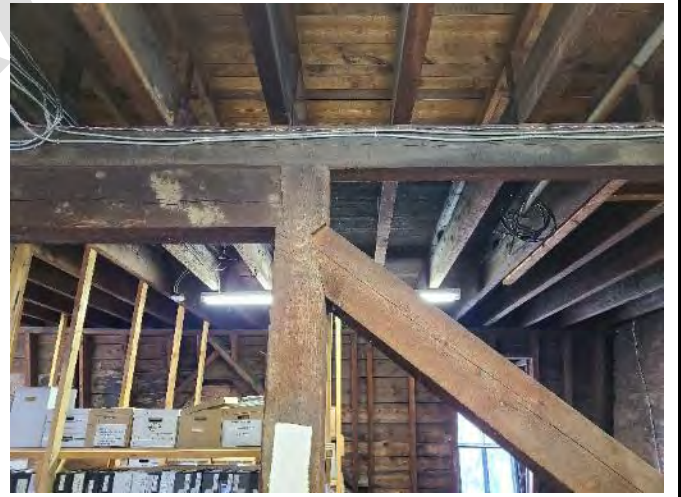
Roof Space

- Typical wood construction is visible within the mansard roof.

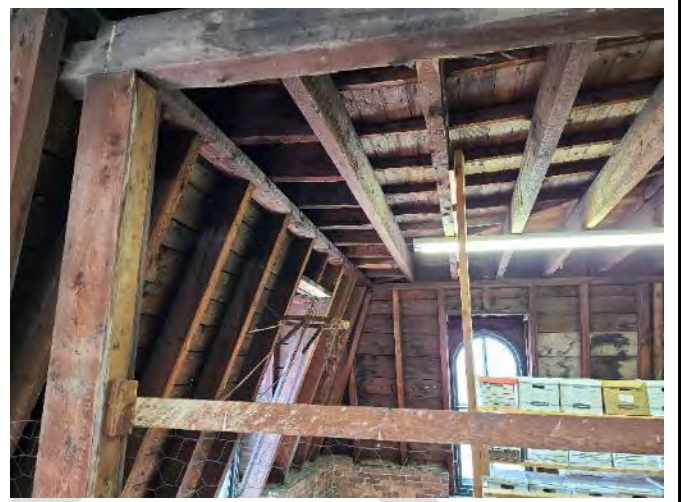
Roof Space

- Typical wood construction is visible within the mansard roof.

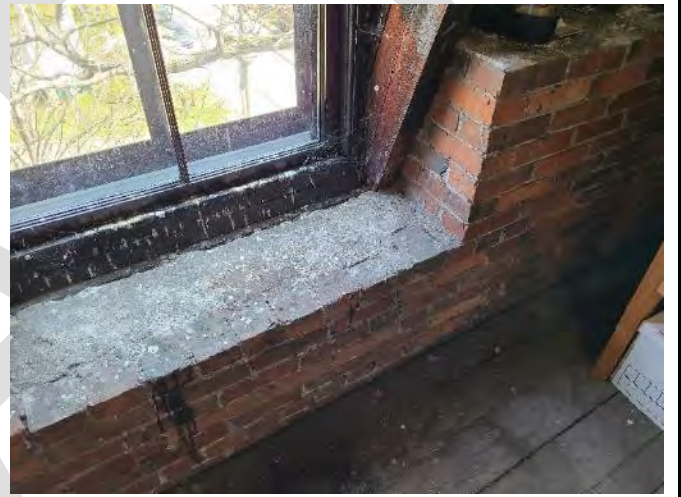
Roof Space

- Typical example of mass masonry wall at the top of the exterior wall at the base of the mansard.

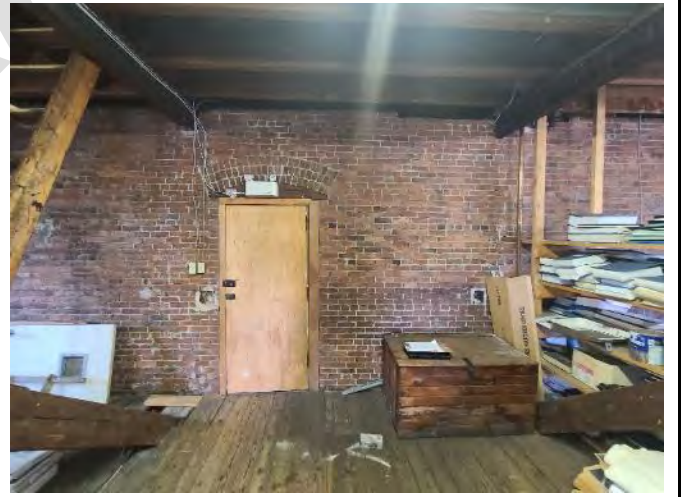
Roof Space

- Masonry wall separating building north to south is visible at the interior of the mansard roof area.

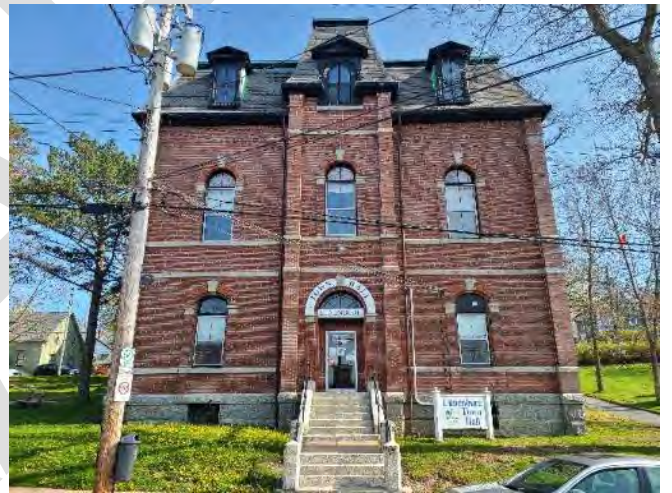
South Elevation

- General image of south elevation.

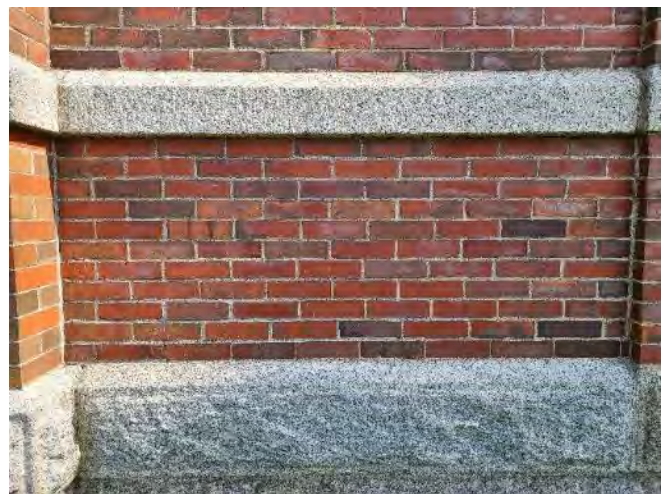
South Elevation

- Substantial crazing of masonry units was observed at all elevations.

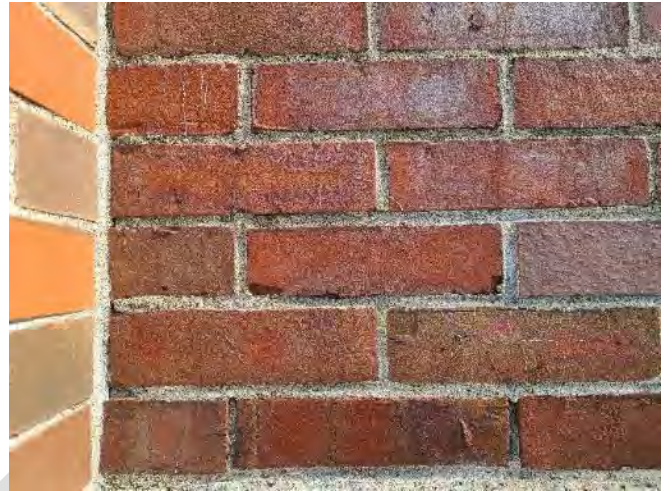
South Elevation

- Substantial crazing was observed at masonry units.
- Previous masonry repairs were observed at the pilaster as seen at the left of the image. New masonry units differ from the older, possibly original, masonry units.

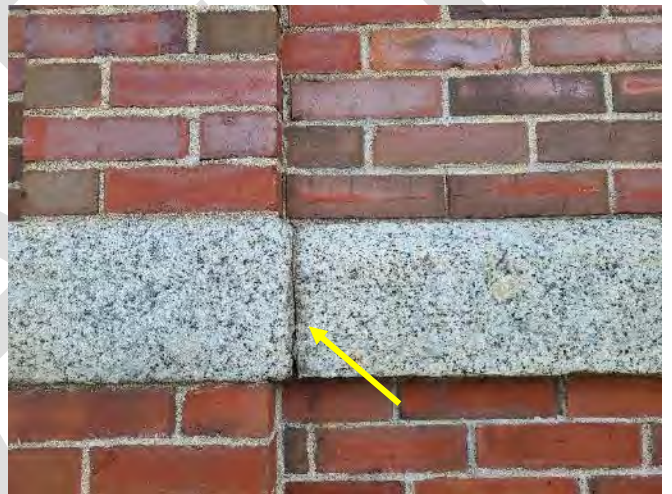
South Elevation

- Substantial crazing was observed at masonry units.
- Cracking was observed at mortar joints of masonry and granite (yellow arrow).

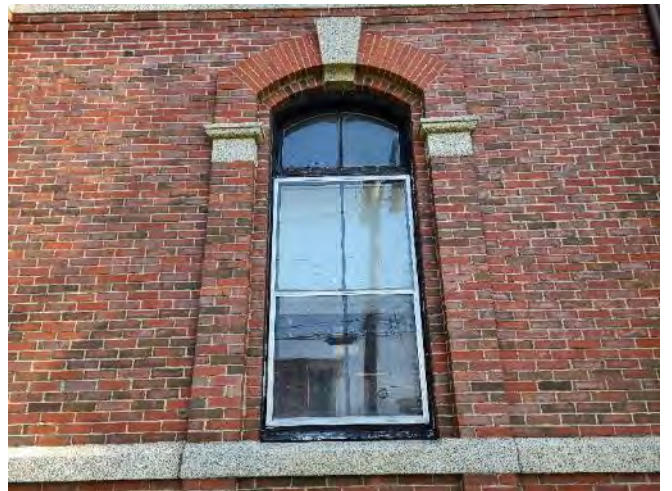
South Elevation

- Typical example of the masonry arches observed at windows at south elevation.

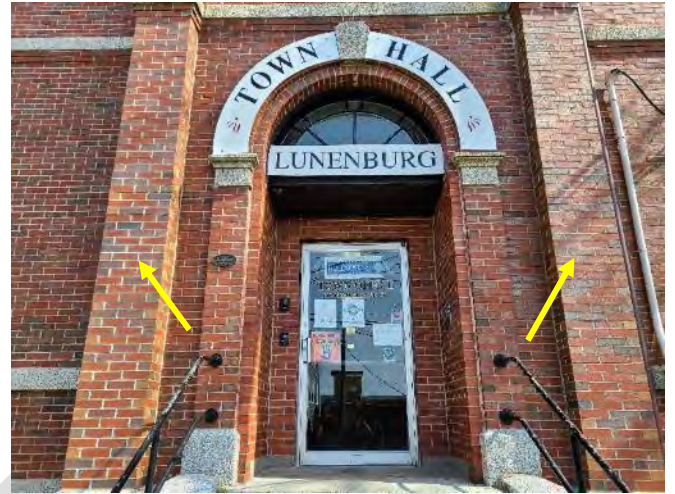
South Elevation

- The pilasters on either side of the main south entrance have been rebuilt.
- The inset entranceway appears to be of relatively new construction as the masonry varies from the original.

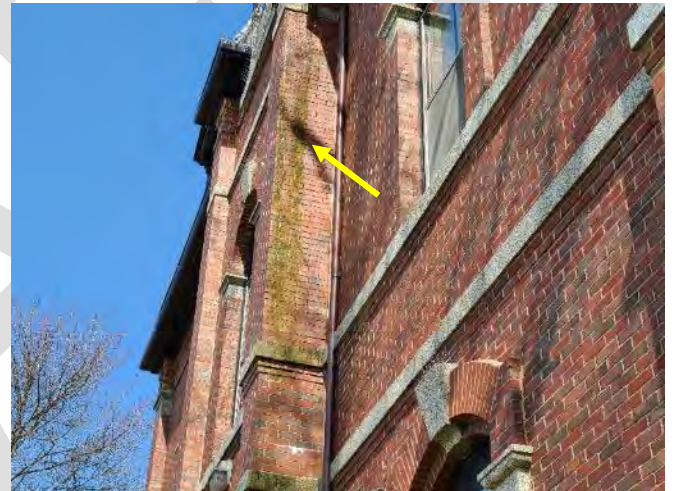
South Elevation

- Organic growth and staining were observed at the pilaster to the right of the main entrance. This may be caused by water run-off overshooting the eavestrough above. Continued wetting may result in premature deterioration of the clay brick masonry units and/or the mortar.

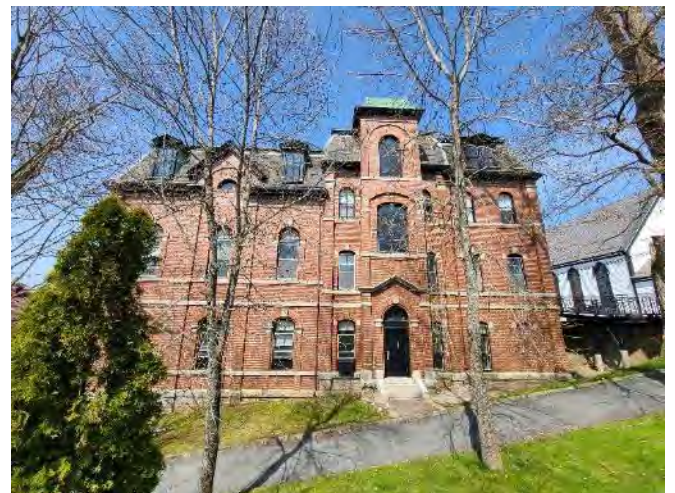
East Elevation

- General view of east elevation featuring a copper roof at the top of the stairway tower.

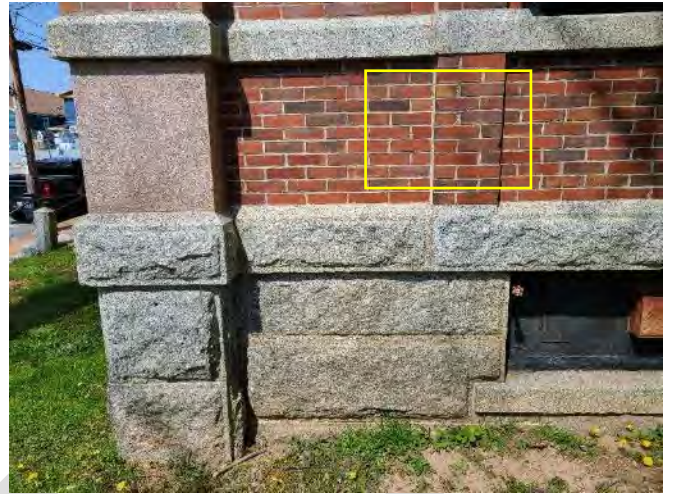
East Elevation

- Significant crazing of masonry was observed. See following image.

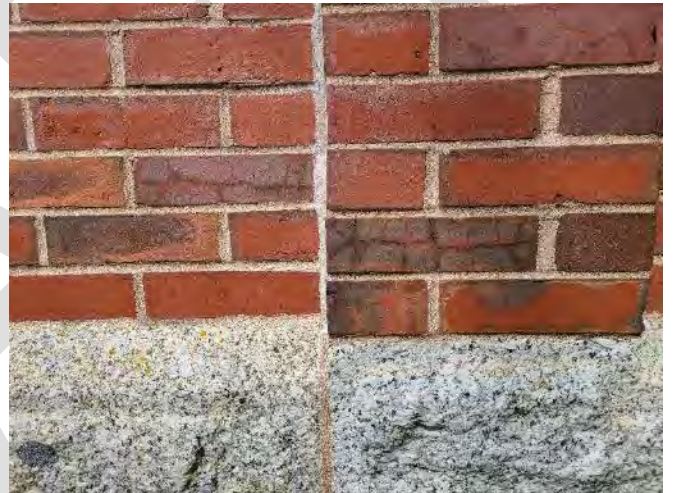
East Elevation

- Significant crazing of masonry was observed across the east elevation. See following image.

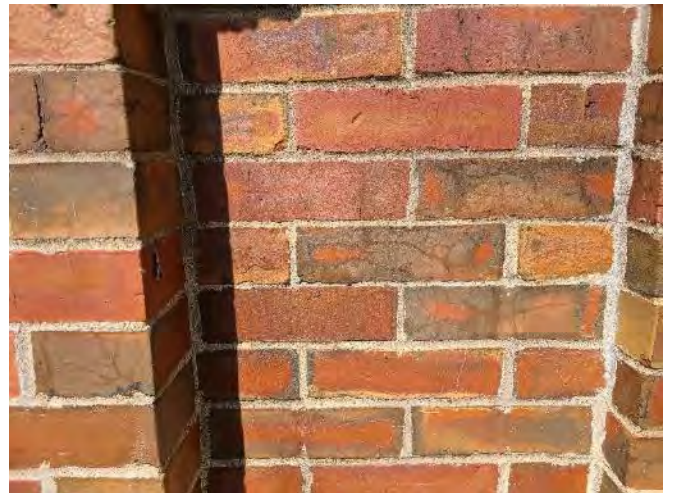
East Elevation

- Significant crazing of masonry was observed across the east elevation.

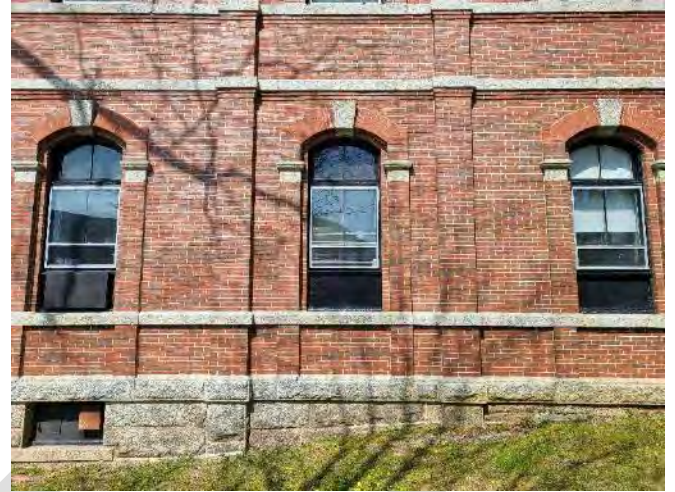
East Elevation

- Typical example of masonry arches at the first floor to the south of the stair tower.
- This detail is duplicated at the second-floor windows above; however, second floor windows feature a taller archway (see following observation), whereas the first-floor arch is shallower.

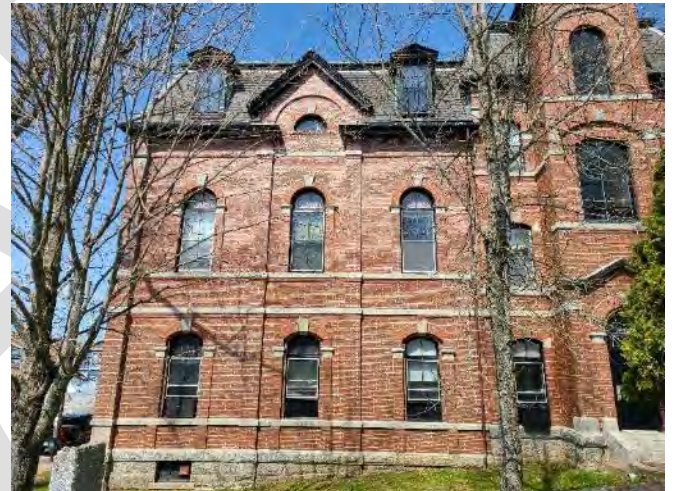
East Elevation

- Typical example of masonry arches at the first floor to the south of the stair tower.
- This detail is duplicated at the second-floor windows above; however, second floor windows feature a taller archway (see following observation), whereas the first-floor arch is shallower.

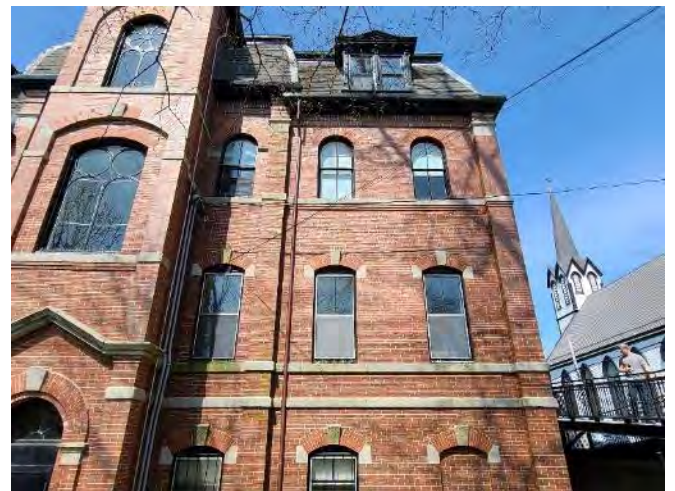
East Elevation

- Typical example of masonry arches above windows at the east elevation. Note, the lack of granite keystones at the third floor.
- Organic growth was observed to the right of the stair tower. See following observation.

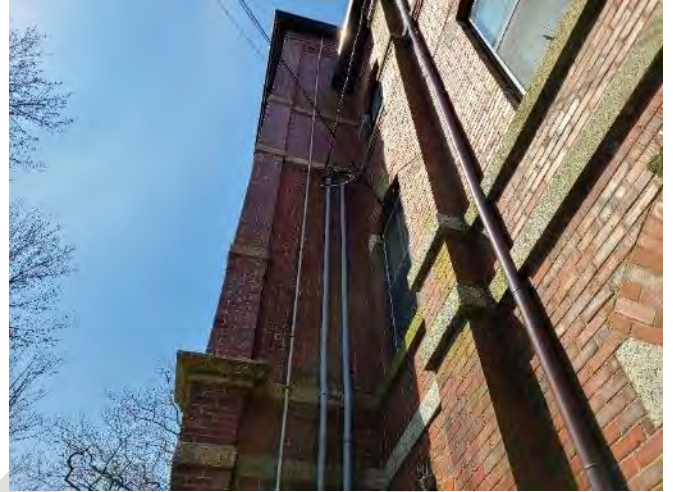
East Elevation

- Organic growth and staining were observed at various locations across the east elevation. This is likely exacerbated by substantial shading by large trees surrounding the property limiting the drying potential of the masonry.

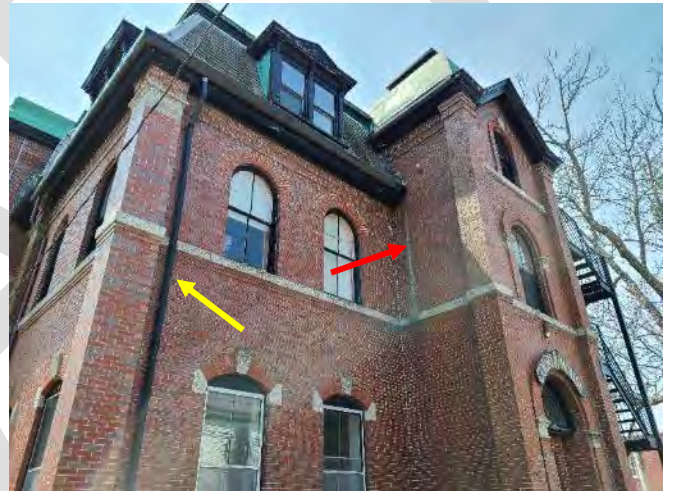
North Elevation – behind retaining wall

- General image of the north elevation behind the retaining wall.
- Notice, the original copper downspout has been replaced with plastic (yellow arrow).
- Staining of the masonry was observed at the interior corner. This is likely caused by water run-off from the roof passing between the gutter and the exterior wall (red arrow). The gutter end may also be damaged.
- Staining and discoloration of the granite ribbon was observed.

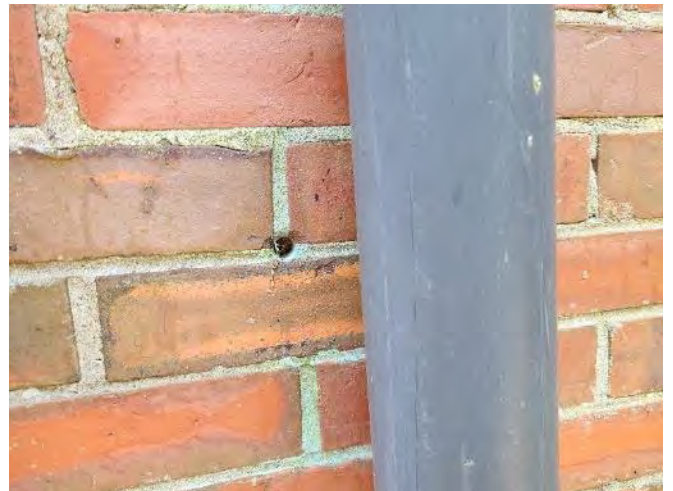
North Elevation – behind retaining wall

- Missing downspout support brackets were observed leaving openings in masonry.
- See following observation.

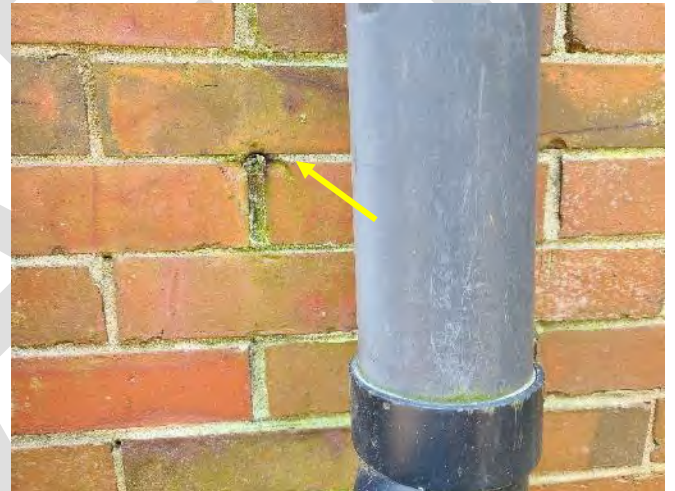
North Elevation – behind retaining wall

- Holes in masonry were observed to be plugged with wood.
- Notice the staining at the masonry.

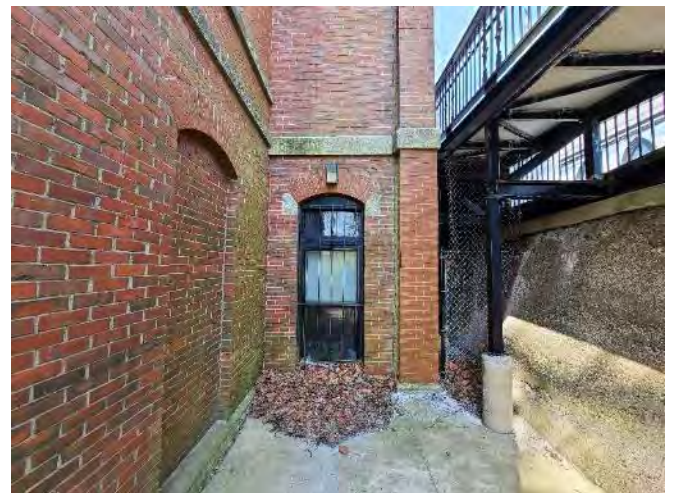
North Elevation – behind retaining wall

- General image of the north elevation behind the retaining wall.
- Organic growth was observed at the north elevation. This is likely exacerbated by this area being a mainly shaded throughout the day limiting the drying potential of the masonry.

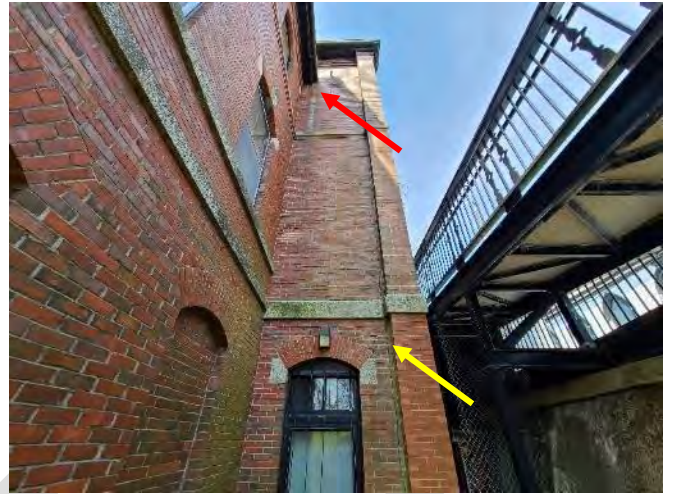
North Elevation – behind retaining wall

- Staining of the masonry was observed at the interior corner. This is likely caused by water run-off from the roof passing between the gutter and the exterior wall (red arrow). The gutter end may also be damaged.
- A crack was observed through the masonry at the upper right corner of the window (yellow arrow).
- See following observation.

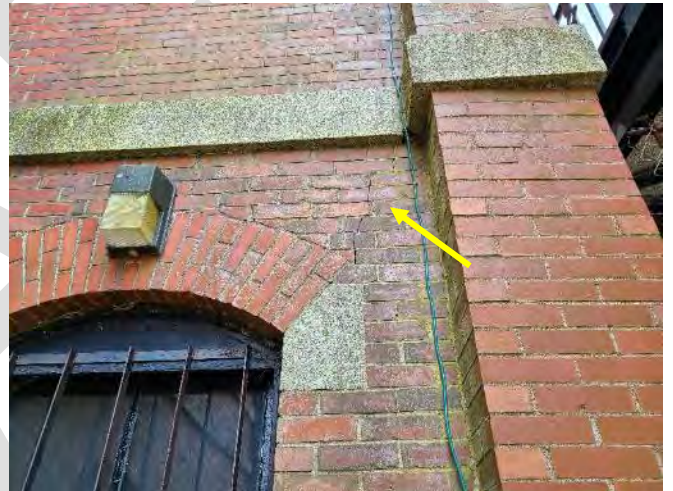
North Elevation – behind retaining wall

- The crack observed travels diagonally through masonry and terminates at the pilaster.
- The pilaster to the right of the window appears to have been rebuilt likely following the report provided by GF Duffus dated April 2008.
- See following observation.

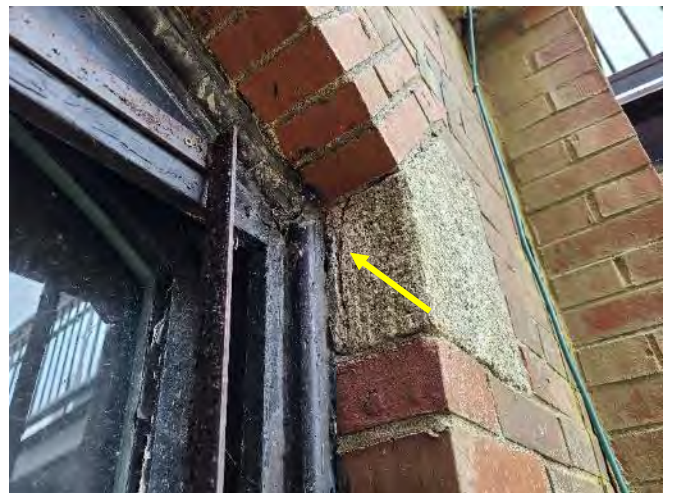
North Elevation – behind retaining wall

- The crack was observed to travel directly through the back of the granite coining.
- The pilaster to the right of the window appears to have been rebuilt likely following the report provided by G.F. Duffus dated April 2008.

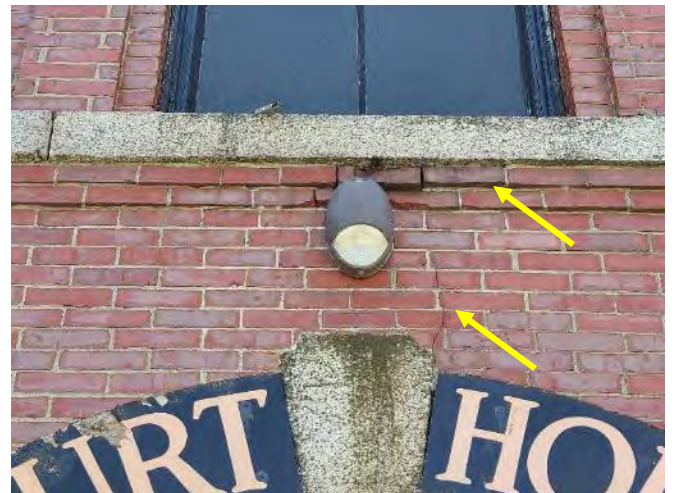
North Elevation

- Deteriorated mortar was observed below the granite ribbon.
- A crack was observed through the masonry originating above the granite keystone, traveling vertically towards the horizontal granite ribbon.
- Staining of the granite was observed in multiple locations.

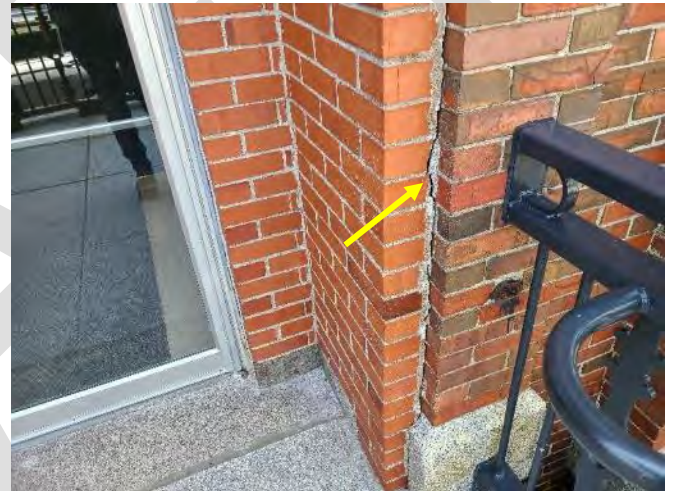
North Elevation

- Cracking of the mortar between the newer masonry and older pilasters to the right and left of the entrance was observed.
- Significant crazing of masonry units was observed to both the right and left of the entrance. See following observation.

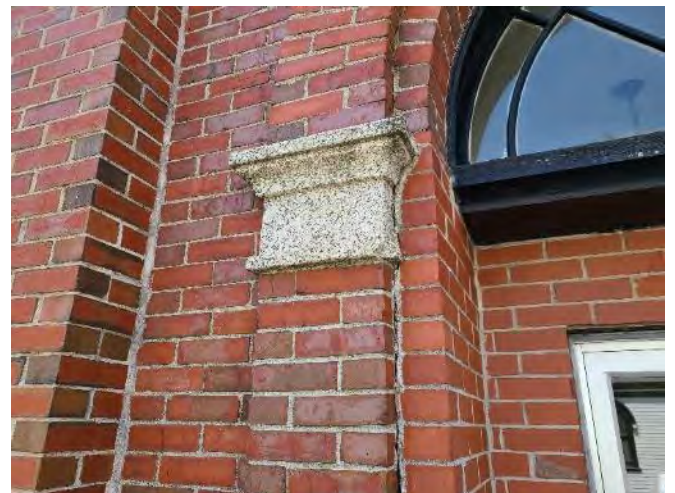
North Elevation

- Significant crazing of masonry units was observed to both the right and left of the entrance. See following observation.

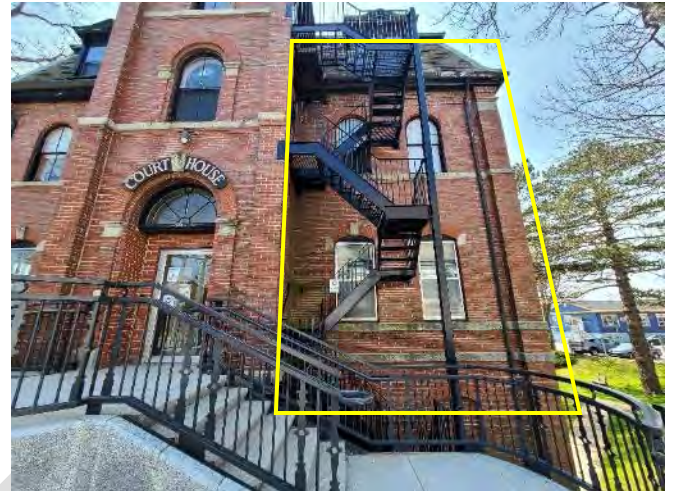
North Elevation

- Staining of masonry was observed at the elevation right of the main entrance.
- Cracking and crazing of masonry were observed at multiple locations.
- See following images.

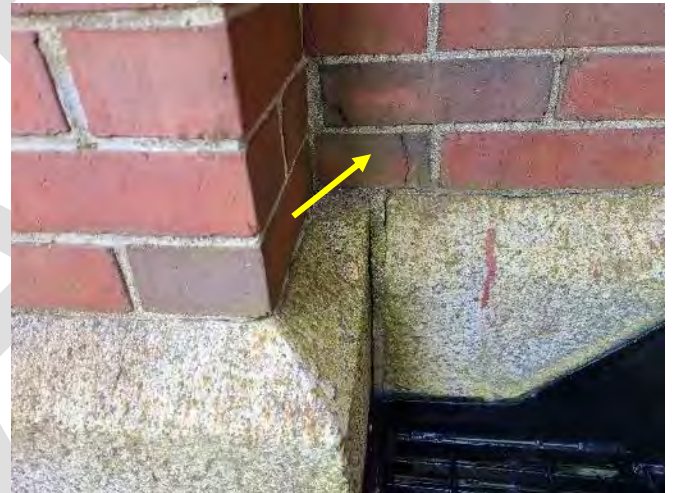
North Elevation

- Cracking of the masonry was observed (yellow arrow). See following image.

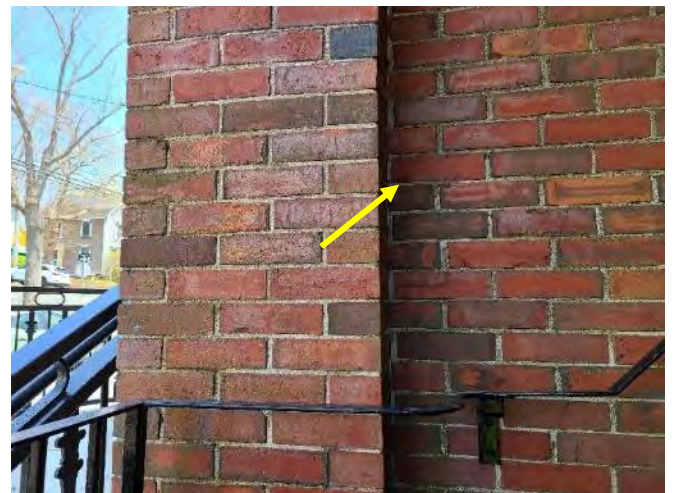
North Elevation

- The cracking shown in the previous observation was observed to travel vertically along the edge of the pilaster (yellow arrow).
- Significant crazing of masonry units was observed.

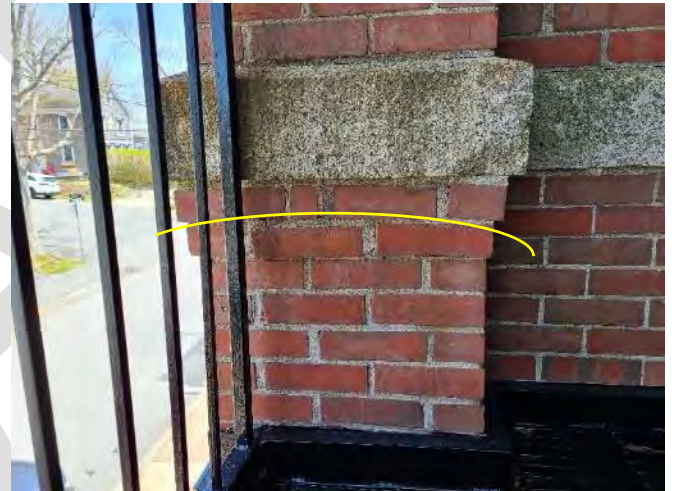
North Elevation

- Masonry making up the corbel below the granite ribbon was observed to be slightly bowed as indicated by the yellow marker.
- Staining of the granite was observed.

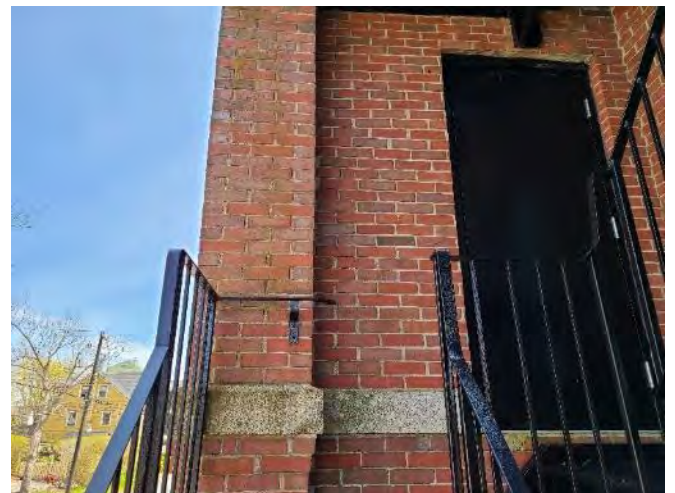
North Elevation

- No masonry lintel was observed above the exterior steel exit doors. See following image.
- Staining of the masonry was observed.
- Some organic growth was observed, particularly above the exit door. See following observation.

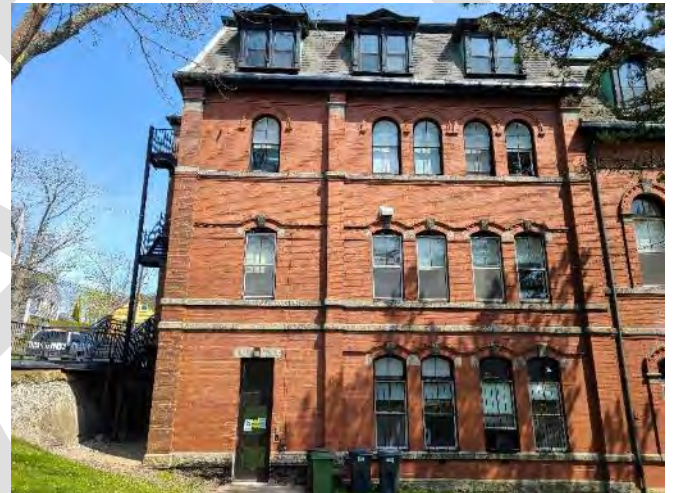
West Elevation

- General image of west elevation.
- The west elevation features two styles of masonry arches unique to the elevation pictured here.
- Crazeing of masonry was observed at multiple locations.
- Cracking of masonry was observed at multiple locations.
- Deteriorated mortar joints were observed at multiple locations.

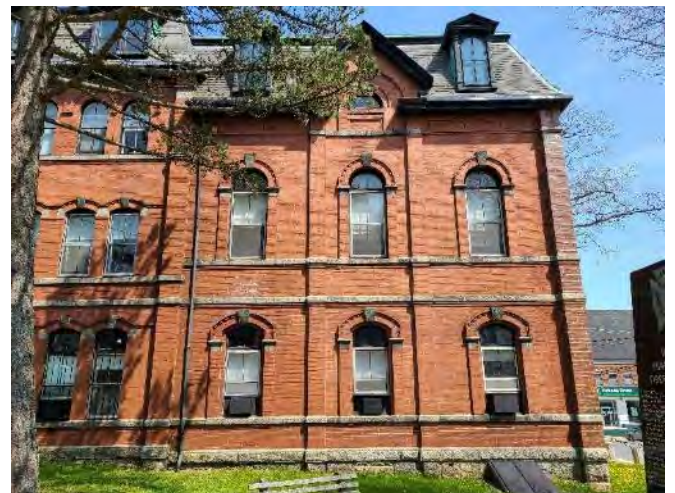
West Elevation

- General image of west elevation.
- Crazeing of masonry was observed at multiple locations.
- Cracking of masonry was observed at multiple locations.
- Deteriorated mortar joints were observed at multiple locations.
- See following observations.

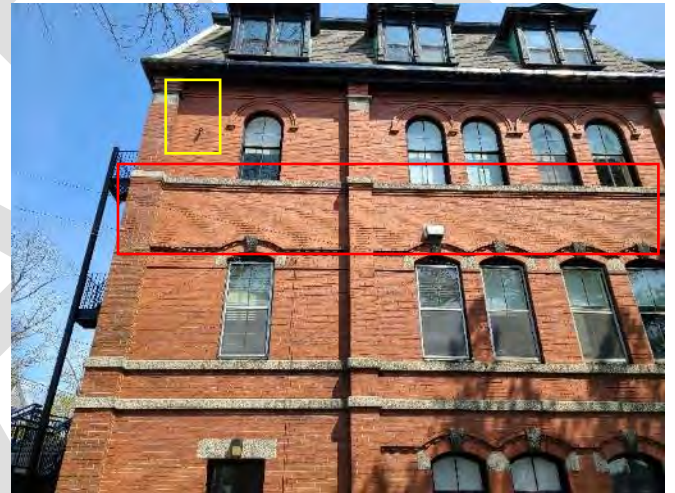
West Elevation

- An abandoned electrical insulator was observed along with an unsealed penetration approximately 50 mm in diameter (yellow box).
- Significant efflorescence was observed at the masonry between the second and third floors (red box).

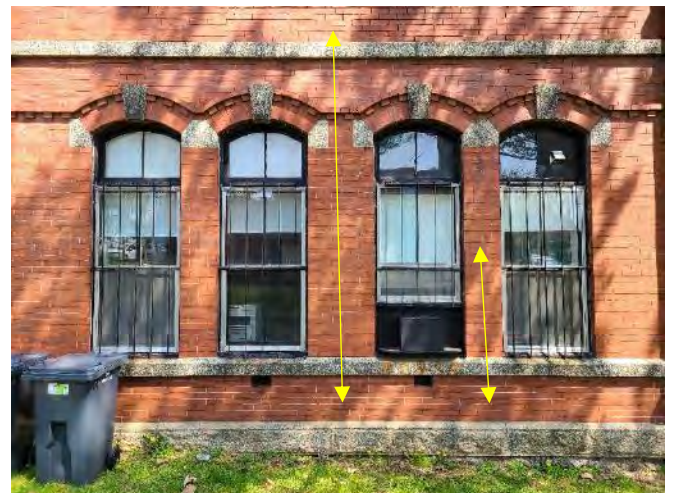
West Elevation

- Typical masonry detailing above first floor windows at the northern most side of the west elevation.
- Masonry cracking was observed at multiple locations (yellow arrow).
- The cracks observed originated at the granite foundation and travel vertically above the first-floor windows.
- See following observations.

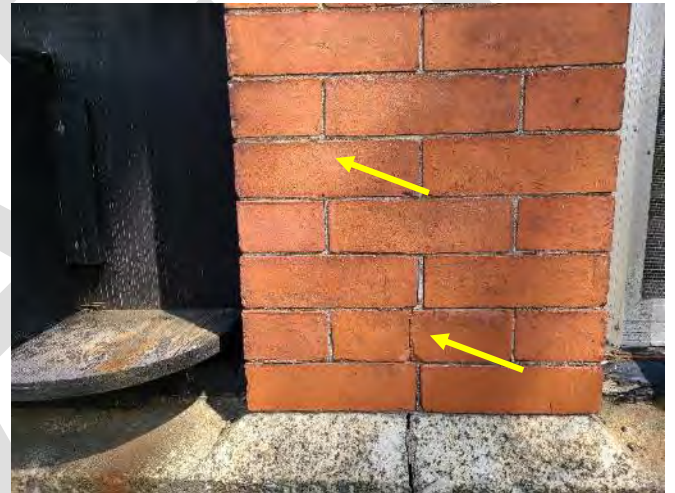
West Elevation

- Masonry cracking was observed at multiple locations.
- The crack, pictured here, originated at the granite foundation and travels vertically above the first-floor windows.

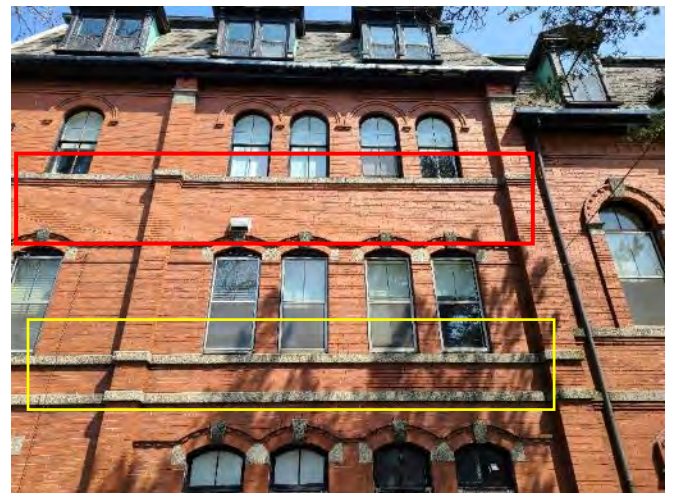
West Elevation

- Typical masonry detailing above third floor windows.
- Significant efflorescence was observed at the masonry between the second and third floors (red box).
- Deteriorated masonry was observed between the first and second floor windows. See following image.

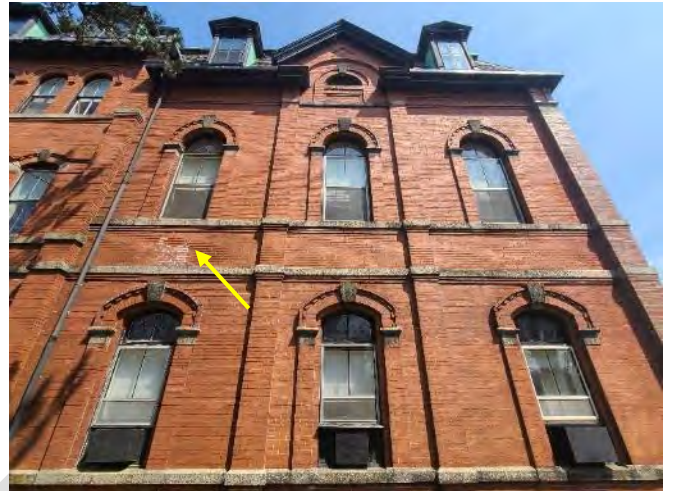
West Elevation

- Typical example of masonry arches common to the west and east elevation.
- A previous repair and repointing effort was observed (yellow arrow). Repair work does not blend with the surrounding masonry.
- Spalling masonry was observed near the downspout (see following observation).

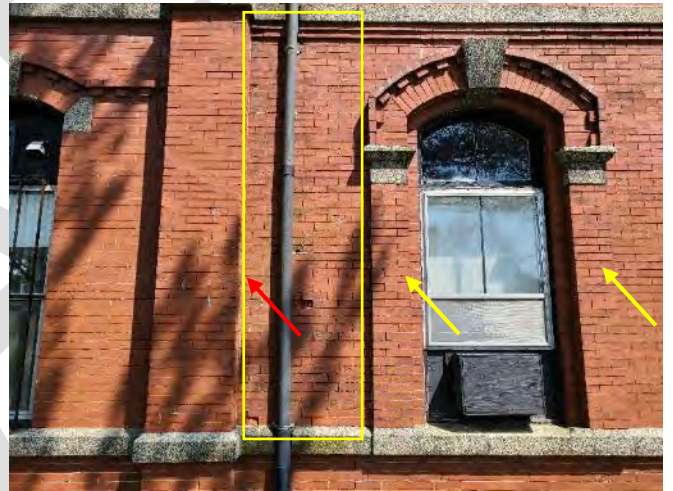
West Elevation

- Spalling masonry was observed near the downspout (yellow box).
- Deteriorated mortar joints were observed at the pilasters supporting the window arch (yellow arrow).
- Deteriorated sealant was observed at the pilaster to the left of the downspout (red arrow). Sealant was also used to repair masonry and joints.
- Previous repairs were also observed at the masonry arch which does not blend with the original masonry.

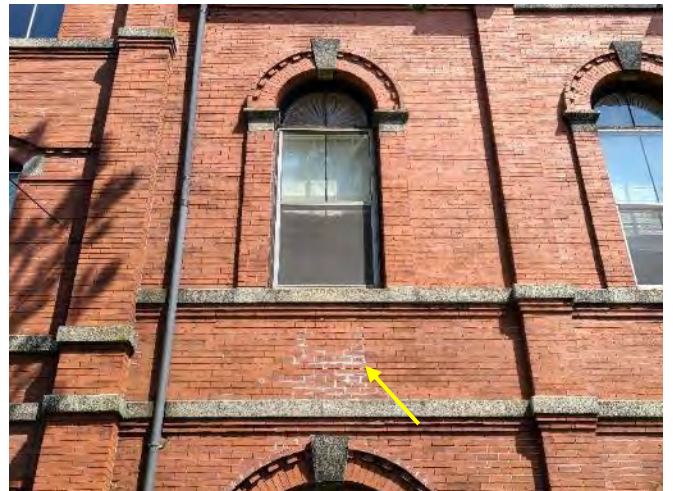
West Elevation

- A previous repair and repointing effort was observed (yellow arrow). Repair work does not blend with the surrounding masonry.
- Staining of granite keystones and springers were observed at most windows.

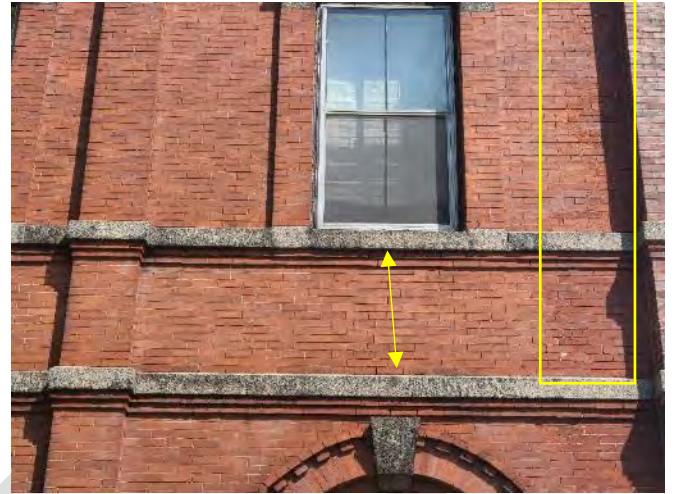
West Elevation

- Spalling of masonry was observed two to the left of the pilaster (yellow box).
- A masonry crack was observed (yellow arrow).
- See following observation.

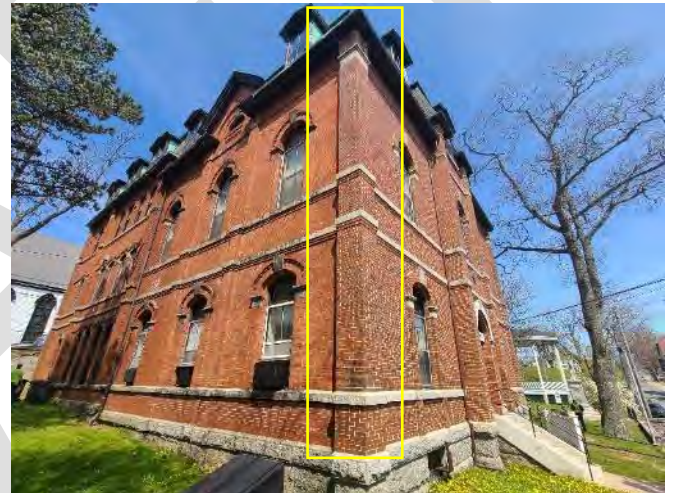
Southwest Corner

- Significant deflection was observed in the masonry forming the outermost pilaster. This was especially visible at the top of the pilaster.

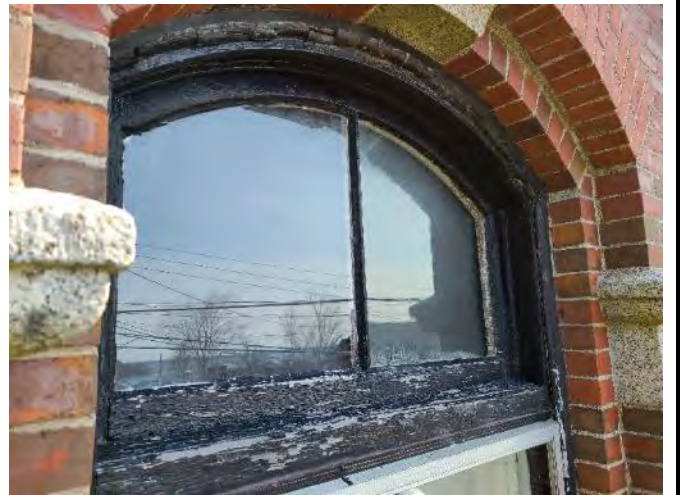
South Elevation

- Paint/stain at the upper arched window was observed to be deteriorated.
- The brickmould for the arch appears to be constructed of multiple pieces of quarter round. This does not appear to be of original construction.

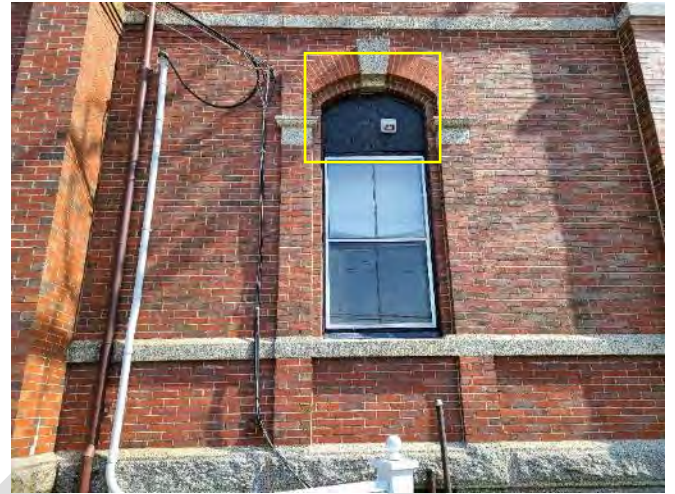
South Elevation

- Upper arched window is infilled with painted plywood to accept a mechanical exhaust vent.
- Paint/stain was observed to be deteriorated.

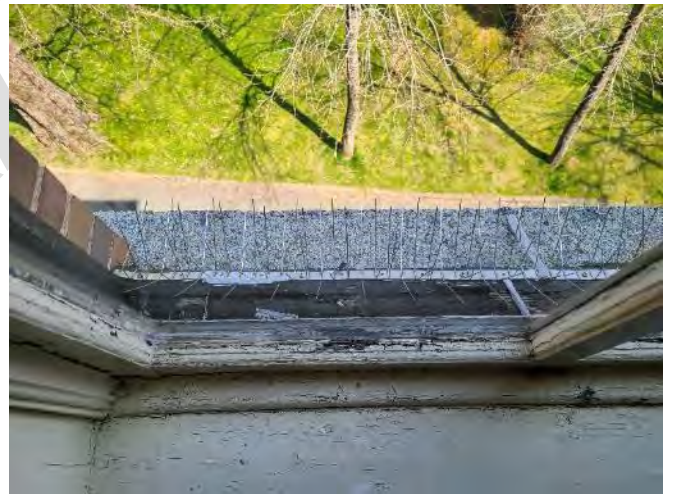
East Elevation – Interior of stairwell tower, 3rd floor landing

- In general, wood sashes and window frames were observed to be in deteriorating condition and in need of rejuvenation.

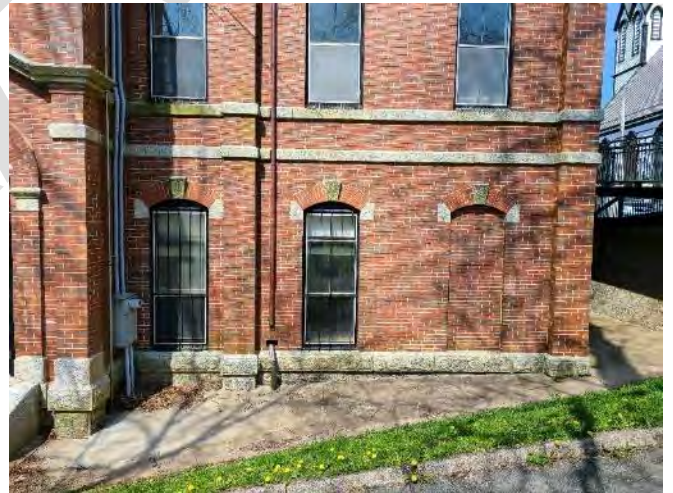
East Elevation

- First floor windows to the right of the stair tower are protected with metal security bars.
- The end window is infilled with masonry.
- Organic growth and staining was observed at the granite ribbon below second floor windows.

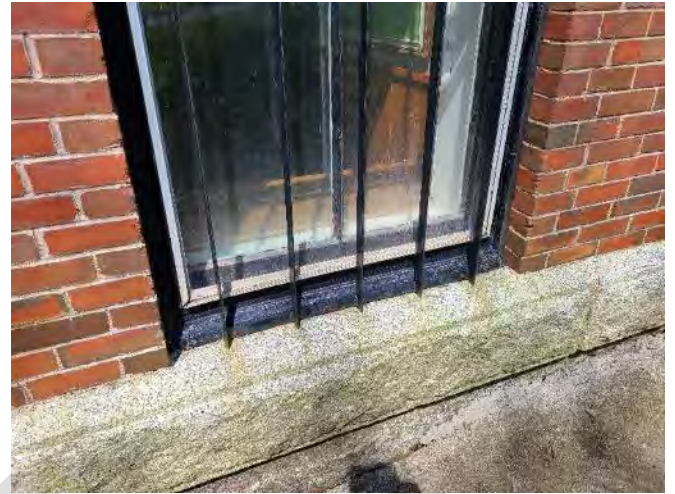
East Elevation

- In general, metal security bars were observed to be in fair condition. Corrosion was observed at multiple locations and translated to staining of the masonry walls below.

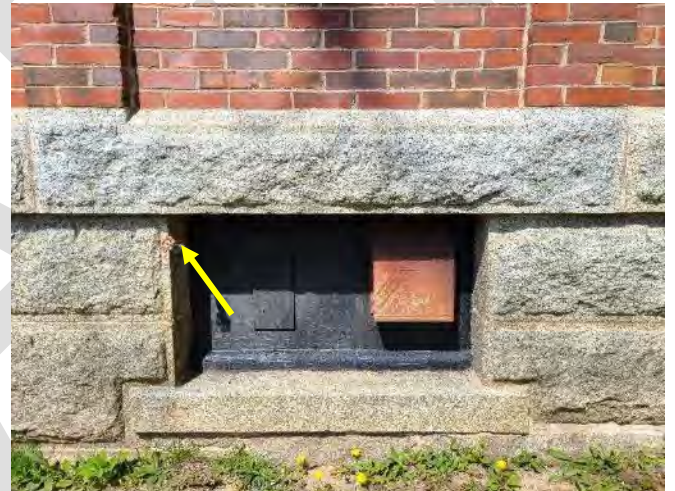
East Elevation

- Basement windows were observed to be infilled with painted plywood.
- A hose bibb (yellow arrow) penetration and hood vent were observed at this window penetration.
- A mechanical vent was observed to be corroded.

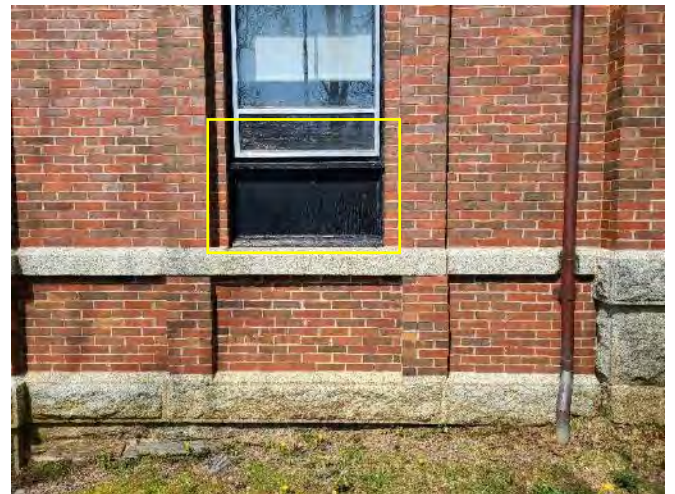
East Elevation

- Windows at the first floor of the east elevation were observed to be boxed out or sealed with varying plywood structures.

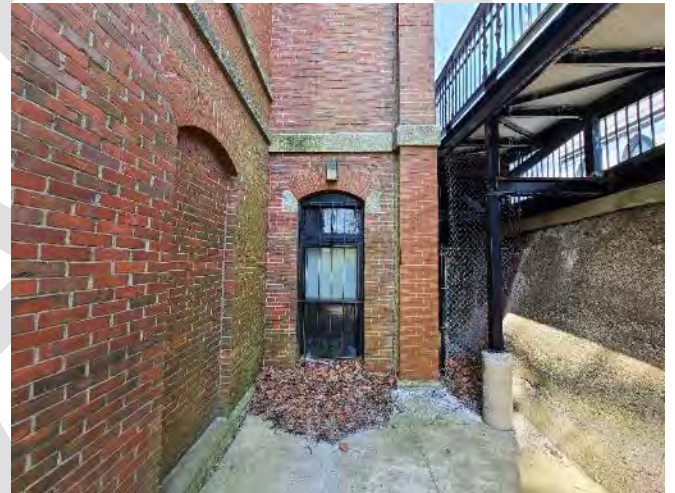
- Paint/stain at the upper arched window was observed to be deteriorated.
- The brickmould for the arch appears to be constructed of multiple pieces of quarter round. This does not appear to be of original construction. See following observation.

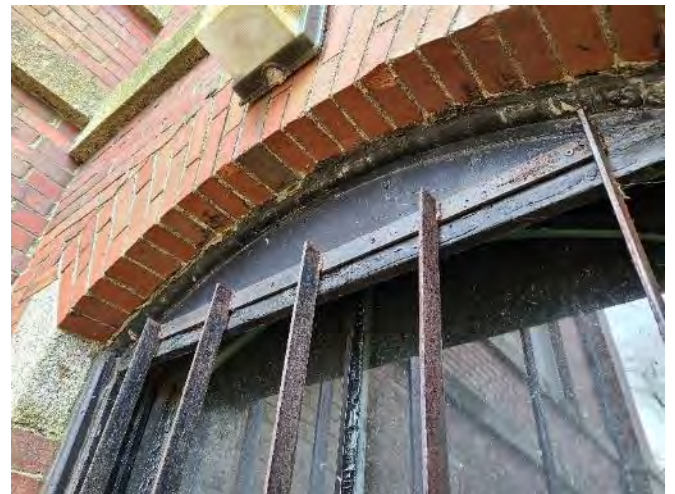
North Elevation – Ground level

- Same as above.
- Deteriorated paint/stain and sealant were observed at the wood frame and sash.

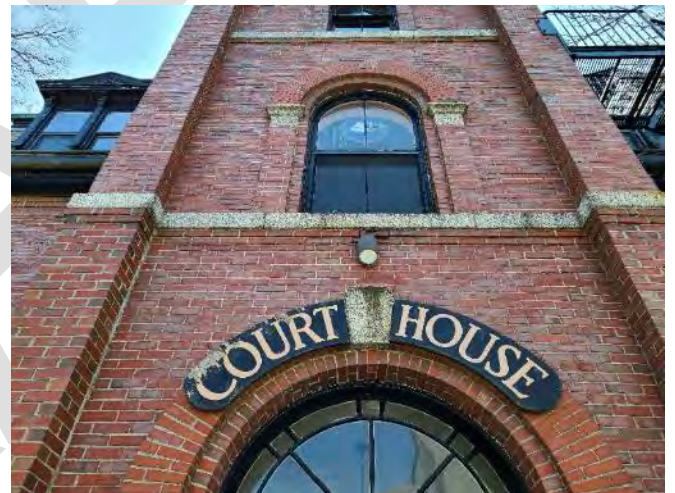
North Elevation – at entrance

- An arched window is observed at the second floor, over the north entrance.
- Deteriorated paint/stain and sealant was observed.

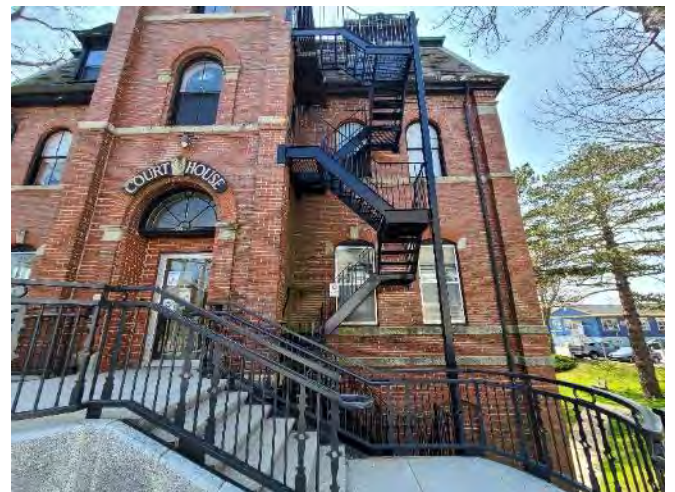
North Elevation – right of entrance

- First floor windows were observed to be square with a shallow, decorative wooden arch above. See following observation.

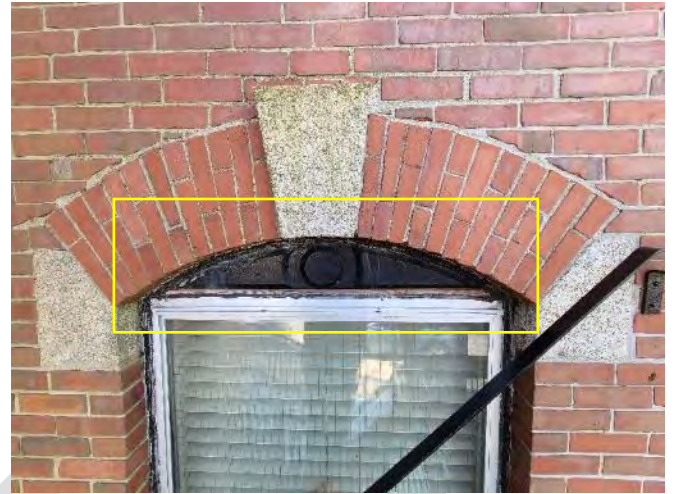
North Elevation – right of entrance

- The head of the first-floor windows was observed to be square with a shallow, decorative wooden arch above.
- Sealant was observed to be deteriorated.

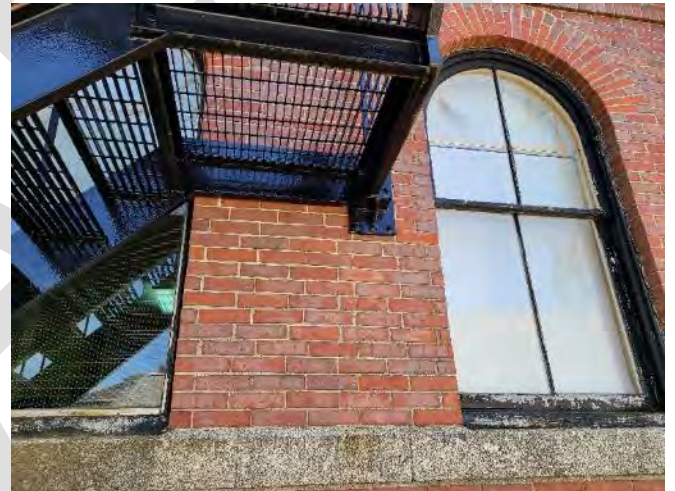
North Elevation – right of entrance

- The second-floor features arched, vertical sliding windows.
- Deteriorated paint/stain was observed as well as deteriorated sealant.
- The window visible at the left of the image was observed to be replaced with a Georgia-wire glass, likely as an increased security measure. See following image.
