COUNCIL MEETING AGENDA

TOWN OF LUNENBURG

Tuesday, December 13, 2022 at 6 p.m.

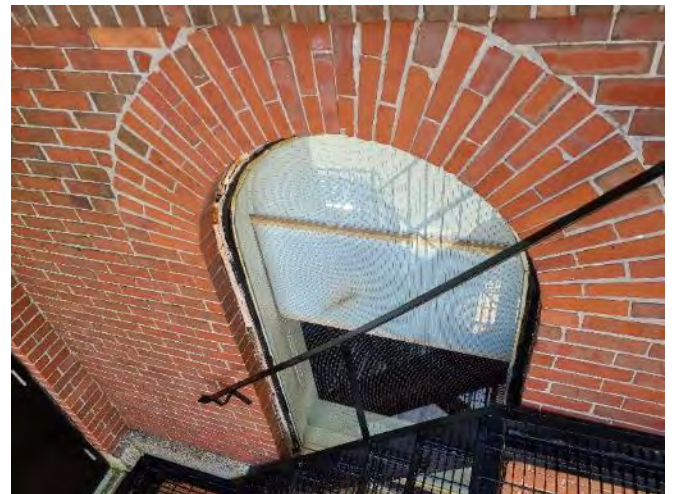
North Elevation – right of entrance

- The window pictured here was observed to be replaced with a Georgia-wire glass, likely as an increased security measure given the potential access provided by the exterior stairs.

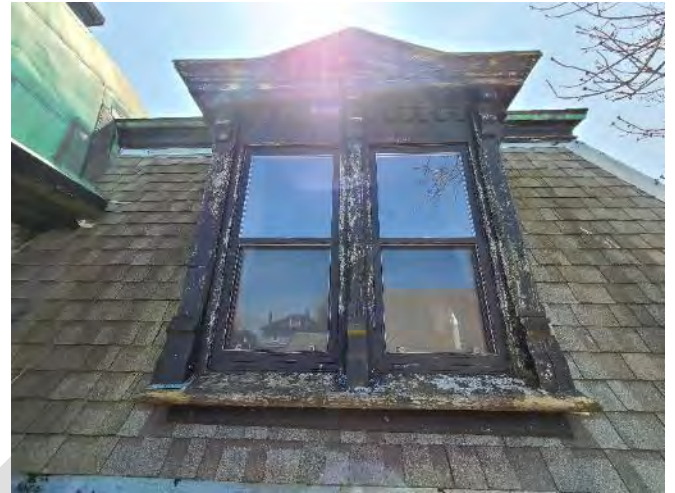
North Elevation – right of entrance

- In general, the design of dormer windows appears continuous around the building, although, single windows as opposed to the double window pictured here are also used.
- The wood framed dormers are generally in fair but deteriorating conditions.
- Paint/stain was observed to be deteriorated.
- Dormer windows were observed to be wood framed, vertical sliders. Some lites have been replaced with more efficient IGU's or the addition of aluminum storm windows.

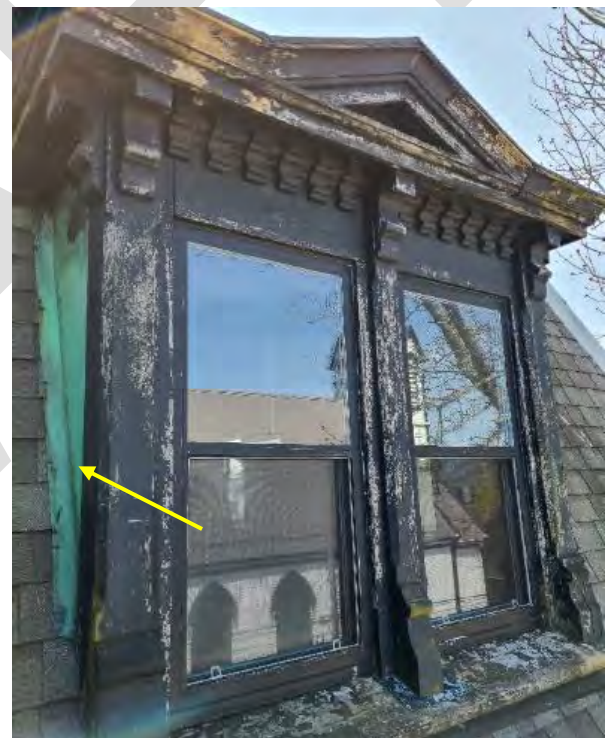
North Elevation – right of entrance

- The installation suggests there are no step flashings at the vertical sides of dormers.

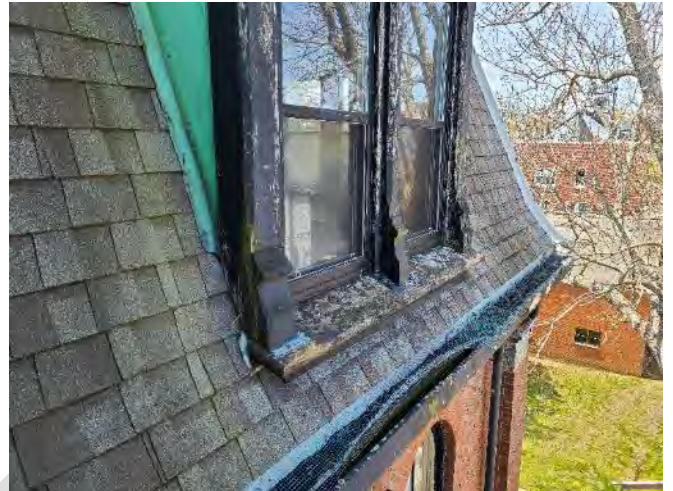
North Elevation – right of entrance

- Deteriorated wood sill and window frame was observed.
- The leaf guard at the gutter was observed to be damaged and poorly secure.

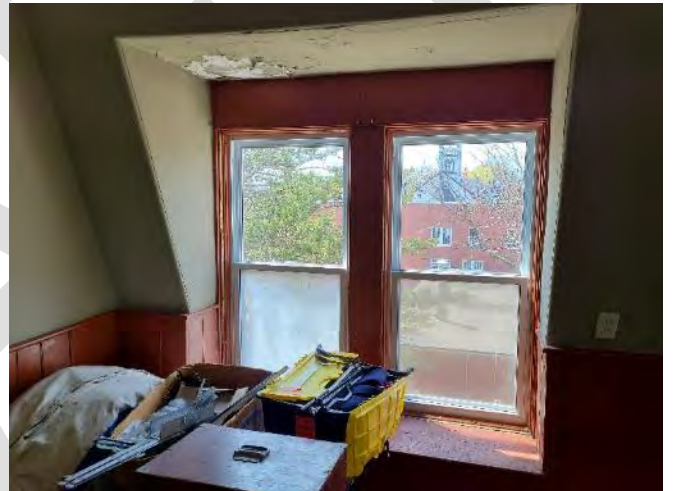
Dormers at the Interior

- Some dormer windows have been replaced with newer, double hung vinyl replacements.
- Significant water damage was observed at the interior at the dormer. See following observation.

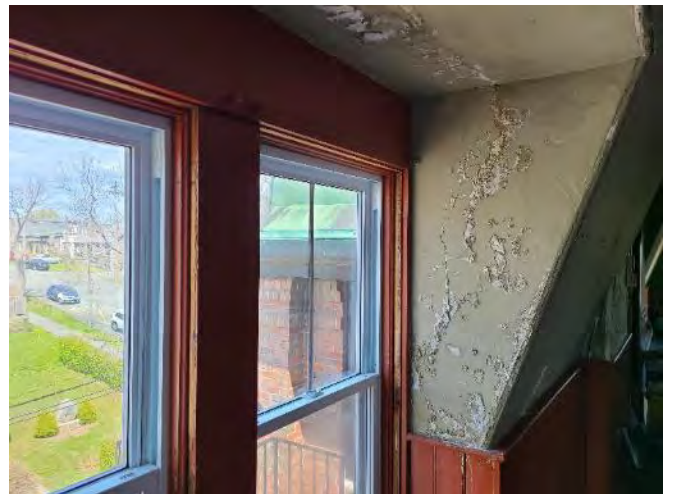
Dormers at the Interior

- Some dormer windows have been replaced with newer, double hung vinyl replacements.
- Significant water damage was observed at the interior at the dormer which appears to be aligned with the interface between the dormer and the adjacent mansard roof.

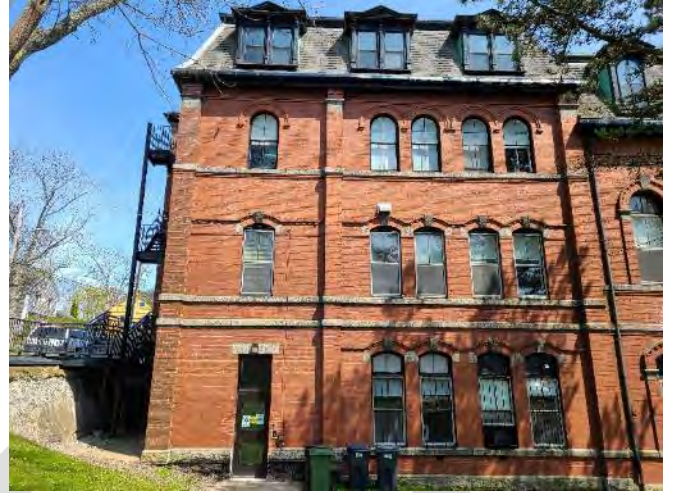
West Elevation – General images

- First floor windows across the west elevation feature arched heads. Multiple windows at this level are boxed out with plywood to accommodate various mechanical elements.
- Second floor windows are square with a decorative wood arch at the head of the window. These feature aluminum storm windows.
- Third floor windows are typically arched.
- All windows were generally found to be in fair but deteriorating conditions with paint/stain and sealant maintenance being required.

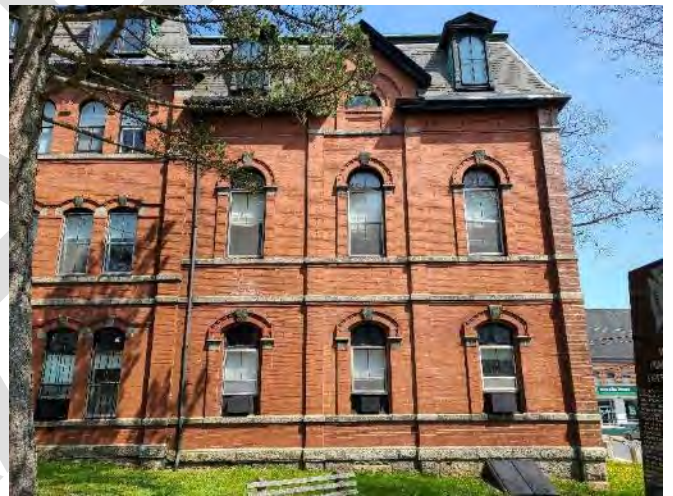
West Elevation – General images

- Same as above.

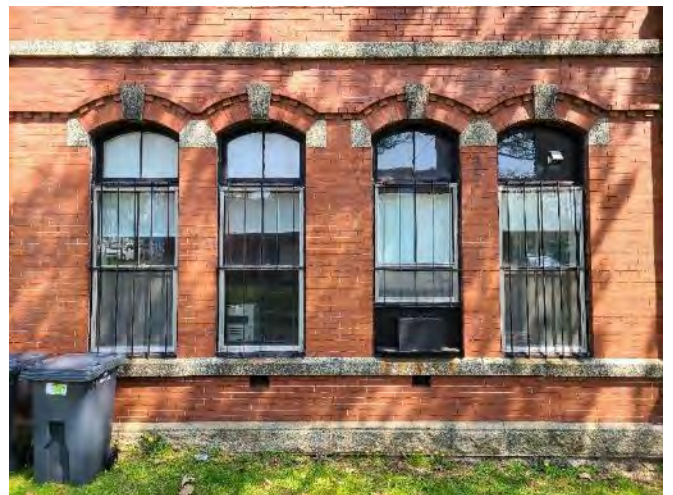
West Elevation

- Typical first floor windows feature metal security bars and aluminum storm windows.
- Corrosion was generally observed at metal security bars which in turn is staining the granite sill/ribbon below.
- Paint/stain at window frames and sashes was generally observed to be deteriorated and in need of maintenance. See following images.

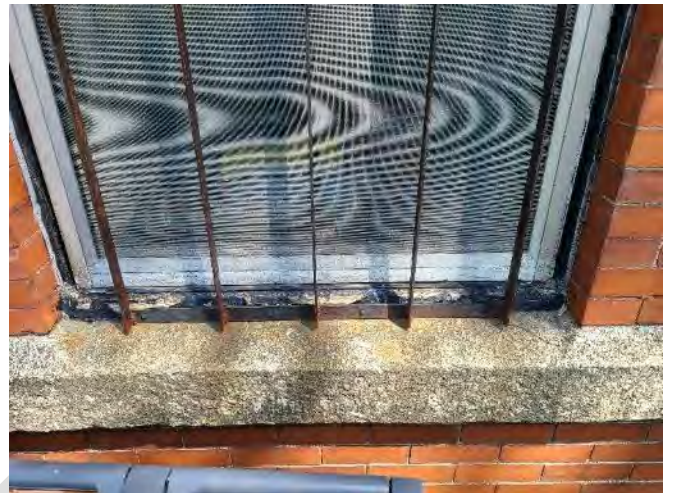
West Elevation

- Corrosion was generally observed at metal security bars which in turn is staining the granite sill/ribbon below.

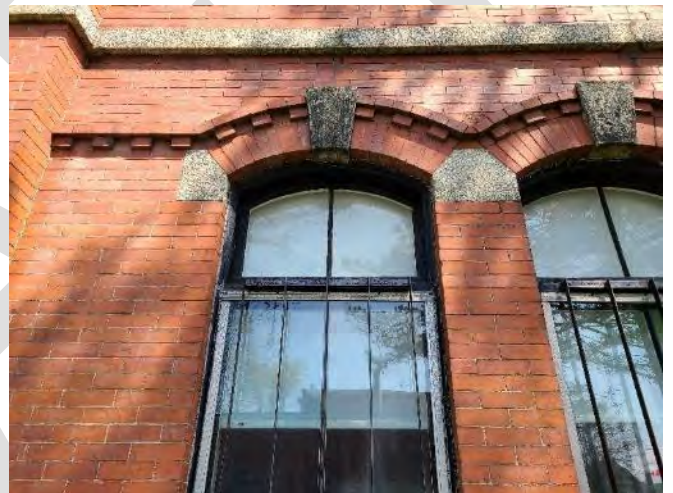
West Elevation

- Typical first floor windows feature metal security bars and aluminum storm windows.

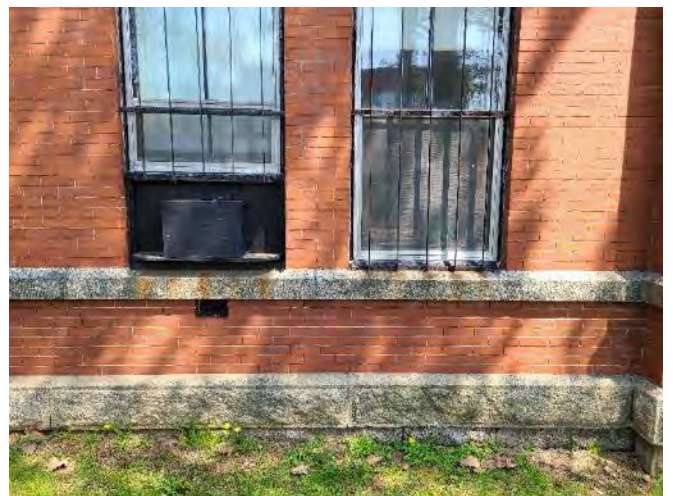
West Elevation

- Various alterations were observed to windows at all elevations.

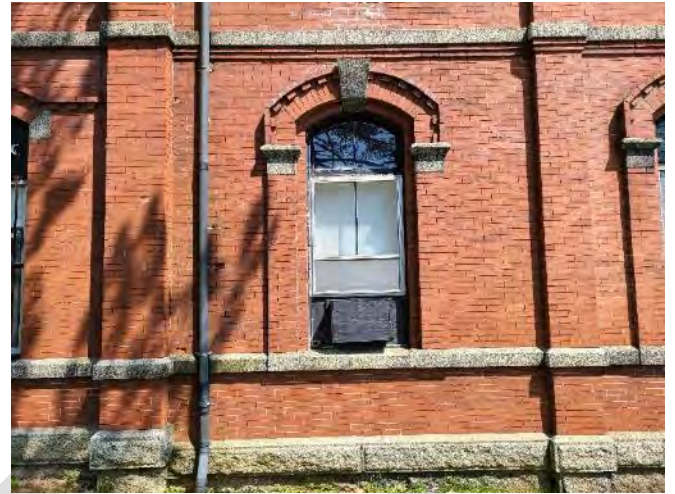
West Elevation

- First floor windows across the west elevation feature arched heads. The window pictured here features a squared arch. Multiple windows at this level are boxed out with plywood to accommodate various mechanical elements.
- Paint/stain was observed to be deteriorated at window frames, sashes and plywood components.

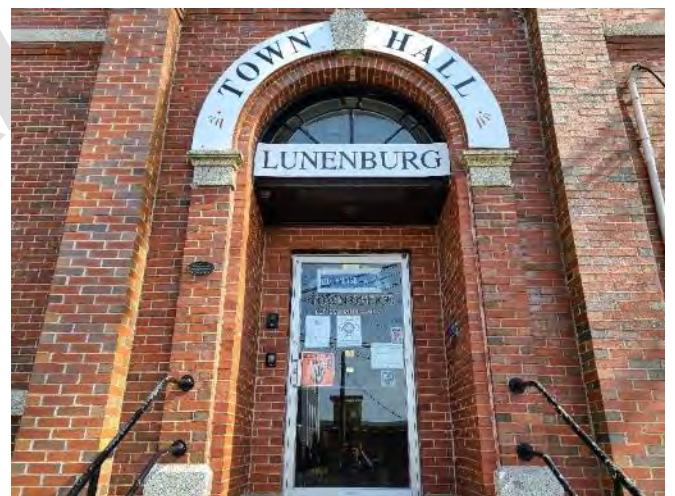
South Elevation

- The main entrance was likely remodelled to accommodate the existing aluminum entrance door. Note, the arched lite was preserved.

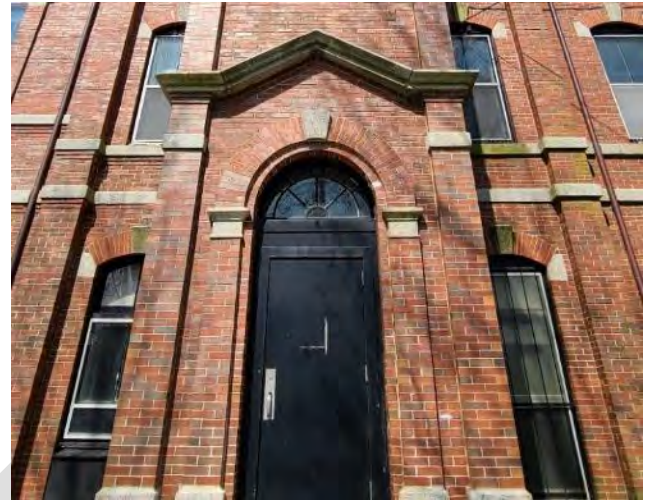
East Elevation

- A newer metal slab door has been installed. The arched lite above was preserved.

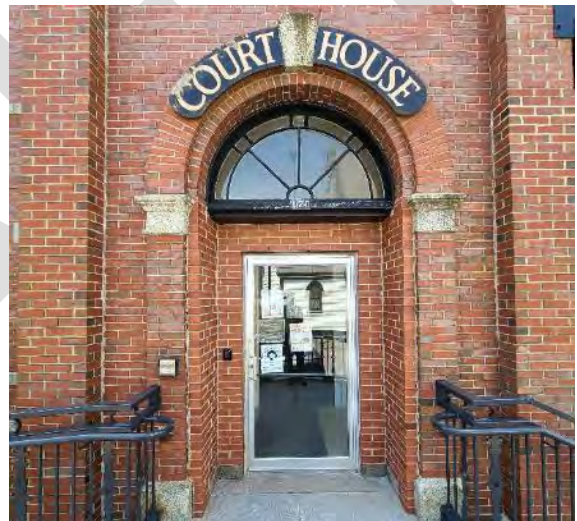
North Elevation

- The main entrance was likely remodelled to accommodate the existing aluminum entrance door. Note, the arched lite was preserved.

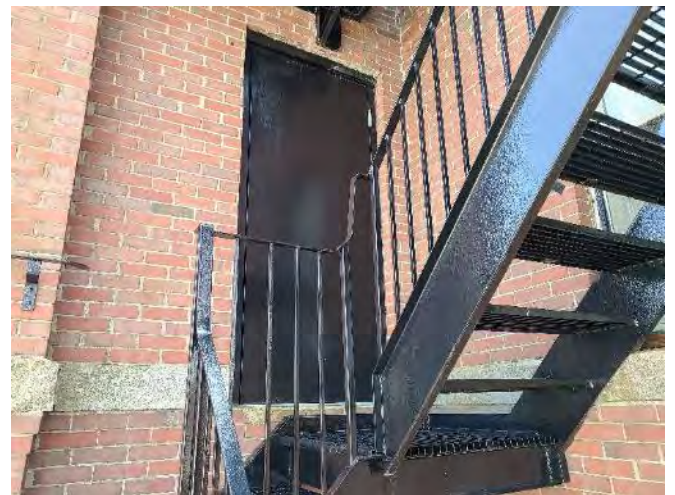
North Elevation – second floor

- Newly installed metal slab door for emergency egress at the second floor. This does not appear to be part of the original construction. Note, a lintel was not installed above the head of the door to effectively distribute the weight of the overhead masonry.

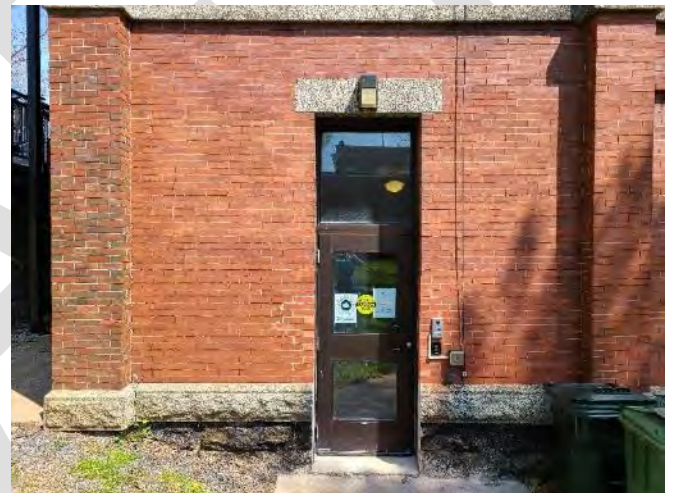
West Elevation

- An accessible aluminum entrance system with overhead lite was observed.

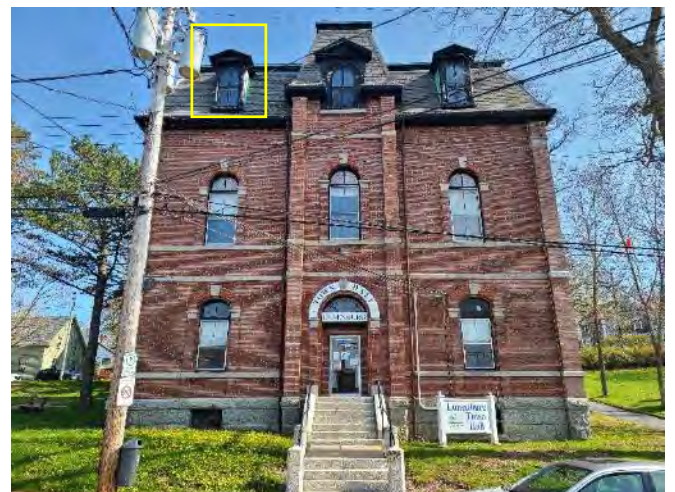
South Elevation

- Prominent mansard roof and dormers typical around the building.
- The roof of the left dormer was observed to be temporarily repaired; however, the pressure sensitive material applied is now damaged, missing and no longer providing protection.

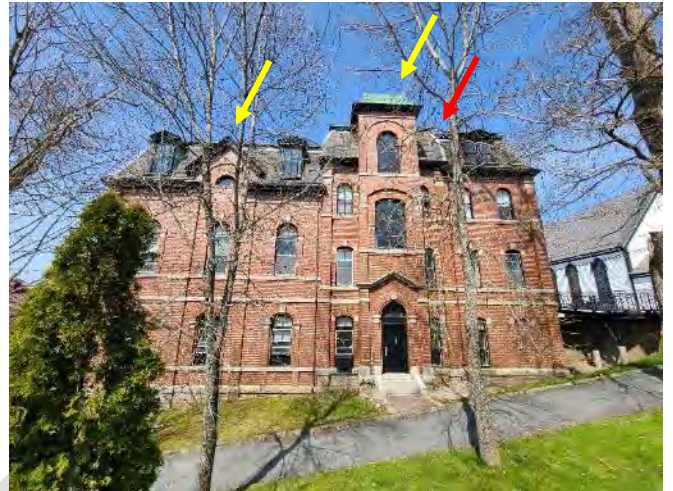
East Elevation

- Prominent mansard roof and dormers typical around the building.
- The east elevation also features a copper roof above the stairway tower and a unique gable roof towards the south elevation (yellow arrows).
- The style of the mansard roof at the hip changes to a rounded profile at this elevation. The hips, capped with lead are common around the building.

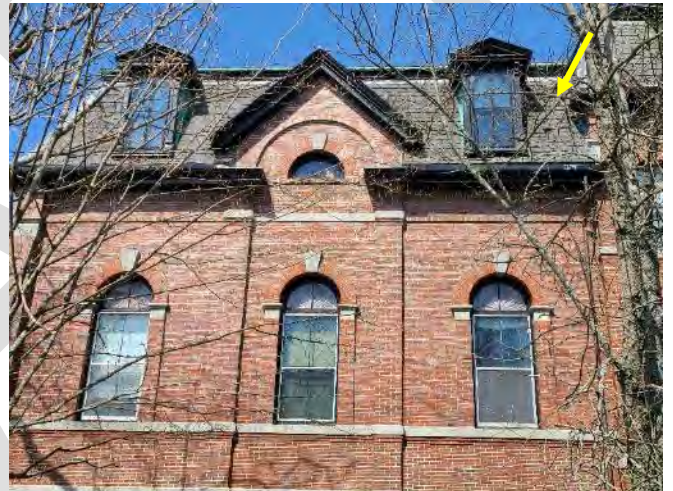
East Elevation

- General image of the hip roof and dormers at the east elevation.
- Deterioration of shingles was observed (yellow arrow). Shingles were torn, curled and in some areas missing. See following observation.

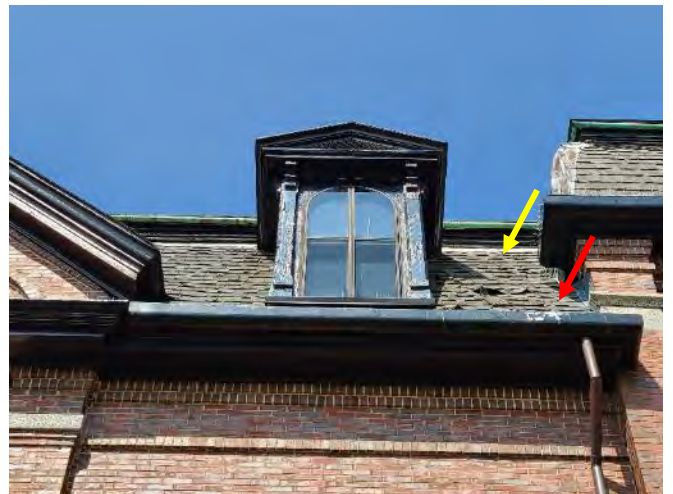
East Elevation

- Deterioration of shingles was observed (yellow arrow). Shingles were torn, curled and in some areas missing. See following observation.
- Paint/stain of the woodwork around the dormers was observed to be deteriorated and in need of repair/maintenance. This was typical of all elevations.
- Paint was observed to be flaking at the gutter to the right of the dormer. This was typical off all elevations.

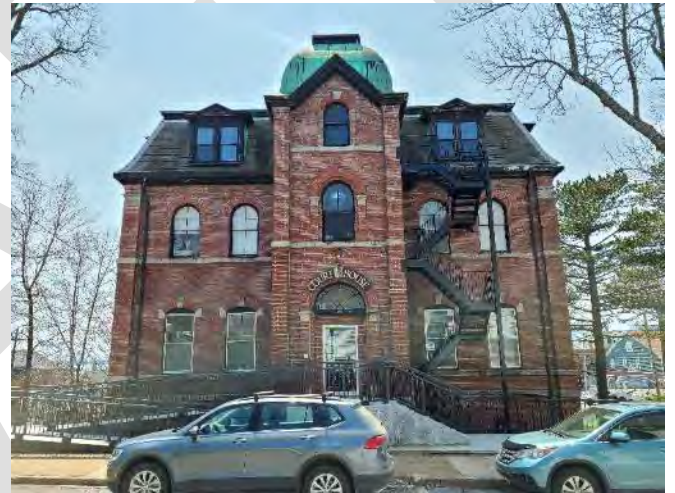
North Elevation

- General image of the roof at the north elevation.
- Prominent copper near-domed roof and dormers are visible.

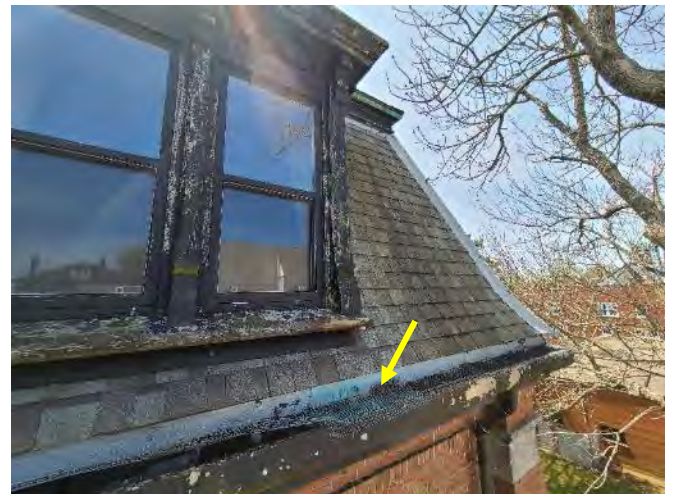
North Elevation

- Staining and organic growth was observed at the mansard. This elevation remains relatively shaded throughout the day due to its orientation and large trees.
- Mesh gutter guards were observed to be damaged and providing little protection. See following observation.

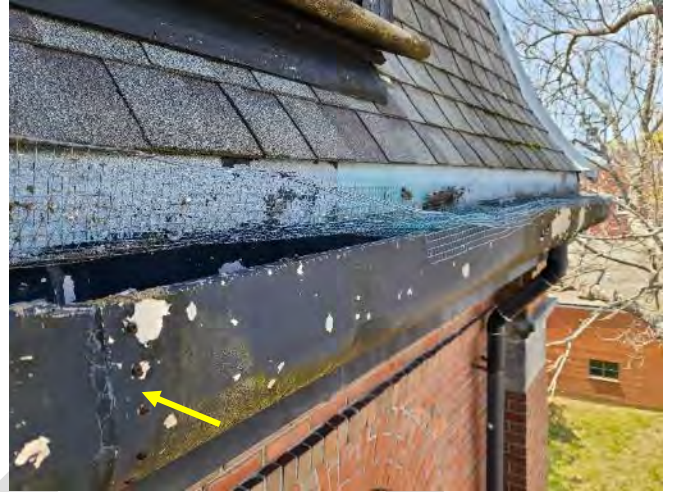
North Elevation

- Mesh gutter guards were observed to be damaged and providing little protection against debris accumulation in the gutters.
- Paint at the gutters was observed to be deteriorating.
- Organic growth was observed along the gutter.
- Sealant at joints in the gutter were observed to be deteriorated (yellow arrow).

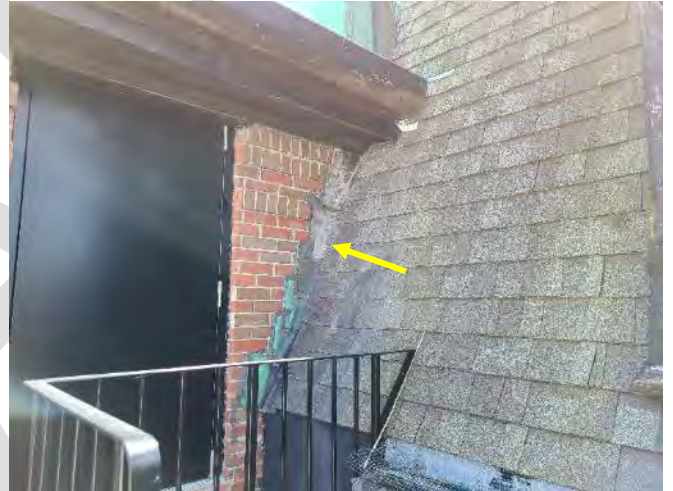
North Elevation

- Step flashing transitioning from lead to copper was observed at the intersection to masonry. Flashing is set into a reglet. See following observation.
- No interlapping with the original step – flashing. This creates a vulnerable flashing detail reliant on sealant.

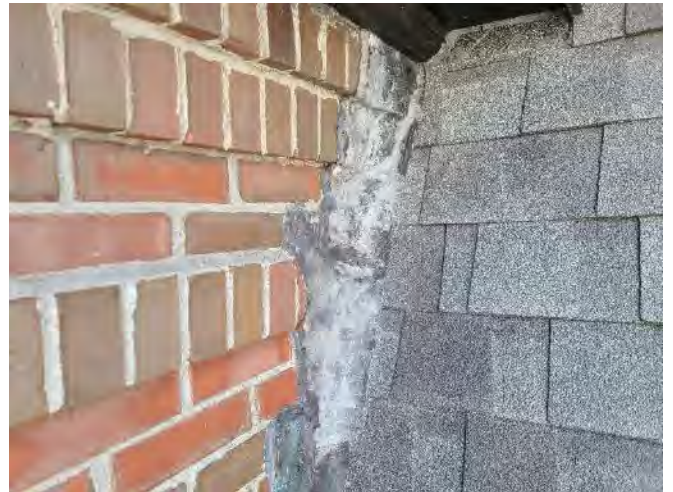
North Elevation

- General image of lead reglet step flashing. Sealant has been applied at the head of the joint and is beginning to deteriorate.
- No interlapping with the original step – flashing. This creates a vulnerable flashing detail reliant on sealant.

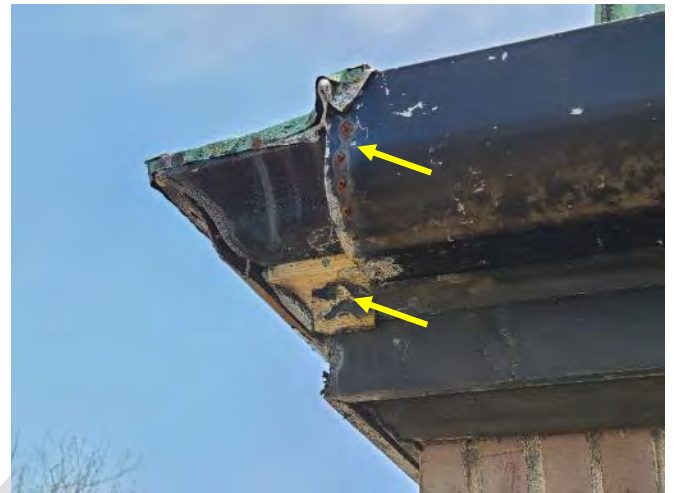
North Elevation

- Previous repairs were observed at the gutter.
- Dissimilar metals and corroded fasteners were observed.
- Untreated wood trim was observed beneath the gutter.

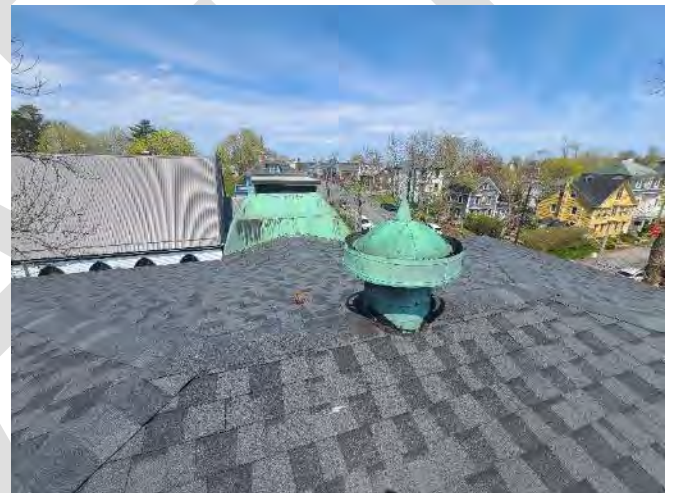
General Image – facing north

- Shingled roof area.
- Copper elements were observed to be deteriorating. Various repairs have been made and sealants applied likely in an effort to mitigate water ingress being experienced at the interior.

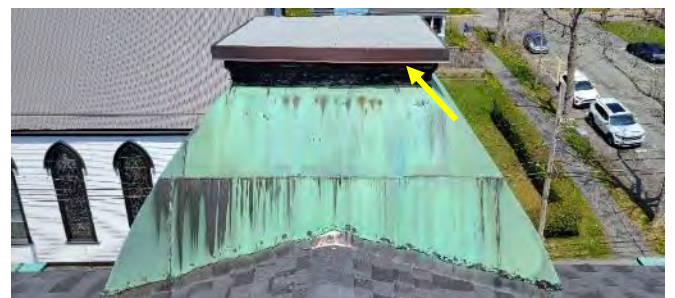
Copper Roof (Dome) – North tower

- In general, copper roofs were observed to have reached the end of their useful life.
- Deteriorated paint/stain was observed beneath the flat top of the copper roof.
- Corroded fasteners and dissimilar metals were observed especially at the foot of the copper roof. See following observations.
- There was no indication of step flashing between the shingle roof detail and the copper roof creating a transition vulnerable to water ingress.

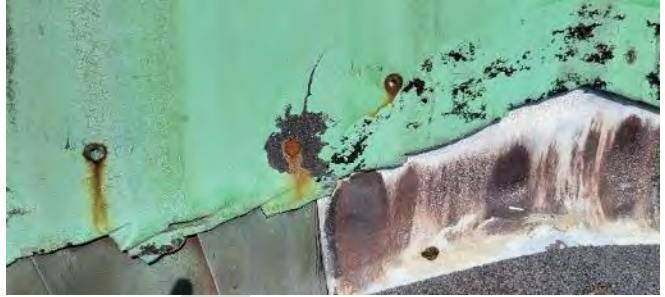
<p><u>Copper Roof (Dome) – North tower</u></p> <ul style="list-style-type: none">Corroded fasteners and dissimilar metals were observed especially at the foot of the copper roof.

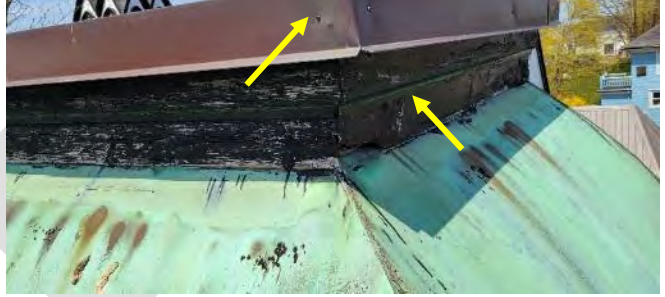
<p><u>Copper Roof (Dome) – North tower</u></p> <ul style="list-style-type: none">Deteriorated paint/stain was observed at the wood and metal elements beneath the flat top of the copper roof.Missing fasteners were observed at the metal flashing.

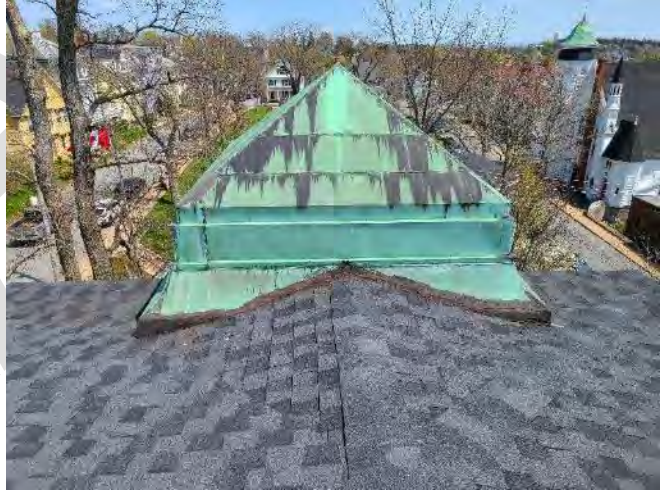
<p><u>Copper Roof (Pyramid) – East Tower</u></p> <ul style="list-style-type: none">In general, copper roofs were observed to have reached the end of their useful life.Deteriorated sealant was observed at the foot of the copper roof. Furthermore, the use of mastics suggest no step flashing was used to transition the flashing upstand. See following image.

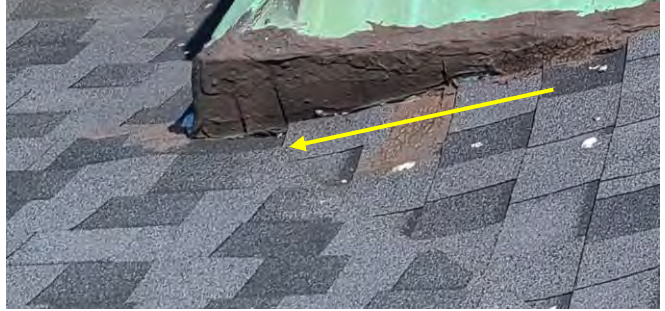
<p><u>Copper Roof (Pyramid) – East Tower</u></p> <ul style="list-style-type: none">Roof valley results in water flow being directed under the shingles that are sloped to the eaves.

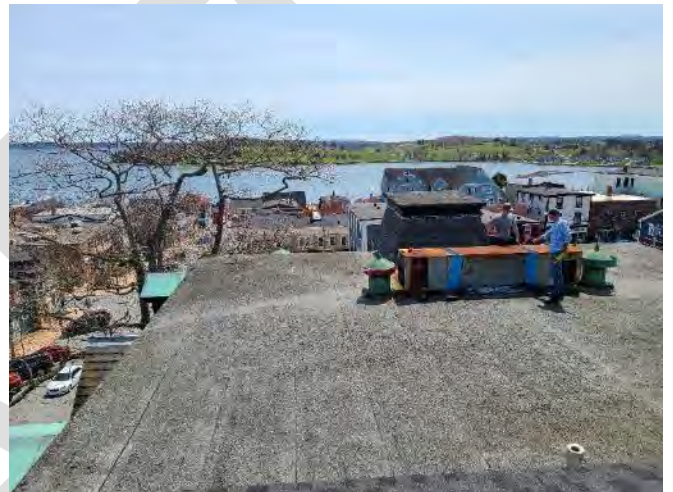
General Image – low slope/mod. bit. membrane roof area

- Low slope roof area is of mod. bit. membrane construction. In general, the roof area has reached the end of its useful life and needs replacement.
- Staining and organic growth were observed at various locations.
- Various open seams were observed in the MB membrane at the roof area.

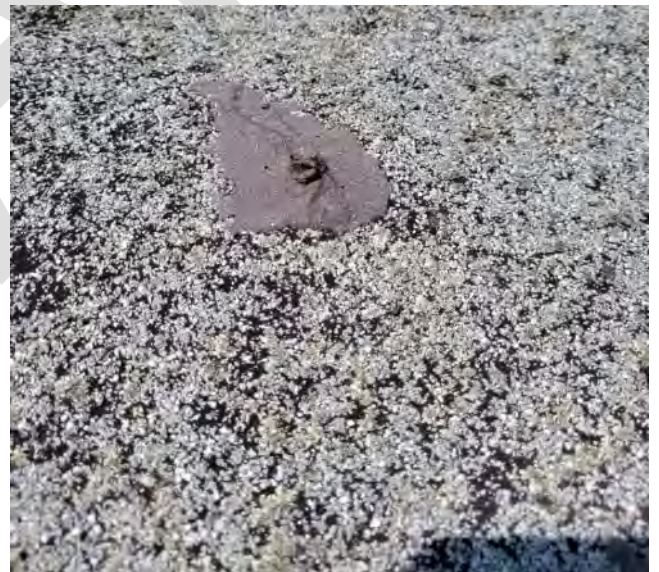
General Image – low slope/mod. bit. membrane roof area, facing north

- In general, the mod. bit. membrane cap sheet was observed to have reached the end of its serviceable life and replacement is recommended.
- Organic growth and loss of granules was observed across the field of the roof area.
- Deteriorated wood trim along with paint/stain were observed (yellow box). See following observation.

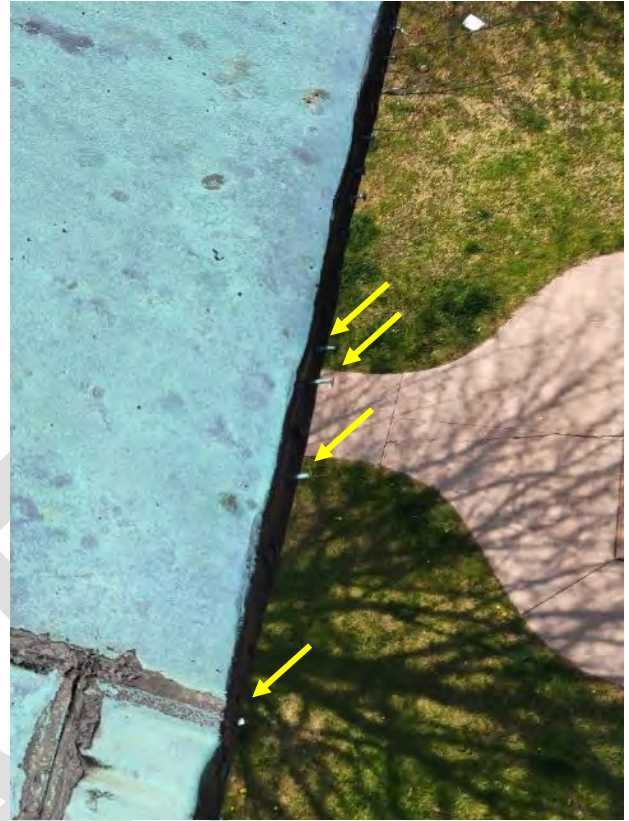
Dormers – facing east

- Damaged shingles were observed at the mansard roof along with debris in the gutters. See following image.

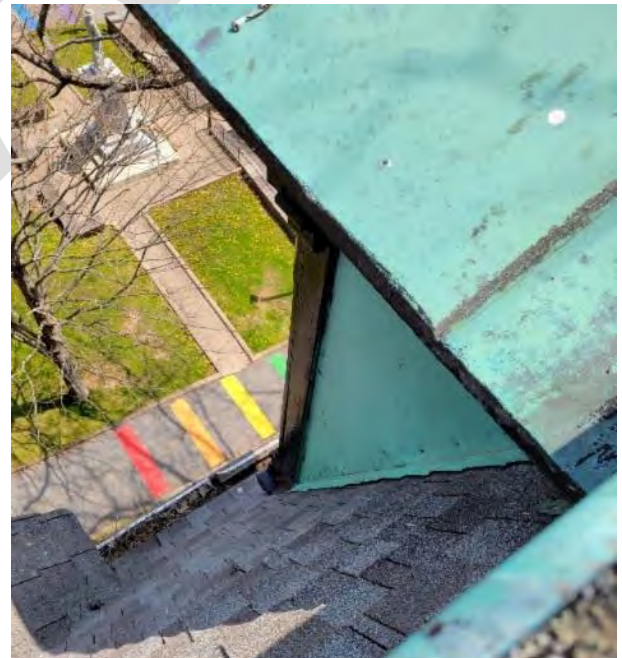
Dormers – facing east

- Damaged shingles were observed at the mansard roof along with debris in the gutters.

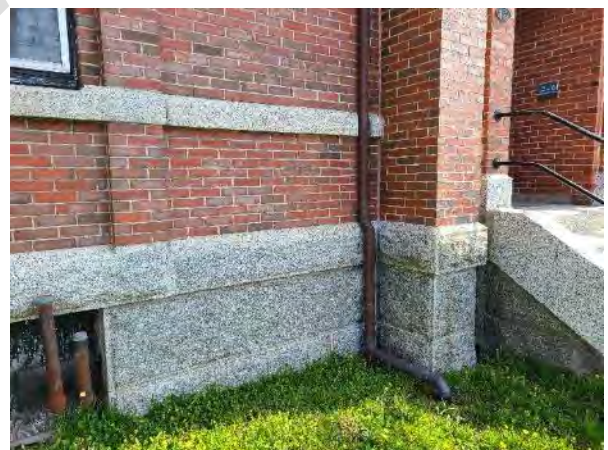
South Elevation

- Copper downspout to the east of the entrance stairs is assumed to tie-into a drainage system below grade. This was not confirmed.
- Uncontrolled roof drainage below grade may be contributing to the deteriorated condition of the support for the granite steps at the south elevation.

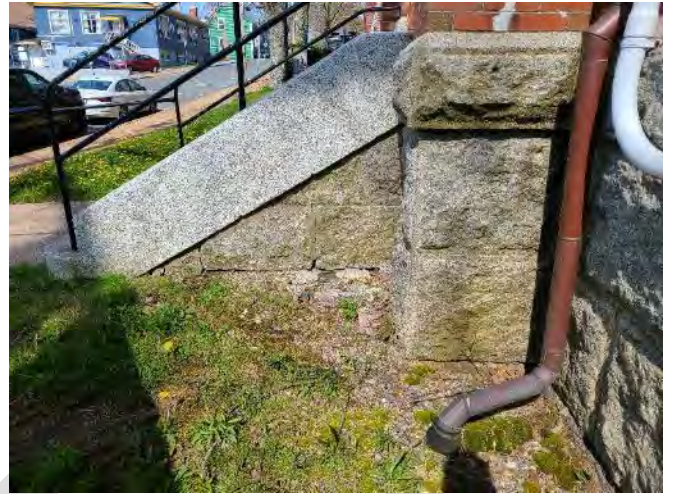
East Elevation

- Copper downspout to the north and south of the tower appear to tie-into a drainage system below grade. This was not confirmed.
- The downspout to the north of the tower was observed to be disconnected. See following observation.
- Uncontrolled roof drainage below grade may be contributing to the deteriorated condition of the support for the granite steps at the south elevation.

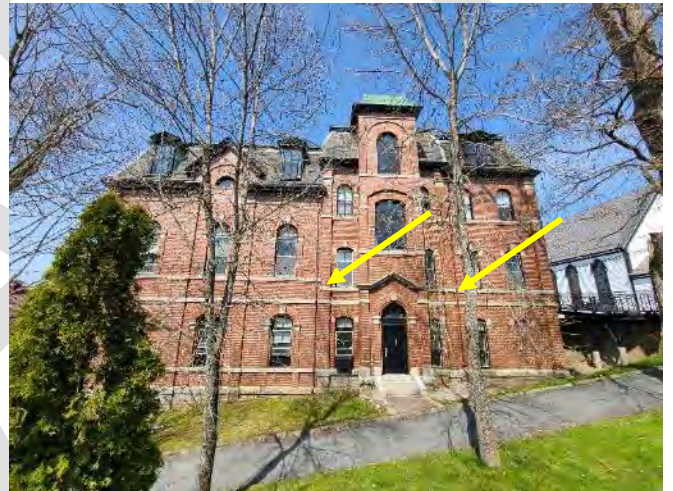
East Elevation

- The downspout to the north of the tower was observed to be disconnected. See following observation.

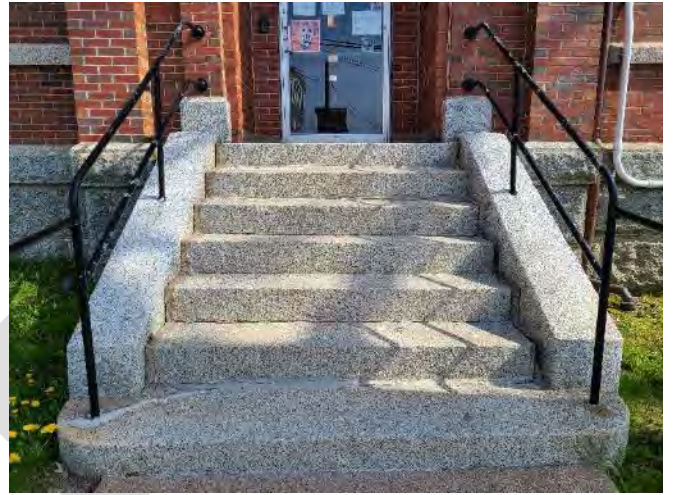
South Elevation

- A large gap between the riser and tread was observed.

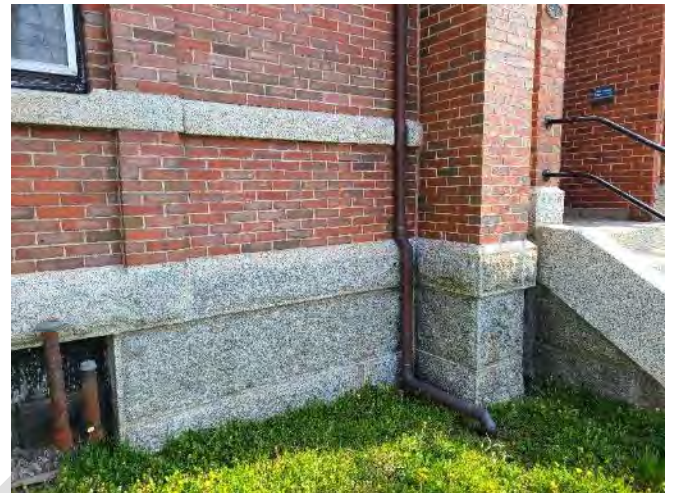
South Elevation

- Downspouts were observed to drain below grade at both the right and left of the south entrance steps. If the drainage is uncontrolled below grade, this could be contributing to the settling observed.
- Deteriorated mortar joints were observed at the right of the south entrance steps, especially at grade level (yellow arrow).

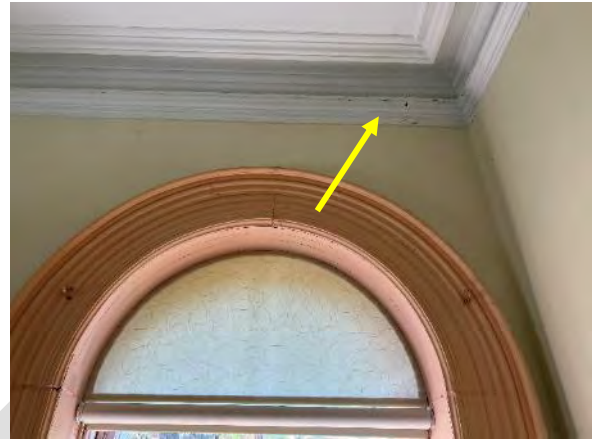
- Notice the diagonal crack traveling from the window casing towards the ceiling.

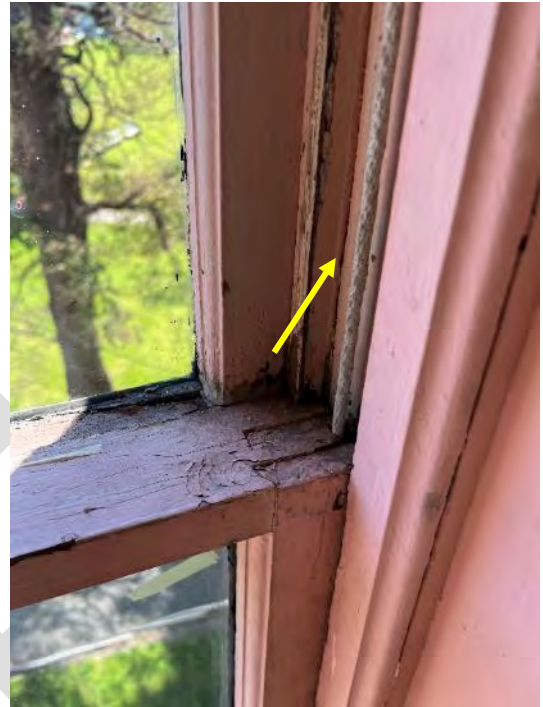
- New cordage was observed at the interior of multiple windows.

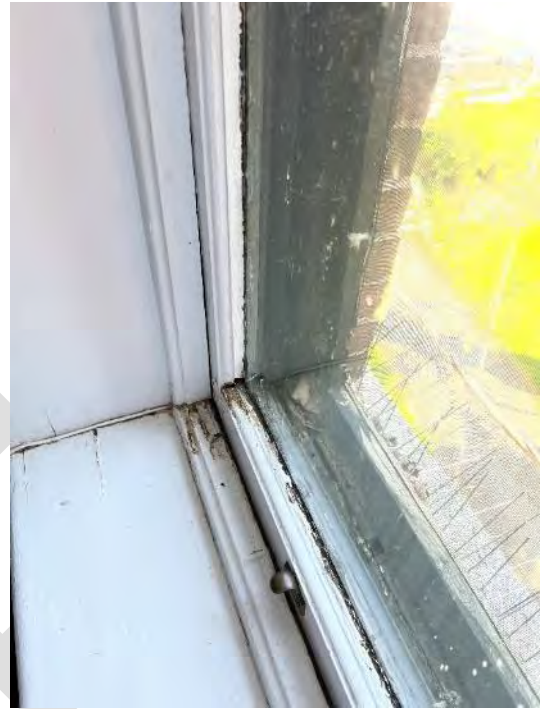
- In general, single-glazing was observed to be in good condition; however, some cracked and damaged panes were observed requiring replacement.

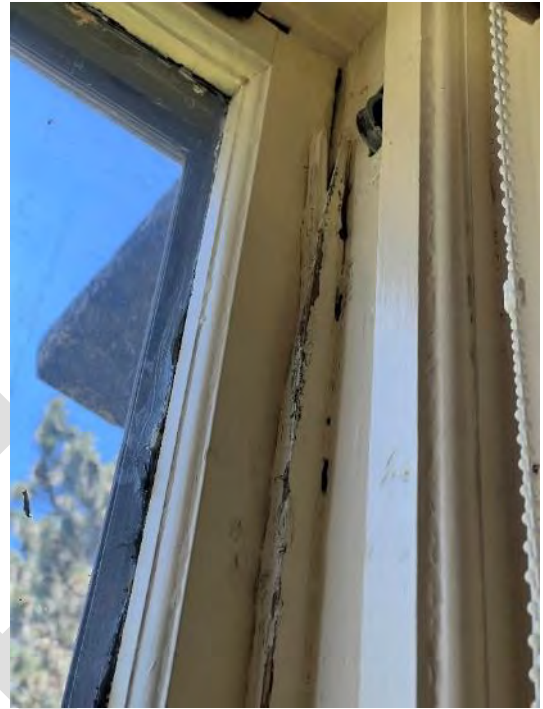
- At the interior of the courthouse, the single-hung windows were observed to be operational.

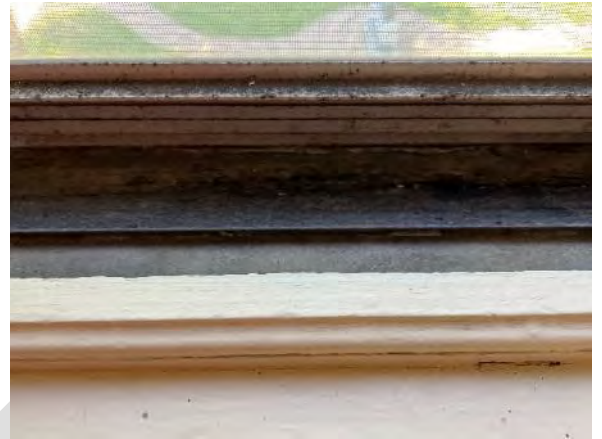
- At the interior of the east stairwell, unique decorative windows were observed to be in fair condition.
- Some deterioration was observed at the interior sill.

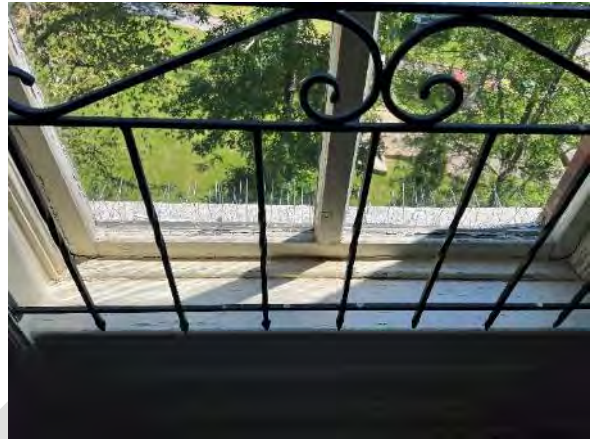
- Signs of water ingress were observed. These may also be caused by deteriorated exterior sealants, paint or deteriorated masonry.

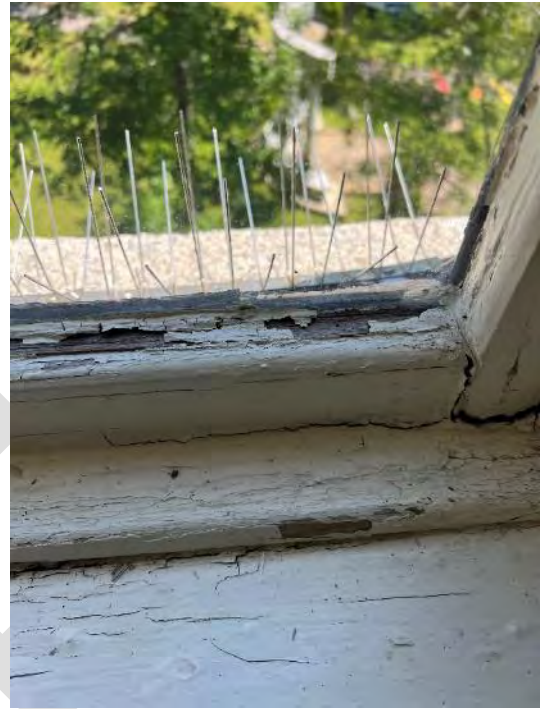
- At the exterior, some deterioration of the window frame was observed requiring the removal of all sealants, stripping and sanding of the window frame, sash, mullions and sill followed by refinishing.

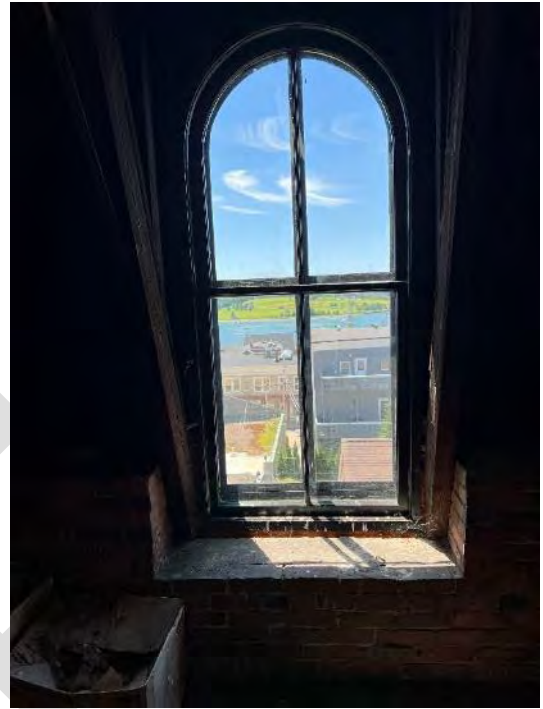
- Newer vinyl windows were observed to be installed at the north upper floor.
- At the north interior, substantial water ingress was observed around dormer windows.
- Deteriorated, crumbling and stained drywall and/or plaster was observed. Water stains were further observed around windows.

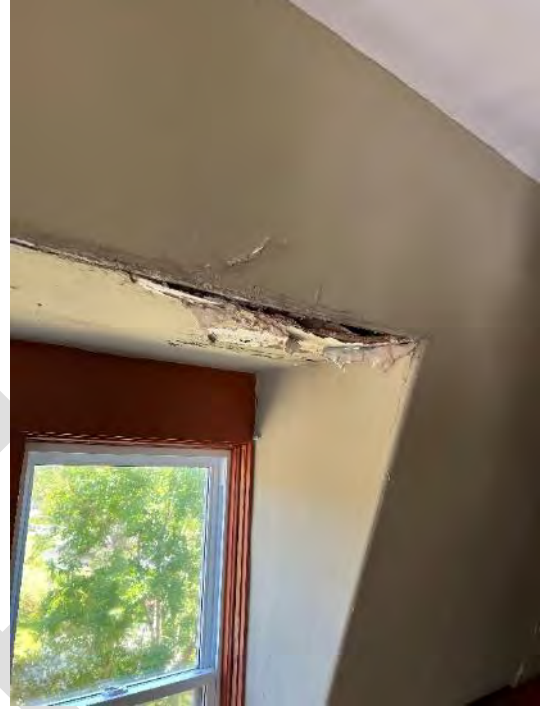
- A newer vinyl window was observed to have a broken seal between glazing causing condensation and fogging.

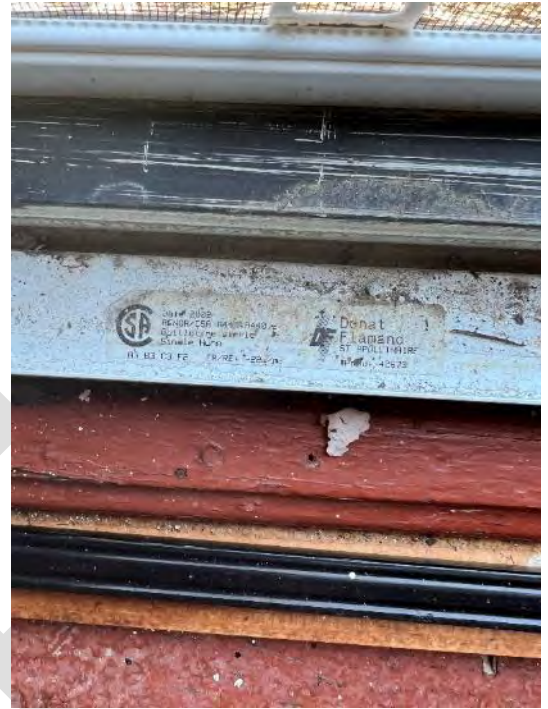
- Significant water ingress was observed possibly due to roofing and/or flashing deficiencies at the exterior. These areas of water ingress will be addressed in the overall rejuvenation effort.
- Ongoing water intrusion has the potential to create indoor air quality issues and the growth of harmful organics. Mold may be present in these areas. Further evaluation is recommended.

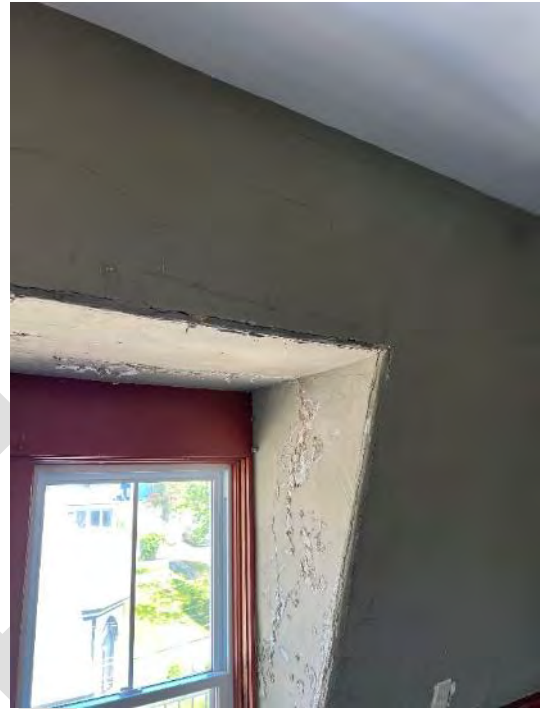
- Significant water ingress was observed possibly due to roofing and/or flashing deficiencies at the exterior. These areas of water ingress will be addressed in the overall rejuvenation effort.
- Ongoing water intrusion has the potential to create indoor air quality issues and the growth or harmful organics. Mold may be present in these areas. Further evaluation is recommended.
