**TOWN OF LUNENBURG  
RFP #TOL2021028**

**REQUEST FOR PROPOSALS  
Town Hall Exterior Restoration**

# LUNENBURG TOWN HALL & COURTHOUSE

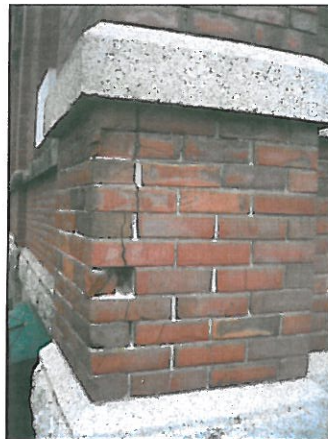
1. SW CORNER PILASTER  
- BEFORE TEST HOLE

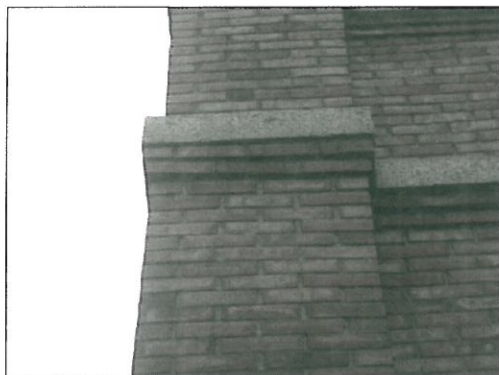
3. POOR REBUILT CORBEL ON PILASTER - REBUILD

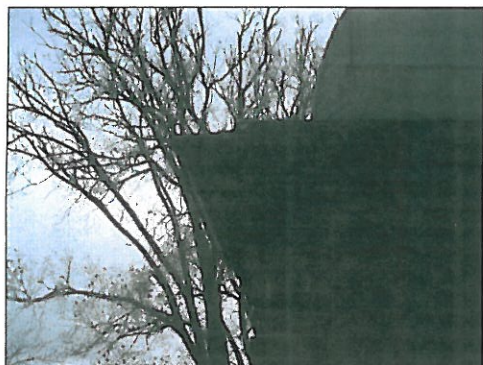
16.

GUTTER INSERTED INTO OLDER TRIM.

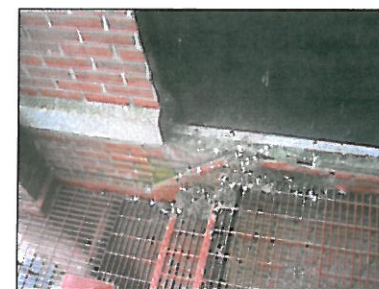
26. BIRD GUANO - REMOVE, BLAST STEEL AND REPAINT

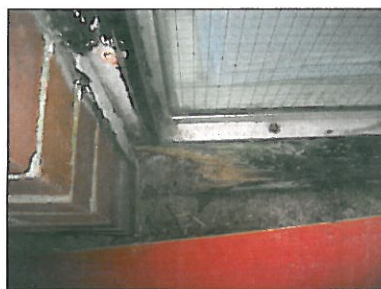
27. ROTTEN SILL - WIRED GLASS WINDOW. REPALCE / RECONDITION

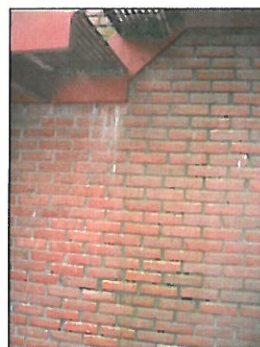
28. MOSS BUILD UP UNDER STAIRS. CLEAN / INSPECT. POINT AS REQ'D

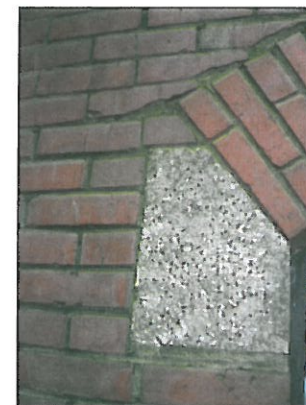
MOSS BUILD UP ON JOINTS - 34.  
CLEAN AND POINT WHERE REQ'D

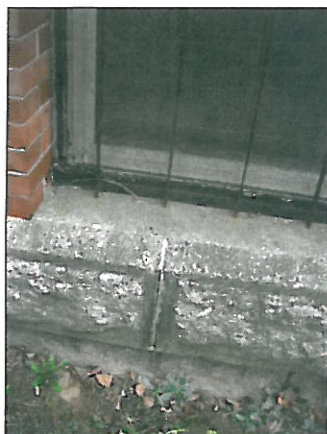
OPEN SILL JOINT GRANITE - POINT - TYPICAL 39.

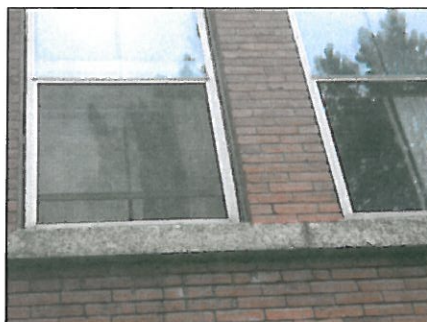
OPEN JOINTS - POINT ALL V+H JOINTS IN GRANITE (TYPICAL) 40.

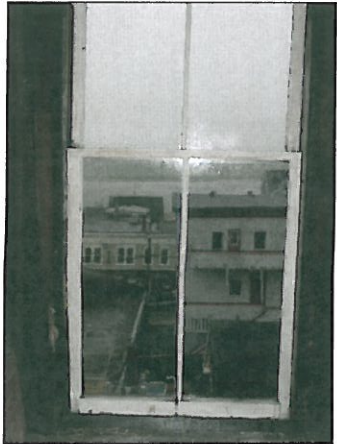
ATTIC WINDOW MISALIGNED. (RC) 45.

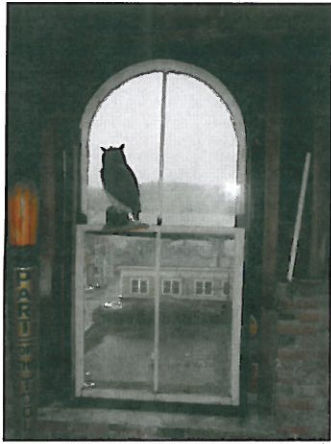
ATTIC - WINDOW TOP SASH DROPPED. (RC) 46.

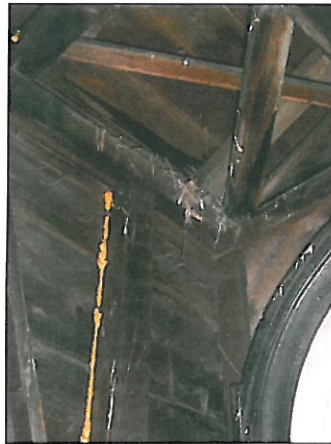
ATTIC BIRD DROPPINGS / NEST. CLEAN UP 47.

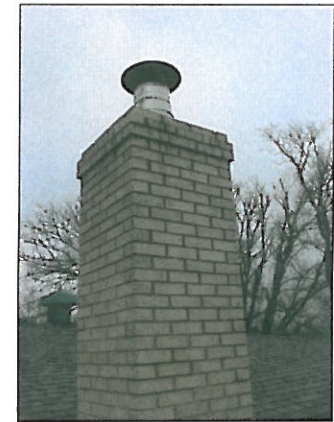
CHIMNEY REPOINT 100%  
PRICE 1/2 TO TAKE DOWN & REBUILD  
WITH RED BRICK TO MATCH BUILDING 57.

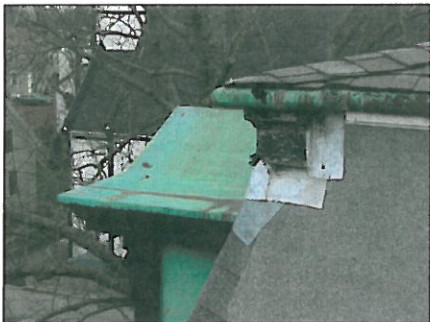
RECONDITION WOODWORK (L&S)  
INSPECT COPPER 58.

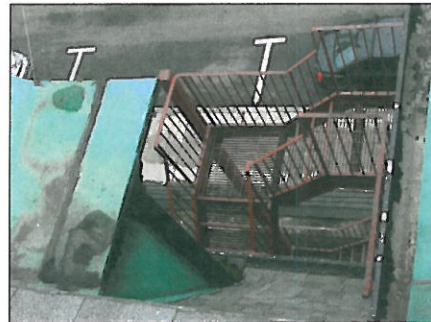
DORMER & FIRE EXIT  
INSPECT COPPER AS PER ALL COPPER, BLAST  
AND REPAINT STAIRS WITH SPECIFIED PAINT  
SYSTEM. 59.

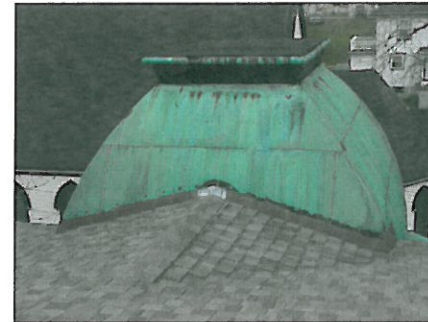
INSPECT COPPER  
(SEE NOTES PHOTO 55 THIS PAGE) 60.

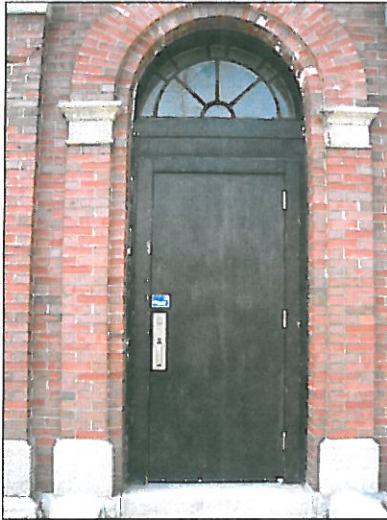
EXISTING DOOR - RECONDITION L&S

SPECIAL PRICE #1 - TO REMOVE THIS DOOR AND REINSTALL ORIGINAL RECONDITIONED DOUBLE DOORS.

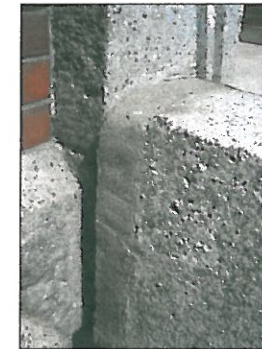
SOUTH STAIR - PRICE #3

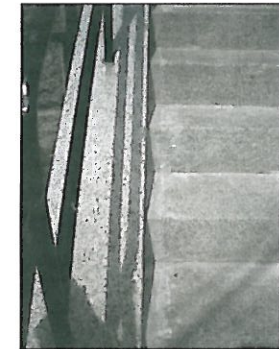
SOUTH STAIR - PRICE #3

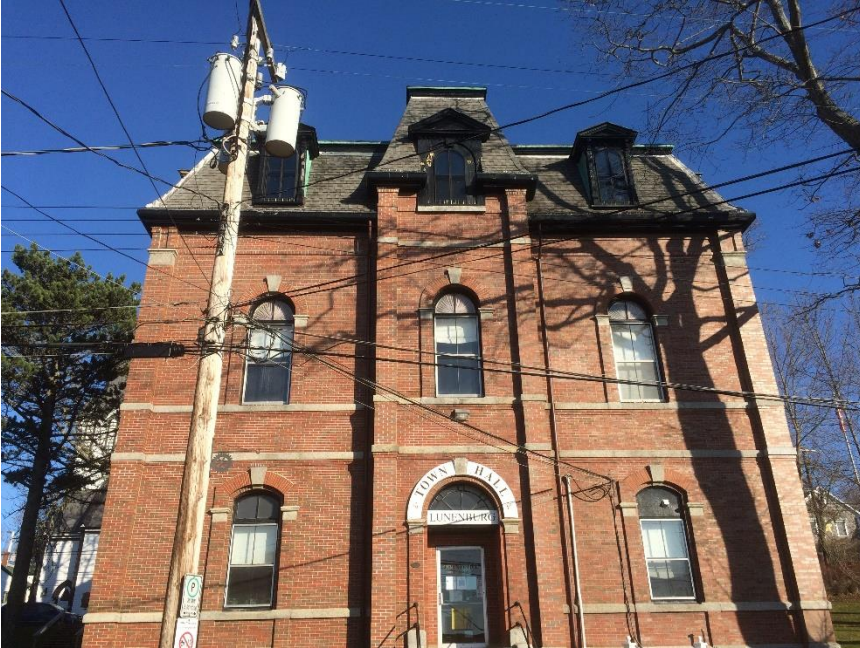
The existing building is wood-framed with masonry exterior walls (see Photo 1). The footprint of the building is approximately 50 ft x 80 ft. A cornerstone in the southeast corner of the building indicates that the building was constructed in 1891. The building is composed of a 4-storey north section and a 3-storey south section. The elevation of the roof of the north section of the building is approximately 3 ft higher than the elevation of the roof of the south section of the building (See Photo 2). Both roofs are Mansard-style, with low-slope hipped upper roof sections. Both roofs contain dormers (see Photo 3) and cupolas (see Photo 4). The roof of the south section of the building also contains a masonry chimney (see Photo 5), roof hatch, and a clock tower base (clock tower no longer present) (see Photo 6).

Photo 1 – Lunenburg Town Hall, from Cumberland Street

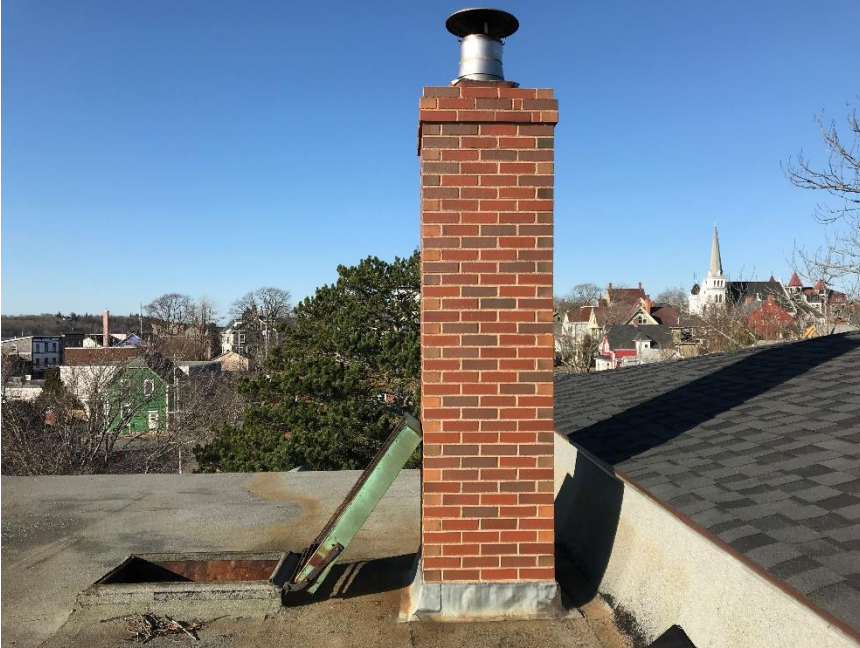
Photo 5 – Masonry chimney

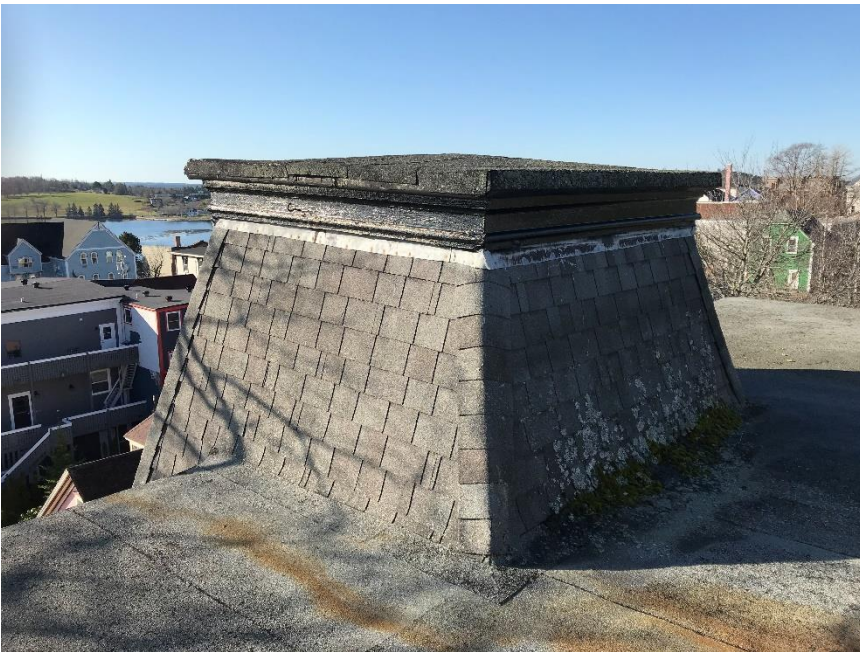
Photo 6 – Clock tower base

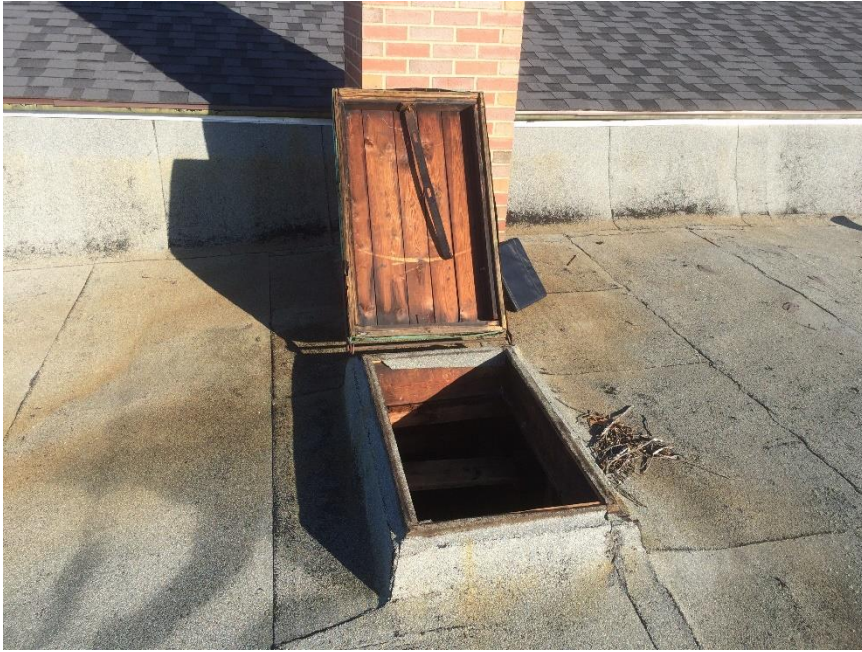
The roofs were accessed via a hatch on the roof of the south section of the building (see Photo 7).

**Photo 7 – Roof hatch**

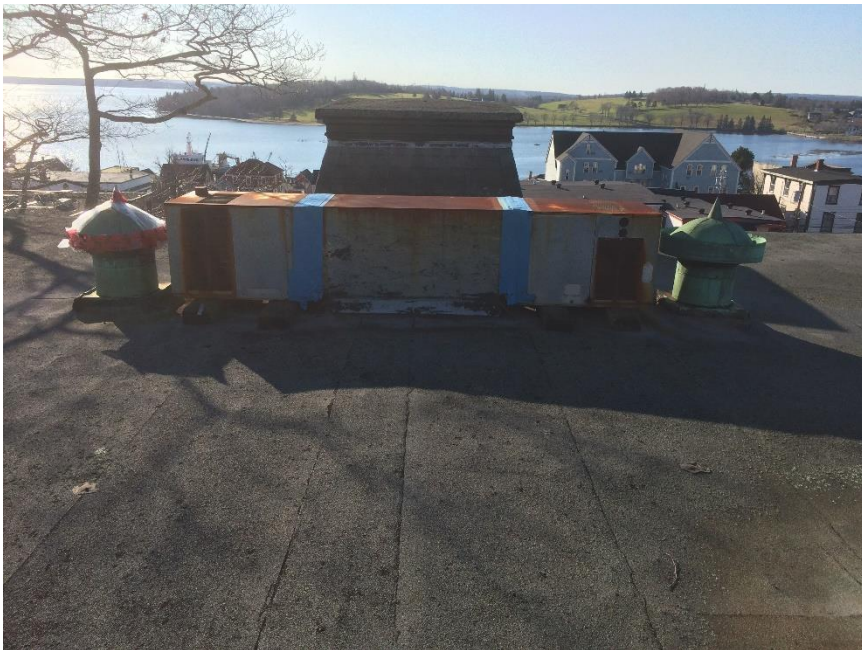
There is a weathered rooftop mechanical unit and two circular roof vents on the roof of the south section (see Photo 8).

**Photo 8 – Rooftop mechanical equipment**

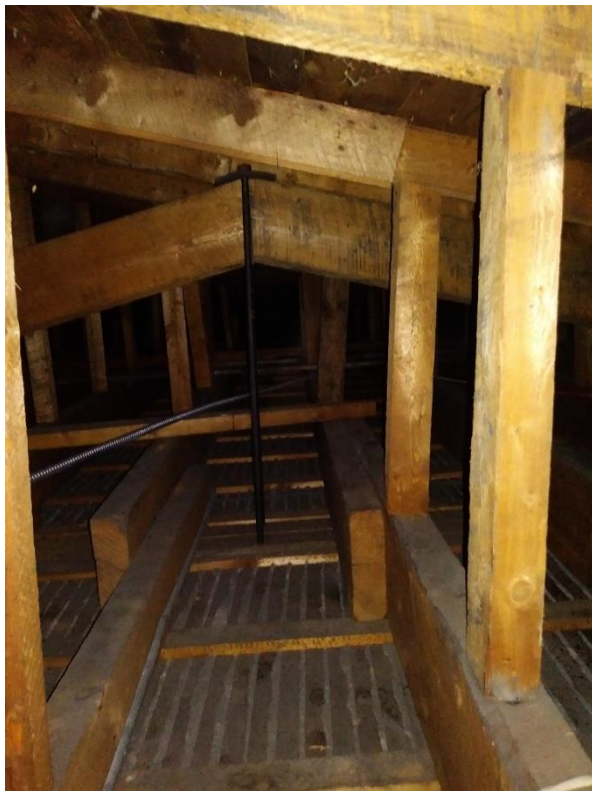
Each roof truss is triangular and consists of two, inclined 8" x 8" wood top chords, an 8" x 8" horizontal wood bottom chord, and two vertical steel round tension bars at the centre (see Photo 10).

Photo 10 – Truss with double steel tension rods

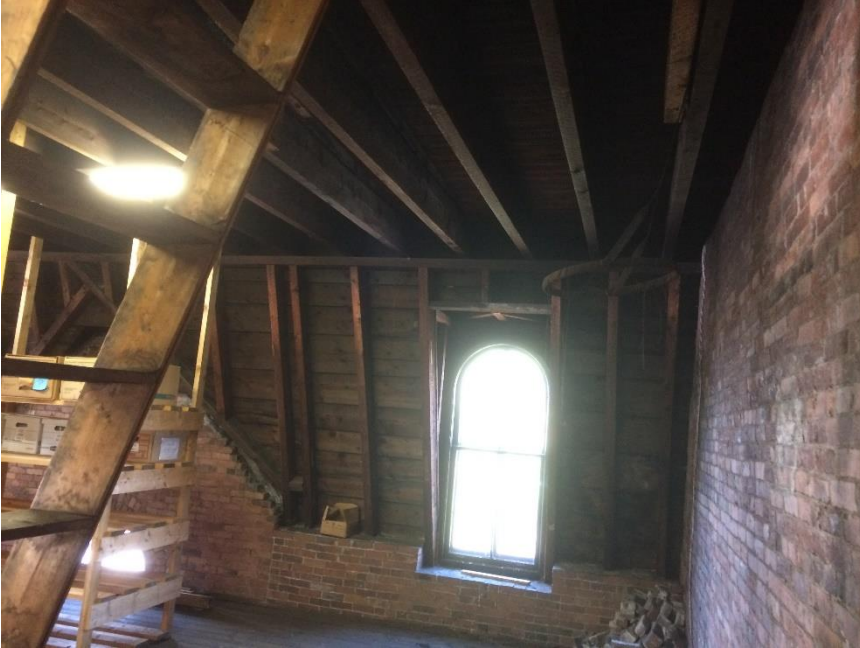
The rafters which frame the Mansard-style portion of the roof are 3" x 6" deep at 20" on centre and span 9 ft (see Photo 11).

Photo 11 – Rafters for the Mansard-style portion of the roof of the south section of the building

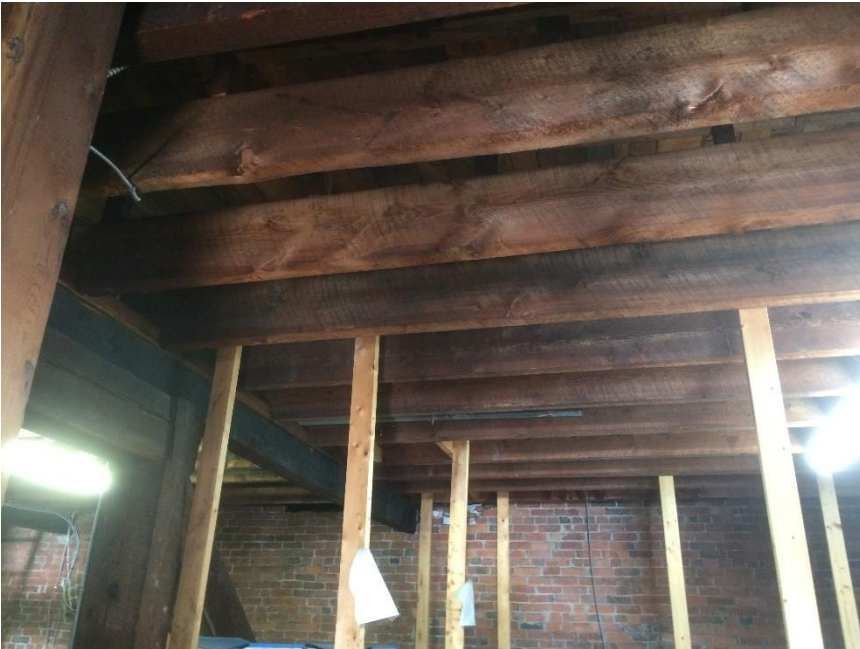
There are three sets of horizontal roof joists (see Photo 12). The first set of joists are 3" x 10" deep at 20" on centre and span from the west exterior wall to the top chord of the first truss. The second set of joists are 3" x 10" deep at 20" on centre and span from the top chord of the first truss to the top chord of the second truss. The third set of joists 3" x 10" deep at 20" on centre and span from the top chord of the second truss to the east exterior wall.

Photo 12 – Horizontal roof joists

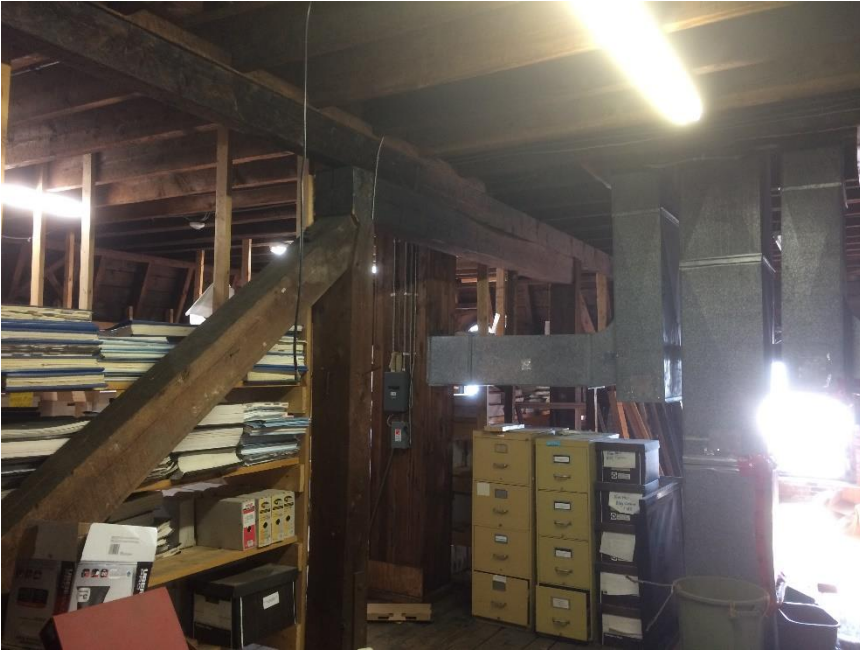
Each roof truss consists of two horizontal wood top chords, a horizontal wood bottom chord, two vertical wood web members at roughly third points of the truss span, and two inclined wood web members at each end (see Photo 13). The horizontal top chords of these roof trusses consist of an 8" x 10" deep member spanning between vertical web members and a 5" x 8" deep horizontal member spanning from the north interior wall to the south exterior wall. Note that this north interior wall separates the north building section from the south building section. The vertical web members are 7.5" x 10", and the inclined top chords of these trusses are 8" x 9". The bottom chord is 8.5" x 12" deep. The connections at the truss node points are composed of steel brackets and/or steel through-bolts (see Photos 14 and 15). The bottom chords of these trusses support the attic floor joists.

Photo 13 – Roof truss in south section of building

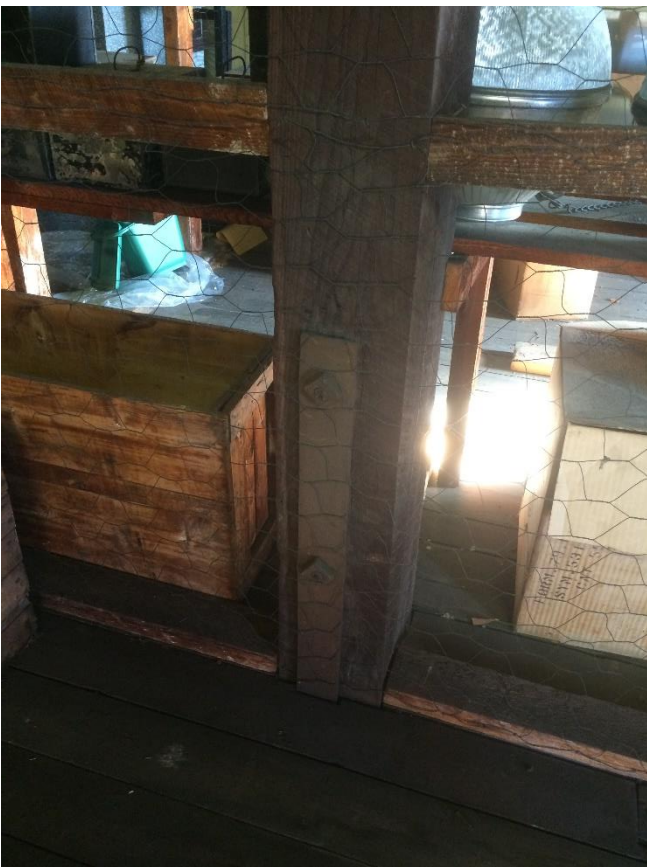
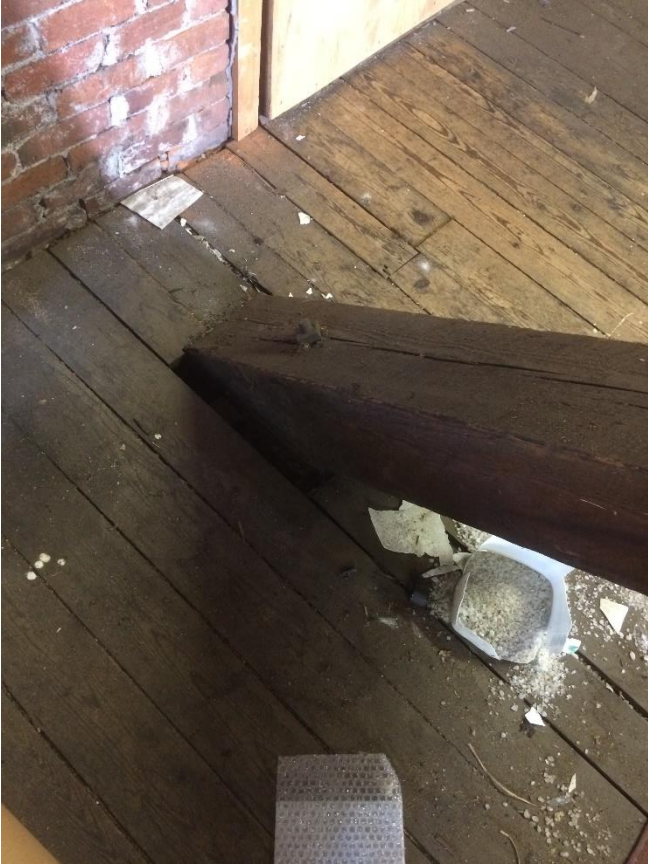
Photo 14 – Truss bracket with through-bolts

Photo 15 – Truss through-bolt connection (inclined web member to bottom chord)

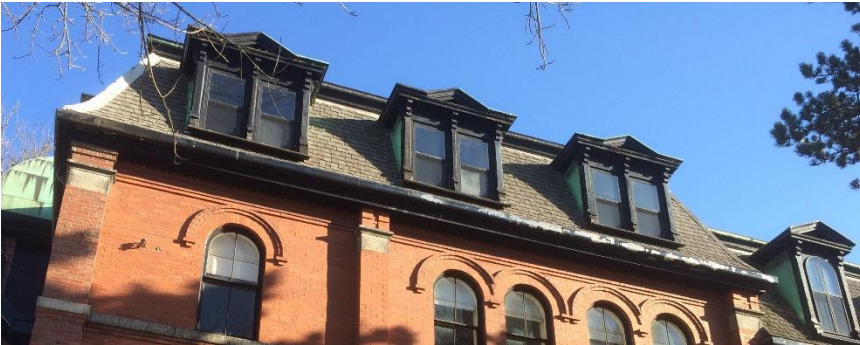
The roofing material on the lower Mansard-style portion of the roof of the north section of the building is composed of asphalt shingles (see Photo 16). The shingles on this section of roof appear to be older than the shingles on the hipped portion of this roof, however, they appear to be in fair condition.

Photo 16 – Mansard-style roof on north section of building

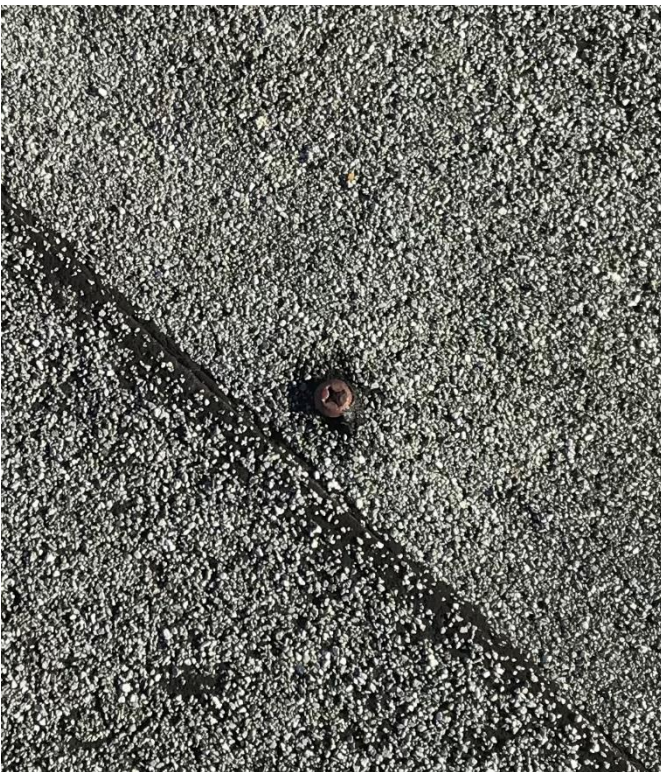
The roofing material on the upper flat portion of the roof of the south section of the building is composed of asphaltic roofing membrane. Moss growth was observed on this membrane (see Photo 20). Screws penetrating the roofing membrane were observed in two locations (see Photos 21 and 22).

Photo 22 – Screw in roof membrane (2 of 2)

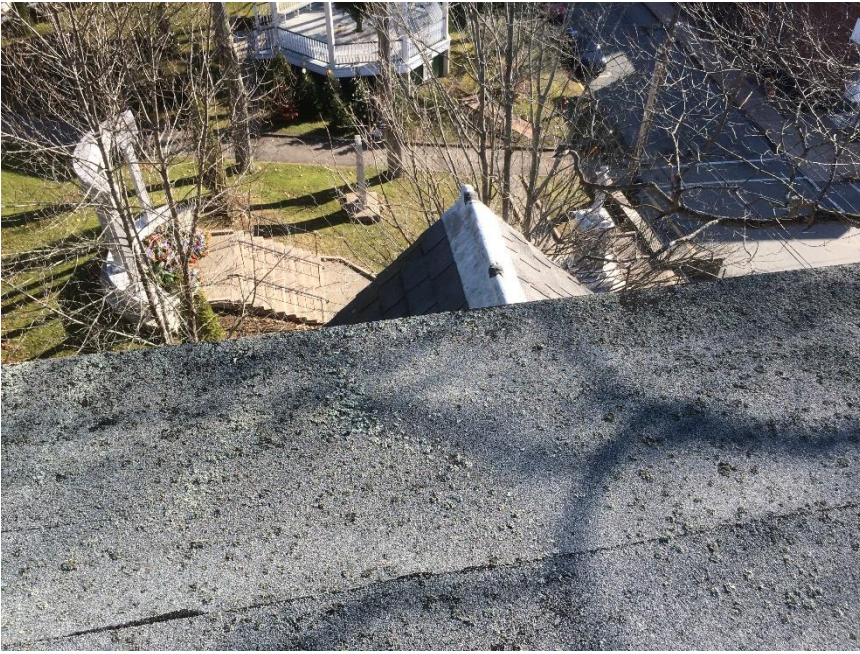
Some of the roofs of the dormers are covered in shingles with a lead ridge cap (see Photo 23) and others are covered in copper (see Photo 24). Paint is peeling on the wood trim of the dormers (see Photo 25).

**Photo 23 – Dormer with metal ridge cap**

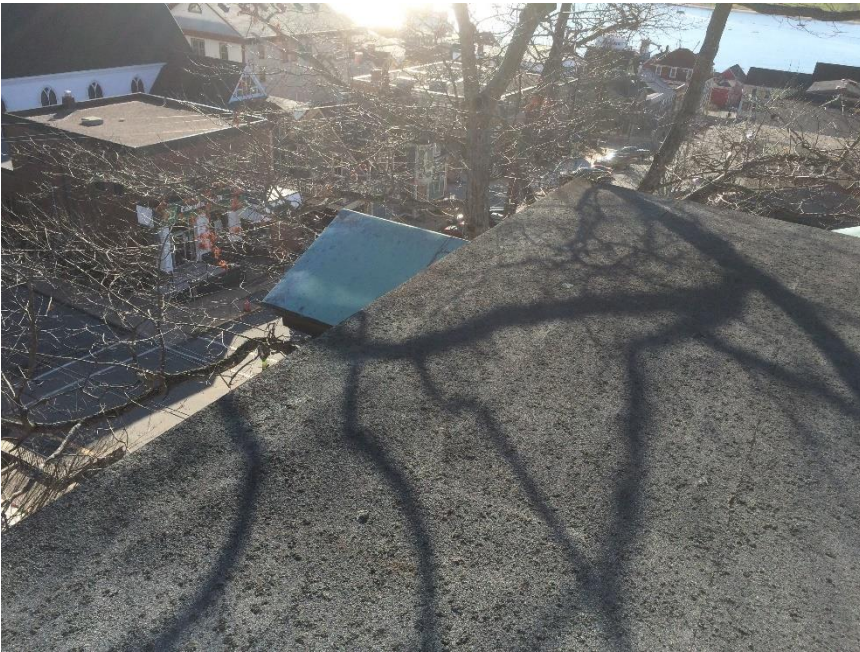
**Photo 24 – Dormer with copper roof**

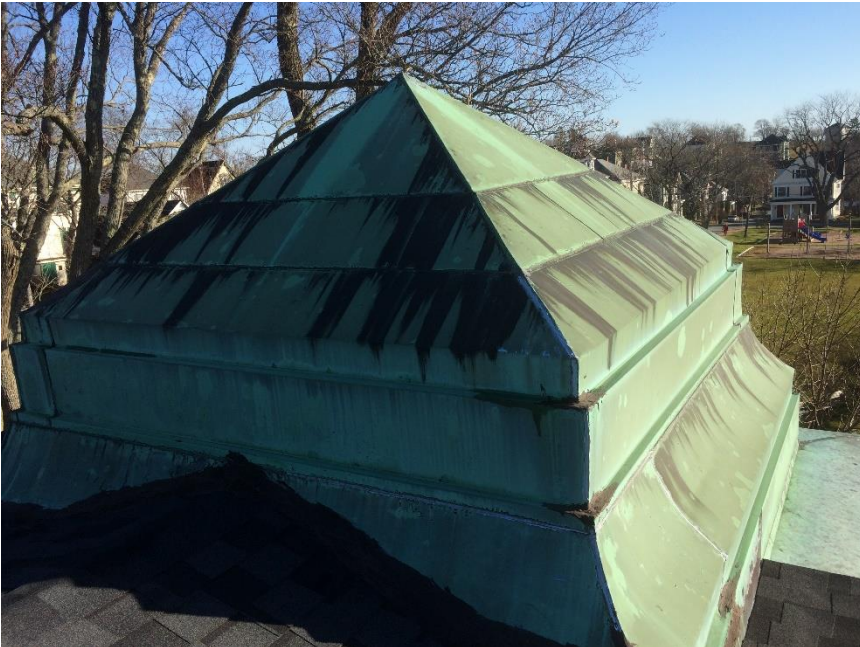
The cupolas are covered in copper (see Photo 26). The cupola on the north side of the north building section is covered in copper with a flat top that consists of roof membrane with a metal edge (see Photo 27).

Photo 26 – Cupola with copper cover

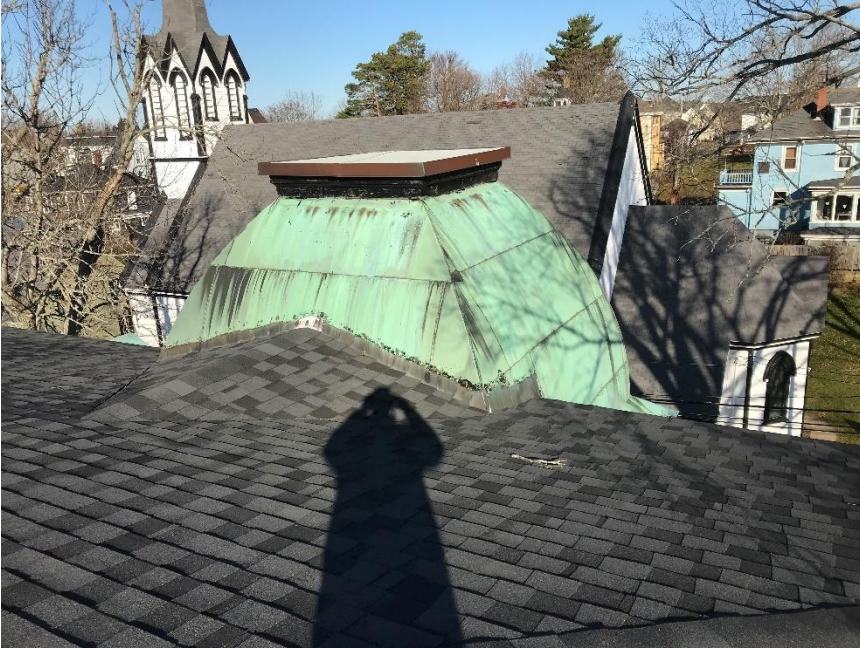
Photo 27 – Cupola with flat top at north end of building

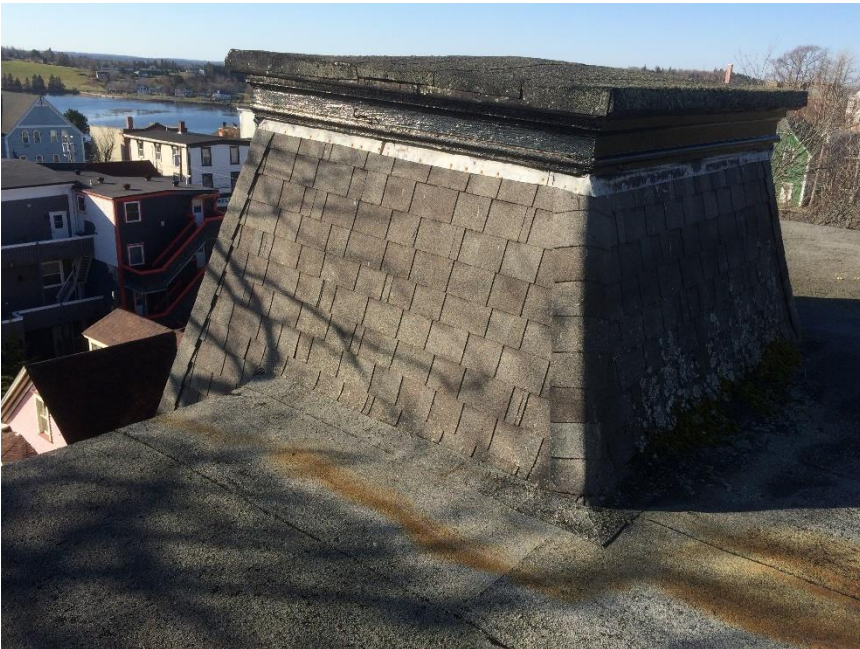
The roof of the south section of the building contains a wood-framed base of a former clock tower (see Photo 28). The sides of this base are covered with asphalt shingles. The base also contains a wooden lid also covered in shingles. Lead flashing is installed at the base of the lid. Moss and lichen growth were observed on the shingles of this base (see Photo 29).

Photo 28 – Base of former clock tower

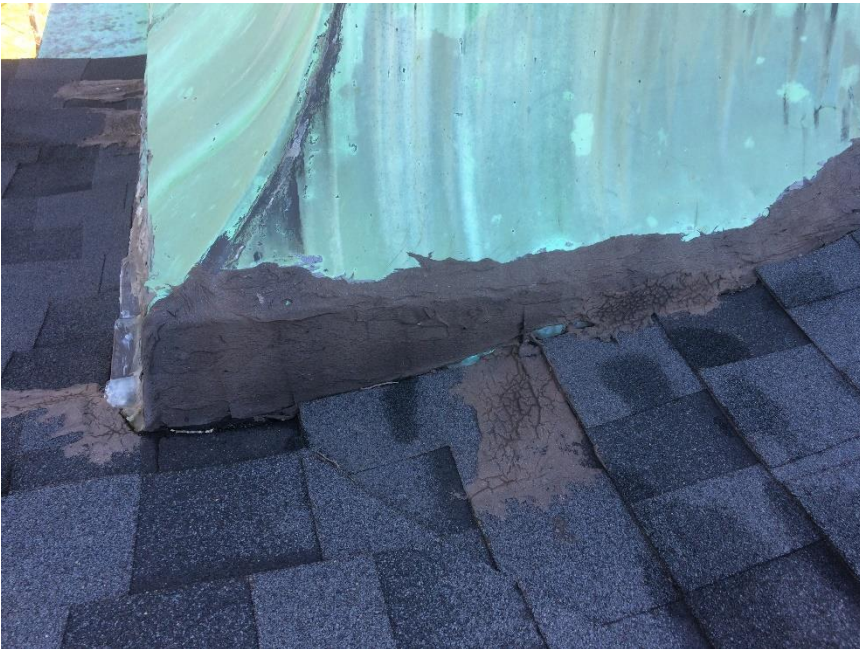
Photo 32 – Lead and tar flashing around cupola

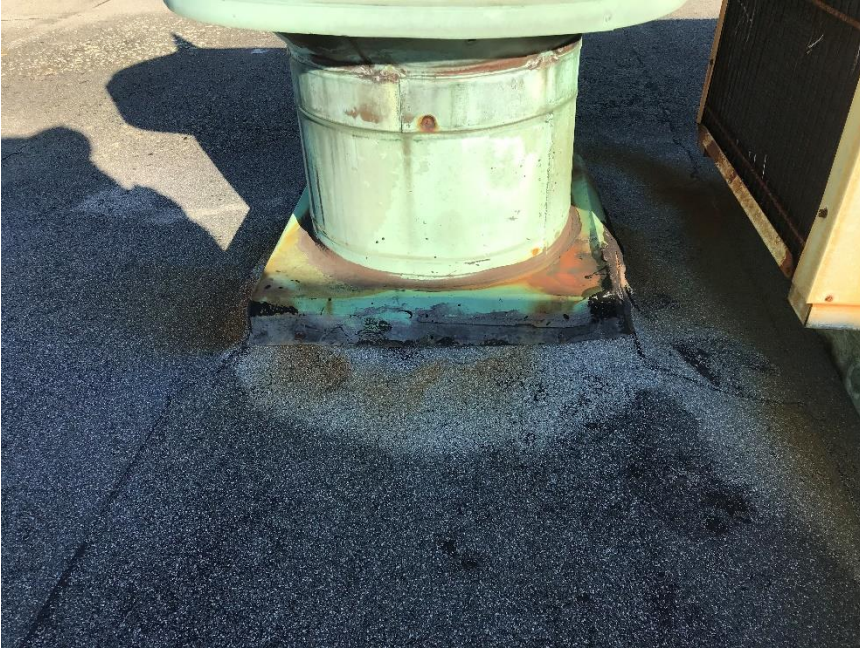
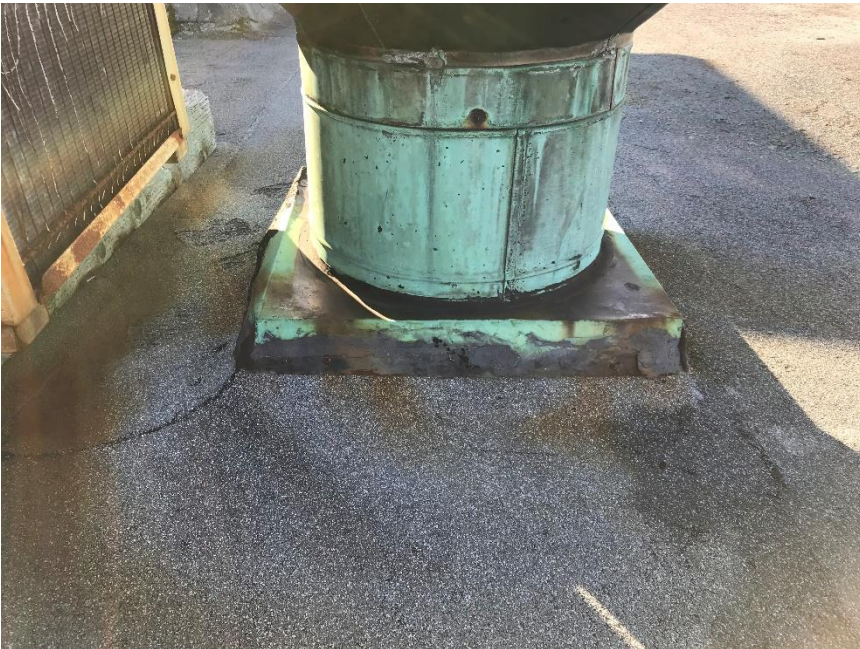
Photo 33 – Flashing around circular roof vent (1 of 2)

Photo 34 – Flashing around circular roof vent (2 of 2)

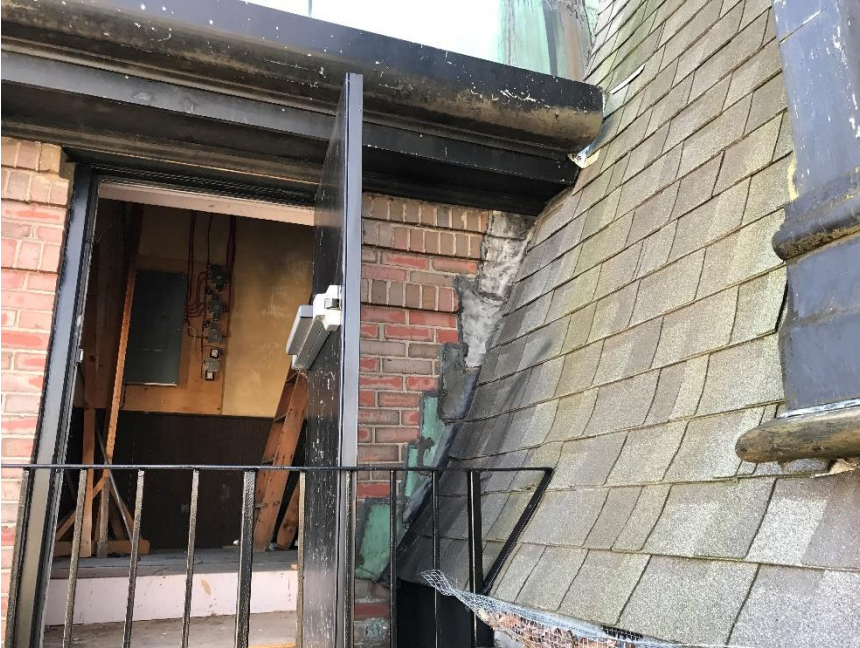
Photo 35 – Lead flashing between exterior masonry wall and Mansard-style roof

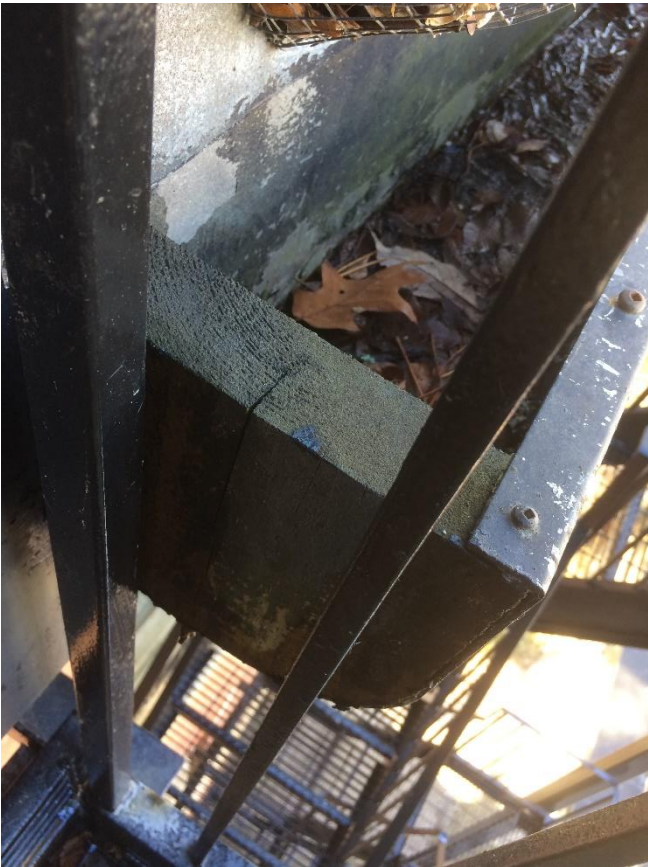
The gutters are composed of bent steel with wood ends (see Photo 36) and have thin steel mesh covers that have been bent up in several locations (see Photo 37). The gutters do not appear to have any observable slope towards the downspouts.

Photo 36 – Typical gutter (bent steel with wood ends)

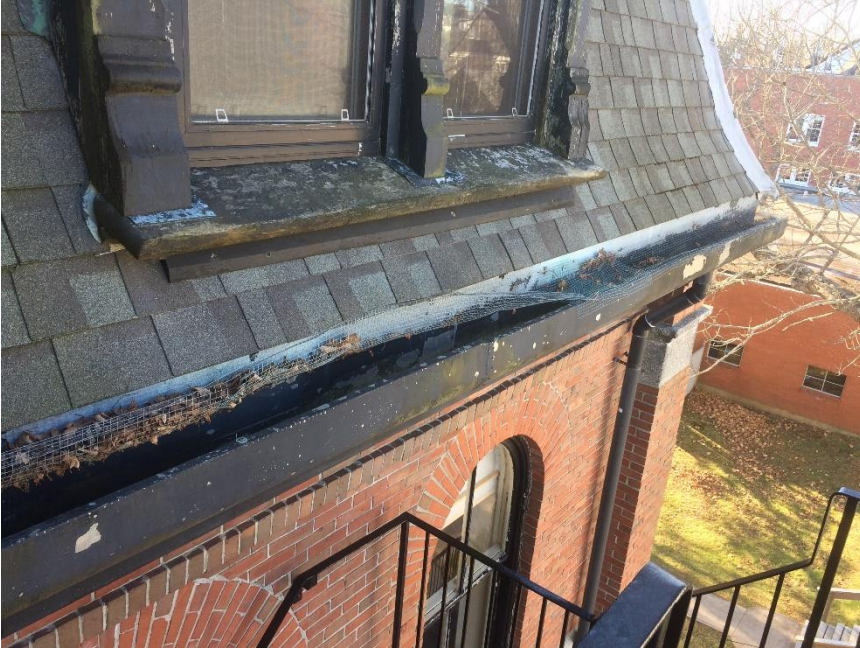
Photo 37 – Bent steel mesh above gutters

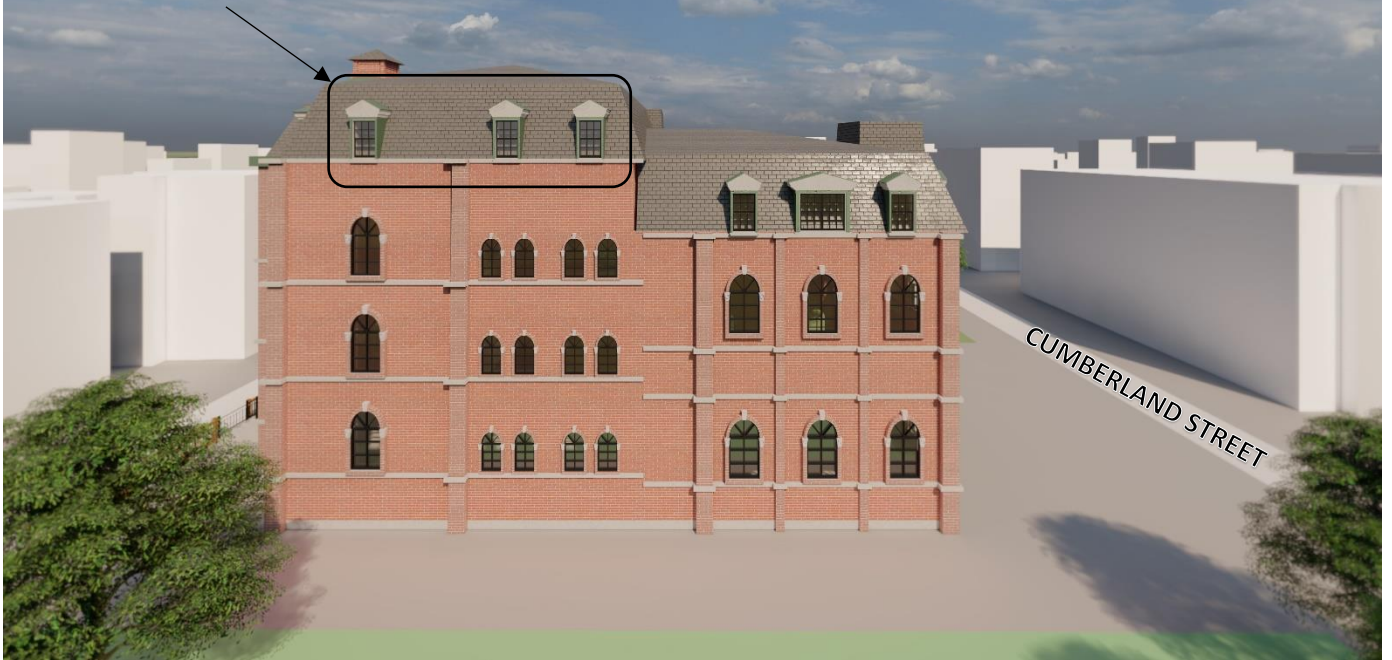
WATER INFILTRATION IN  
UPPER, NORTH ROOF DORMERS
